# Maribyrnong City Council Significant Tree Register 2019 Draft for Consultation

**Homewood Consulting Pty Ltd**

**Maribyrnong City Council**

December 2019

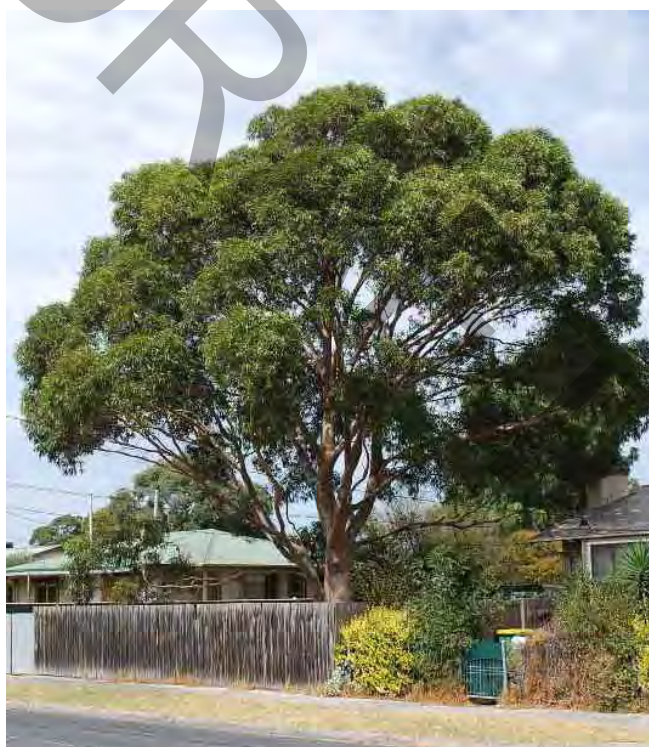
Figure 1: Tree 54 *Corymbia maculata* (Spotted Gum)  
assessed as significant for 'Location of Landscape'

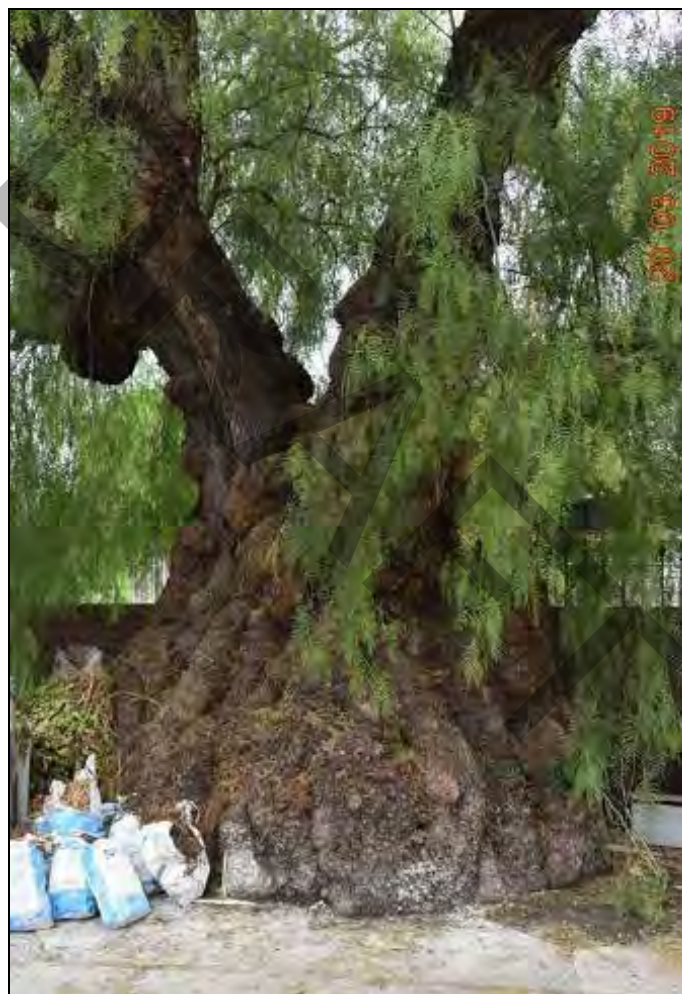
The widest recorded girth is a *Schinus mole* (Peppercorn Tree) with a diameter at breast height (DBH) estimated to be 240cm in diameter followed by a *Ficus macrophylla* (Morton Bay Fig) with a DBH of 160cm and a *Cupressus macrocarpa* (Monterey Cypress) with a DBH of 142cm.

Figure 3: Tree 114 *Schinus molle* has the widest girth
