# Maribyrnong City Council Significant Tree Register 2019 Draft for Consultation

**Homewood Consulting Pty Ltd**

**Maribyrnong City Council**

December 2019

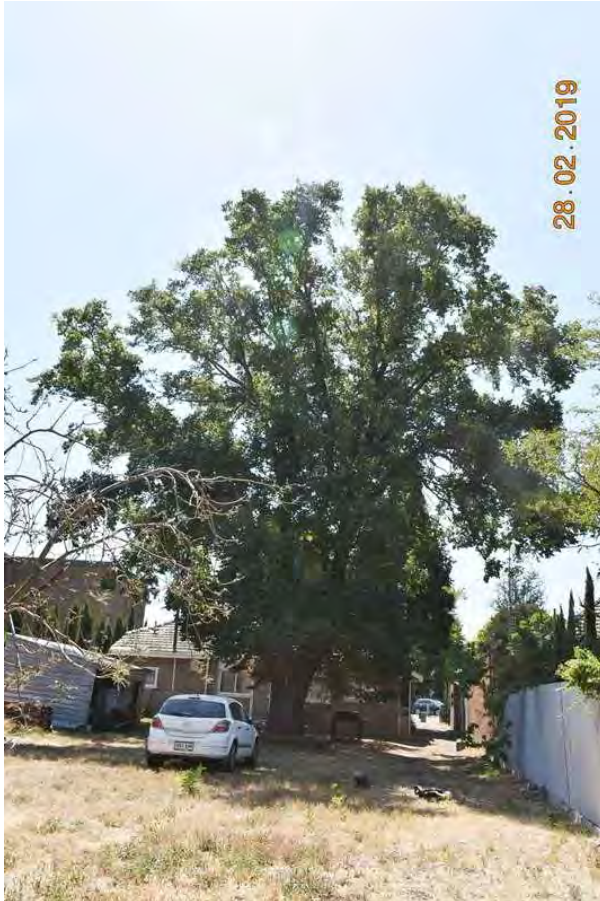
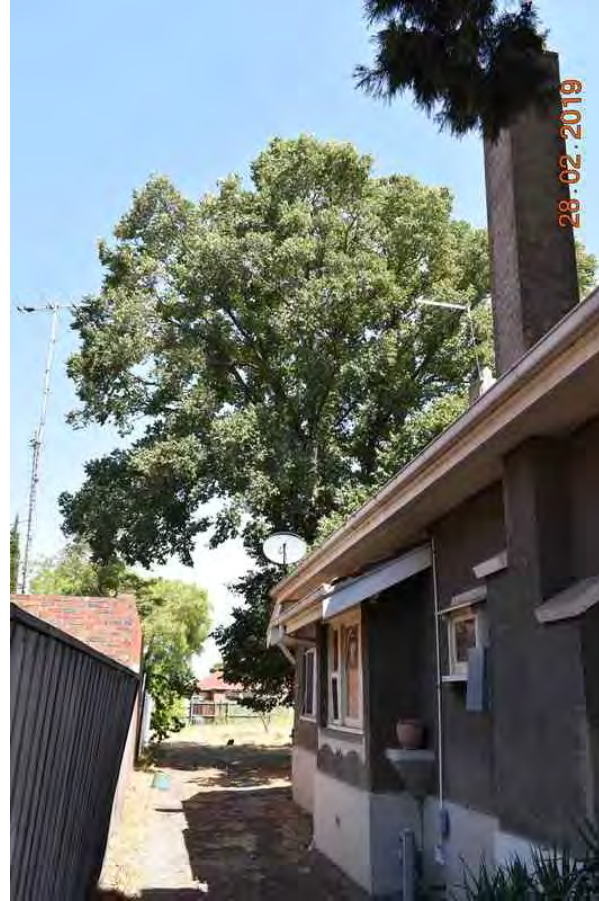
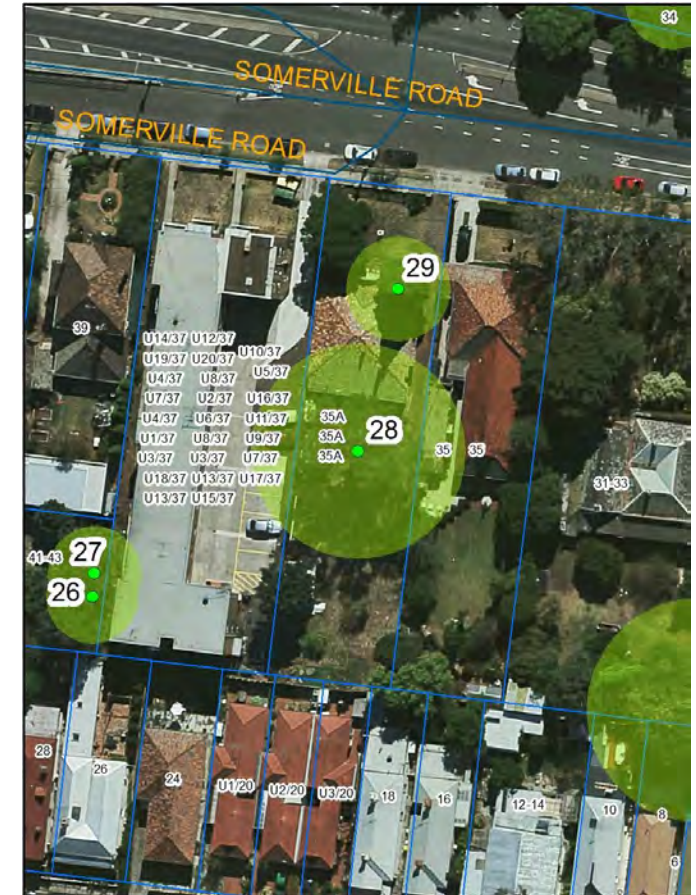
**Defects:** Codominant trunks

**Comments:** Treat for elm leaf beetle, only minor damage.

**Recommended Works:** Risk reduction pruning

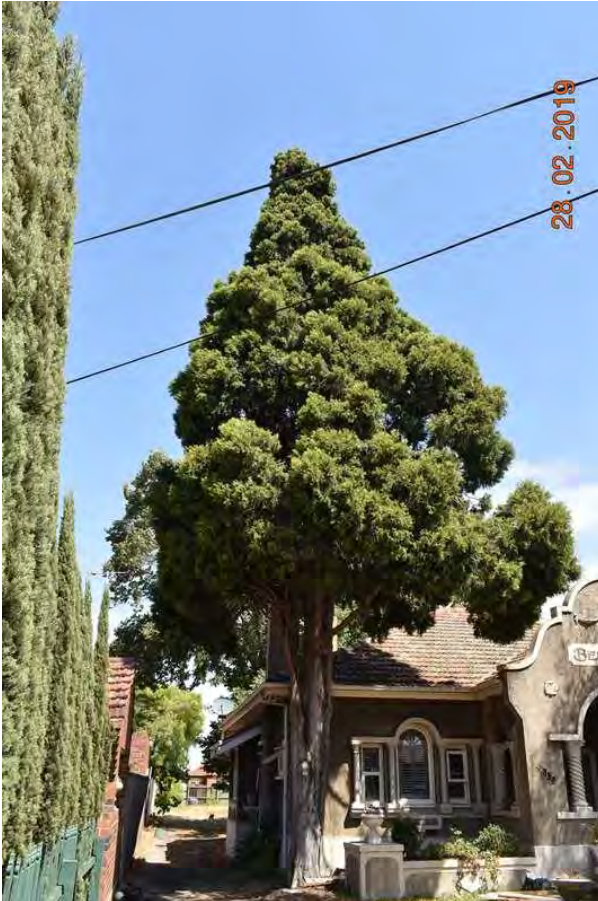
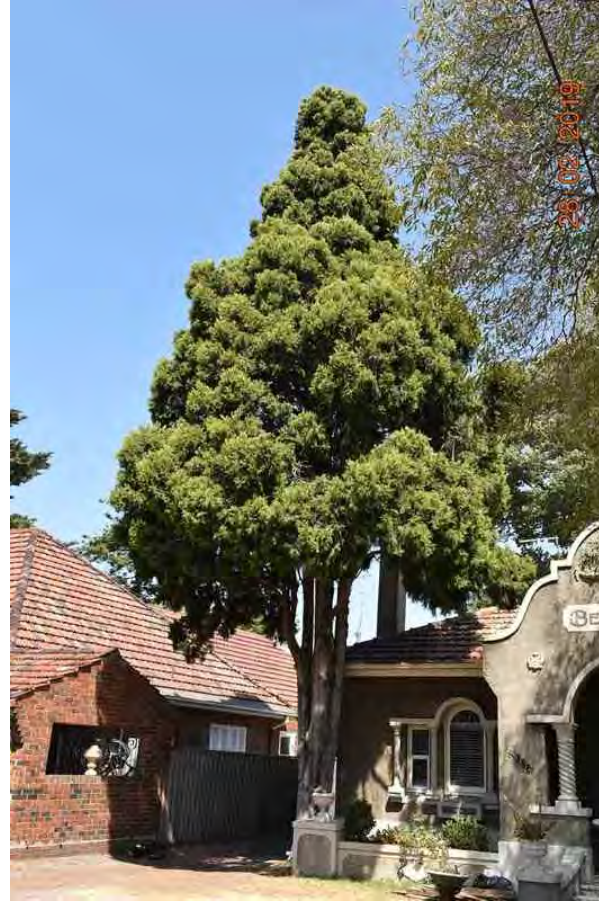
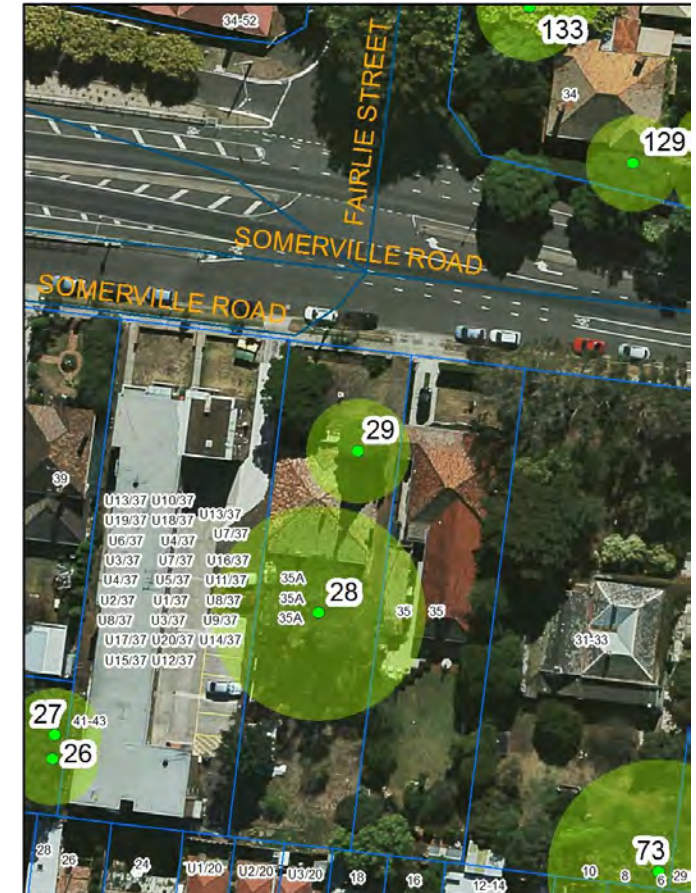
**Asset ID:** 29

**Failure Probability:** 4. Low

**Failure Size:** 3. 101-250mm

**Defects:** Included bark in trunk, Codominant trunks

**Recommended Works:** No works

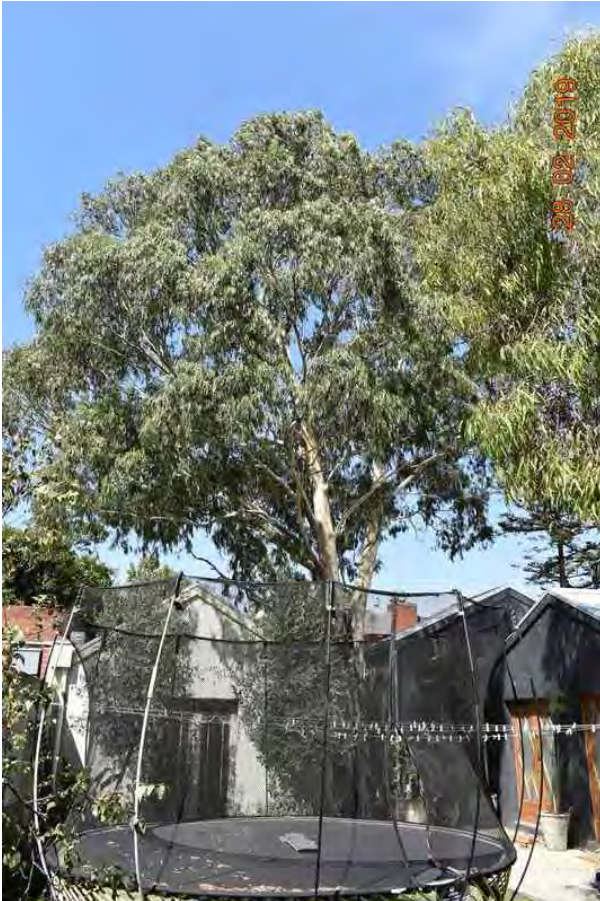
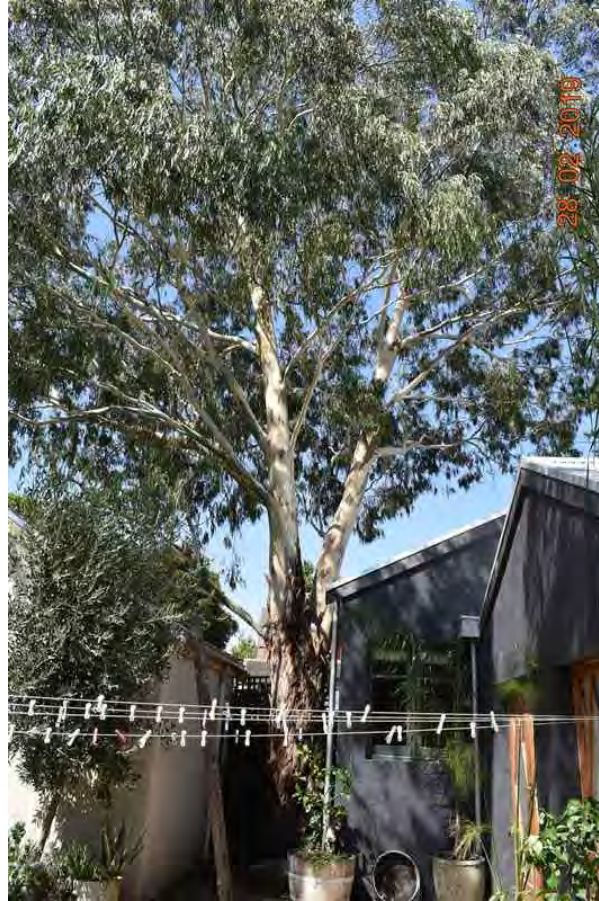
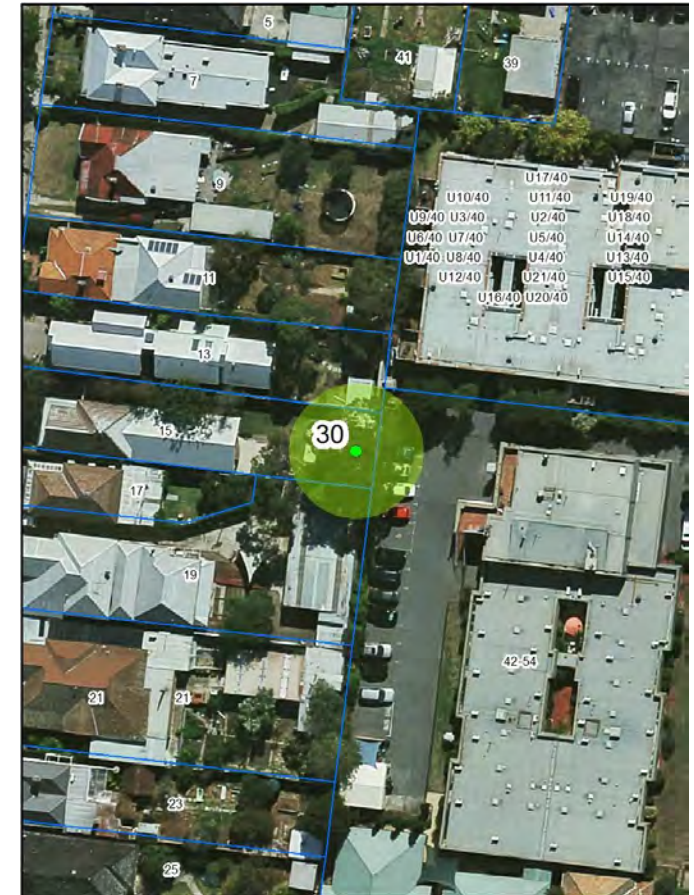
**Asset ID:** 30

**Failure Probability:** 3. Moderate

**Failure Size:** 3. 101-250mm

**Defects:** Included bark in trunk, Codominant trunks

**Recommended Works:** Risk reduction pruning

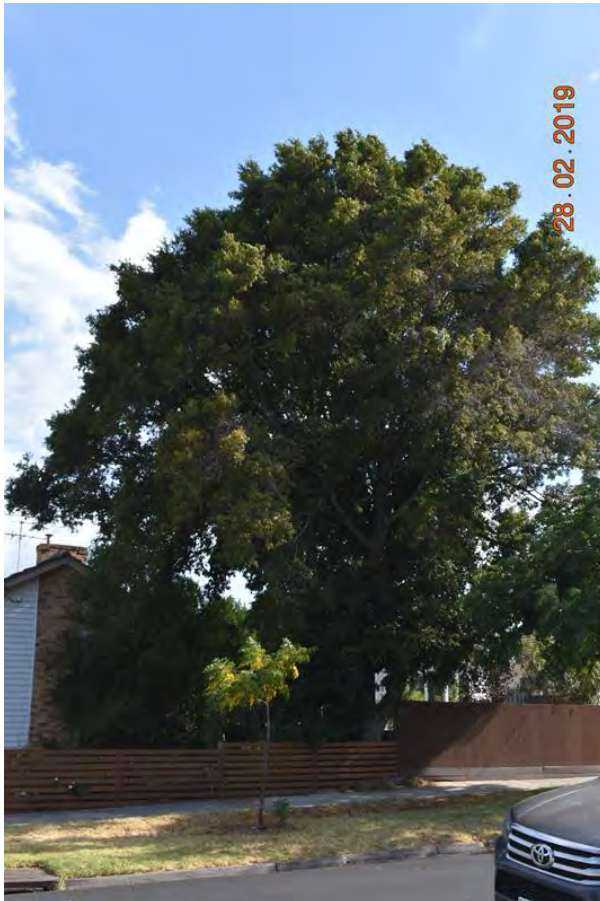
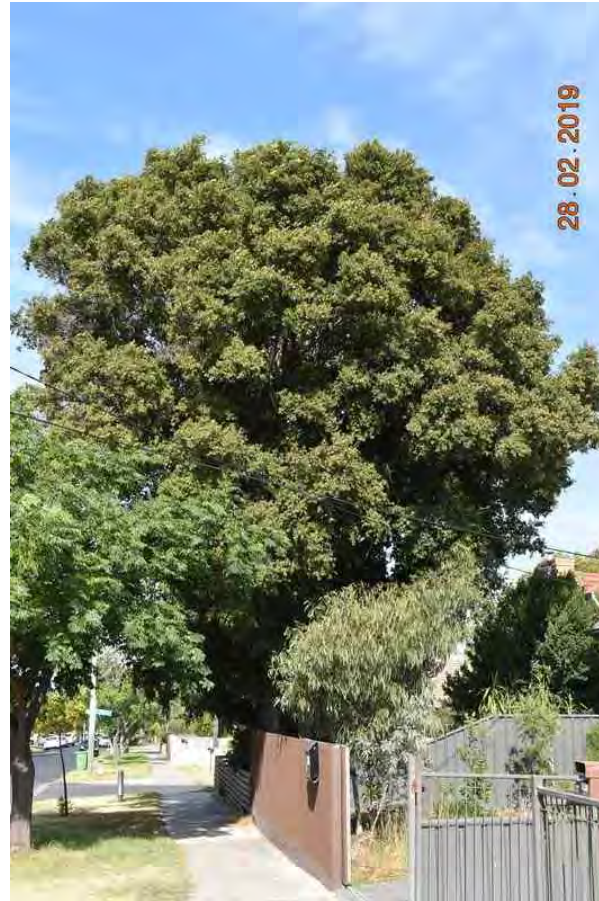
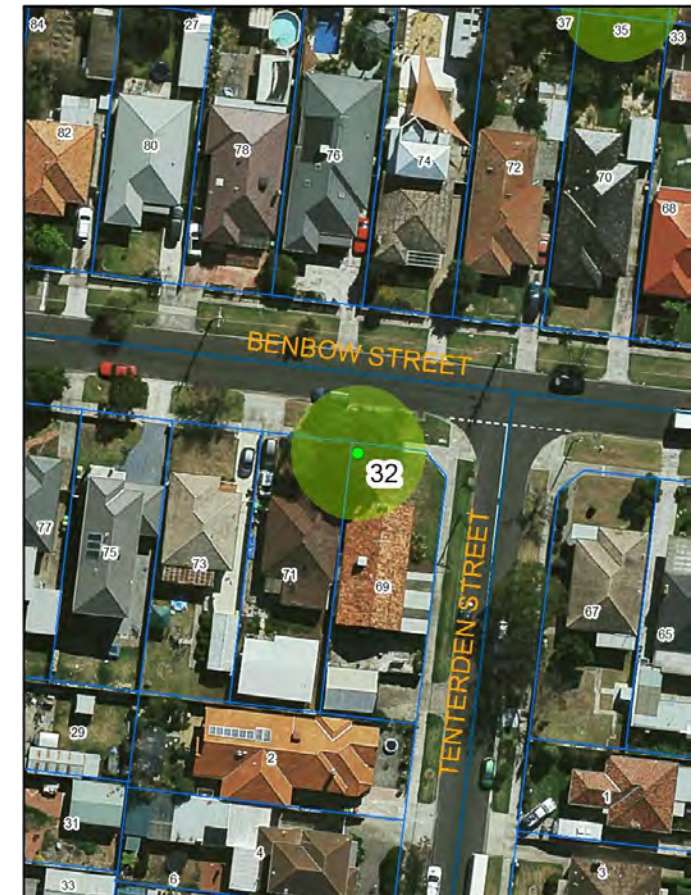
**Asset ID:** 32

**Failure Probability:** 3. Moderate

**Failure Size:** 3. 101-250mm

**Defects:** Codominant trunks

**Recommended Works:** No works

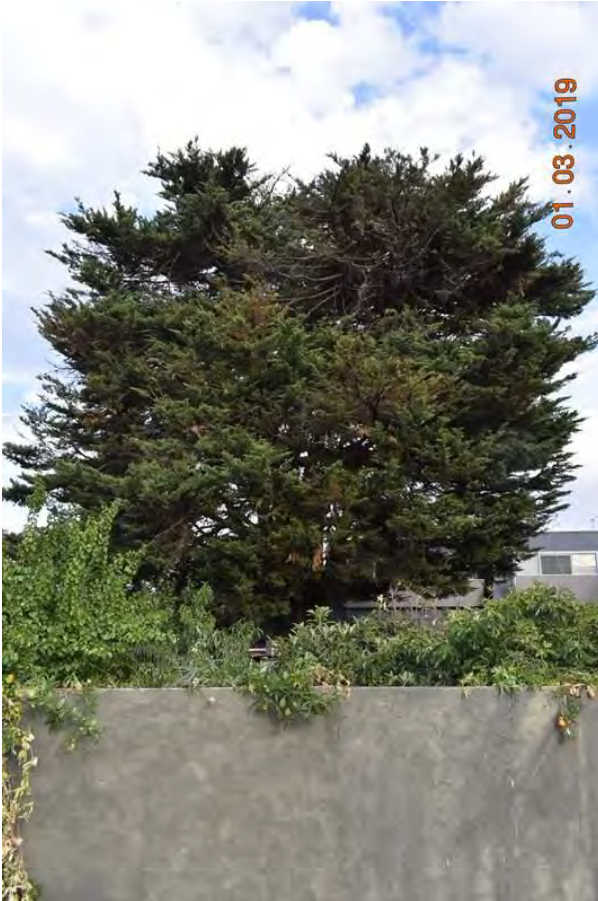
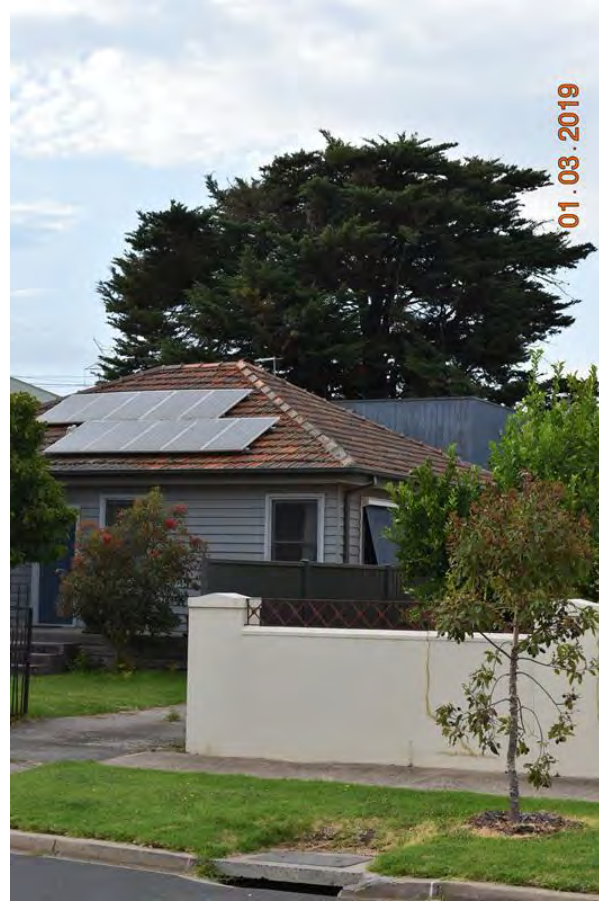
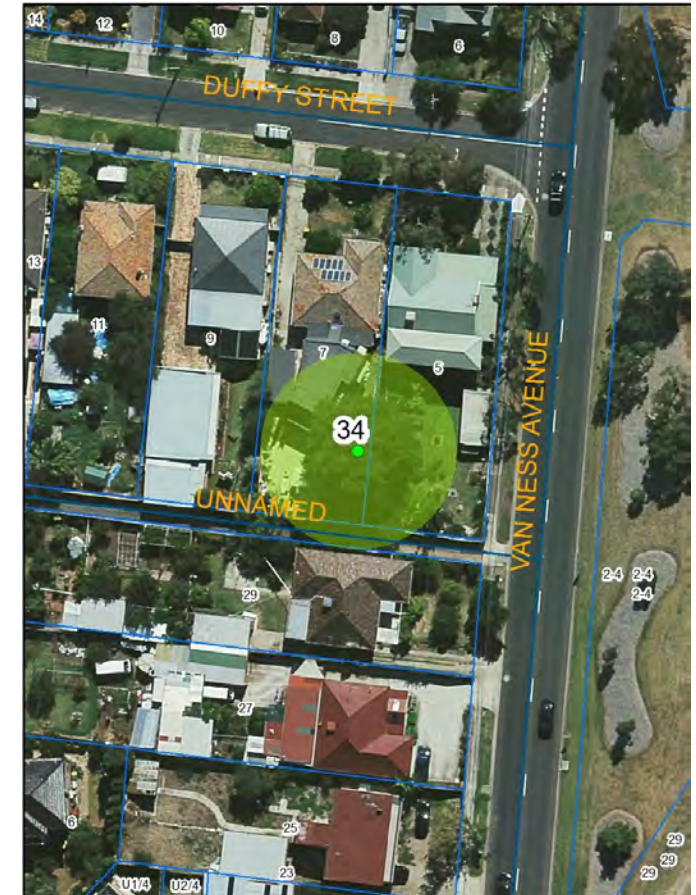
**Asset ID:** 34

**Failure Probability:** 3. Moderate

**Failure Size:** 3. 101-250mm

**Defects:** Deadwood, Codominant stems in canopy, Codominant trunks  
**Recommended Works:** Deadwood removal

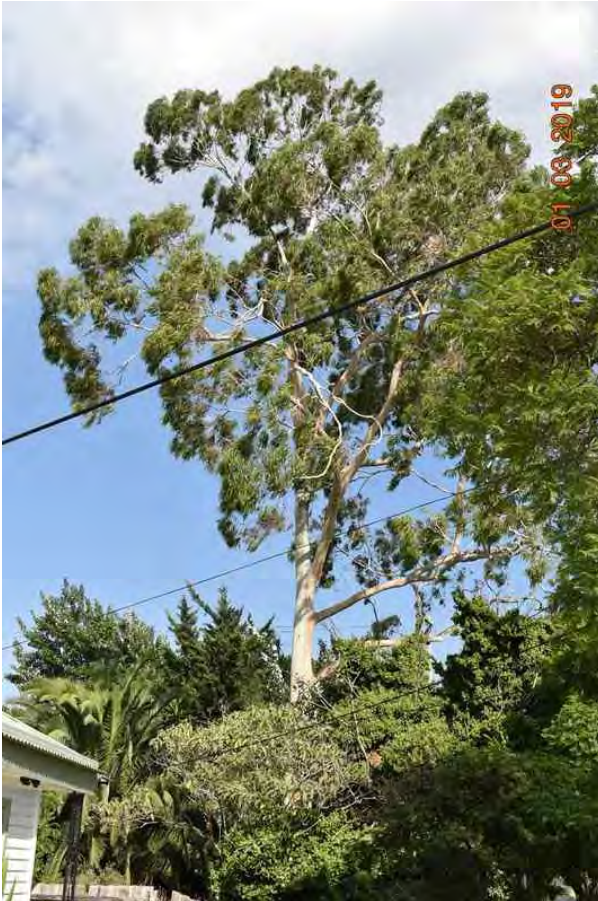
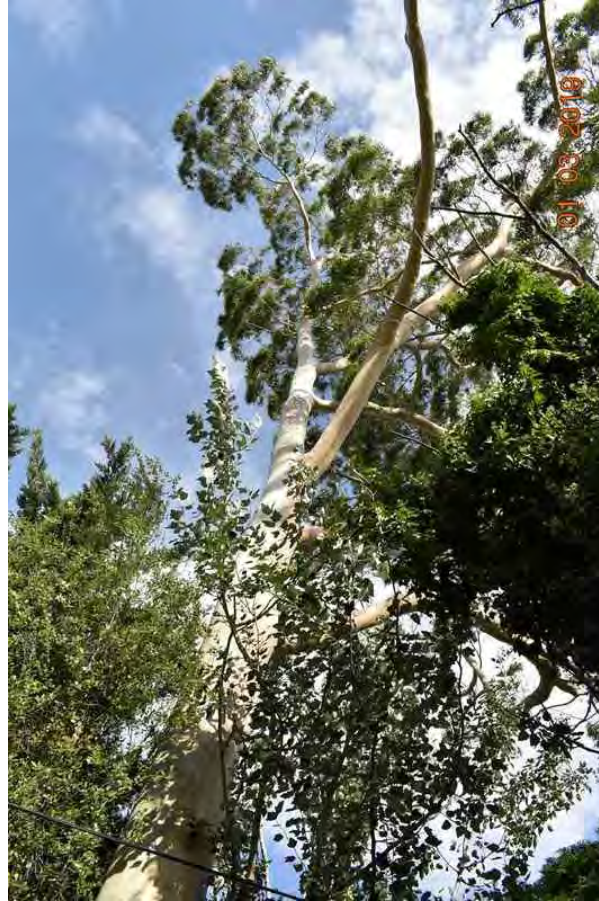
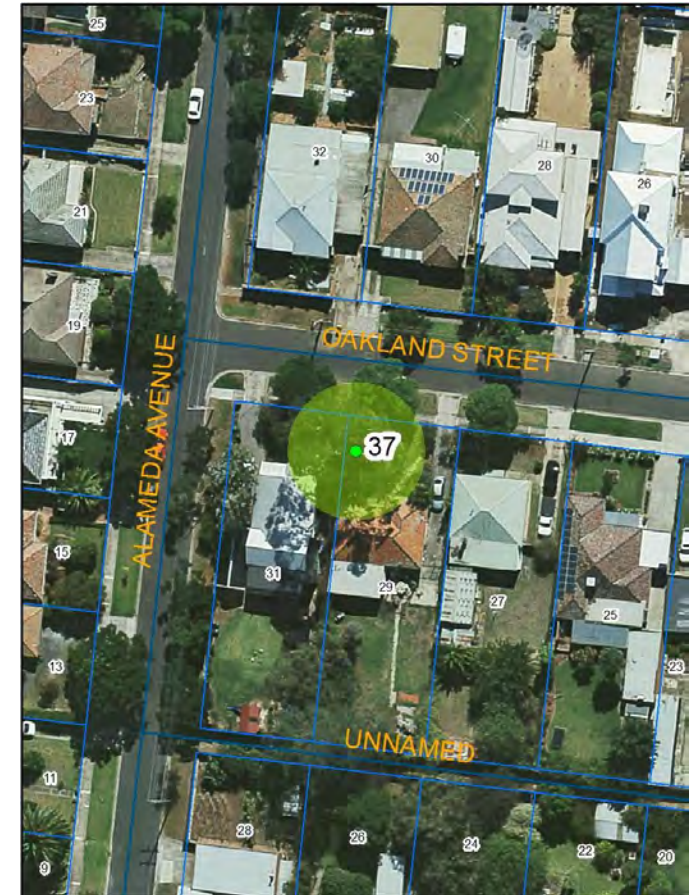
**Asset ID:** 37

**Failure Probability:** 3. Moderate

**Failure Size:** 3. 101-250mm

**Defects:** Codominant stems in canopy

**Recommended  
Works:** Risk reduction pruning

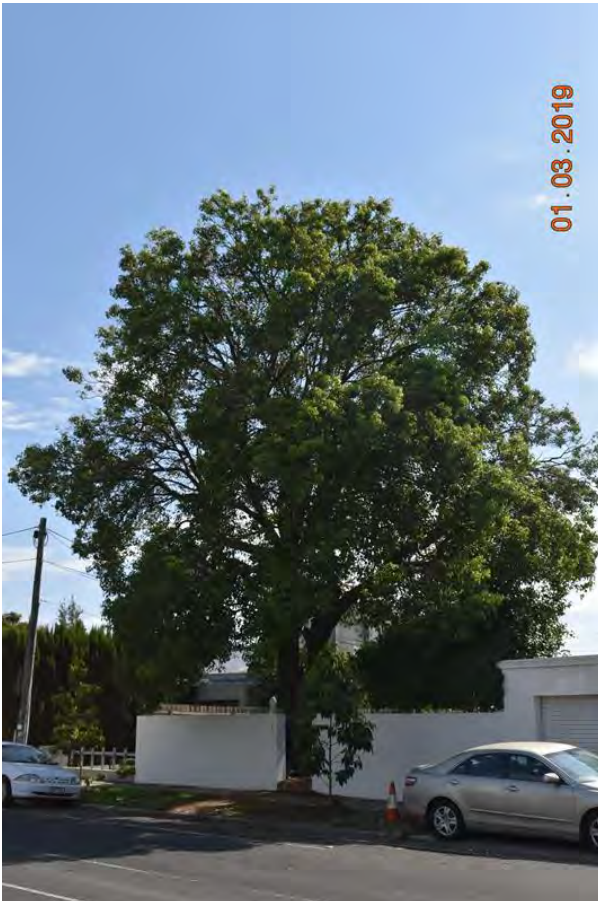
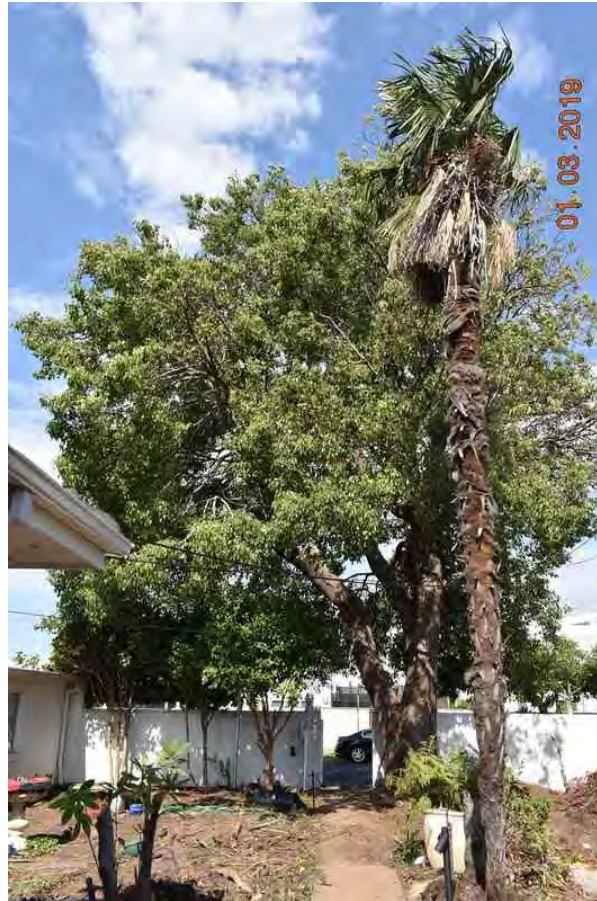
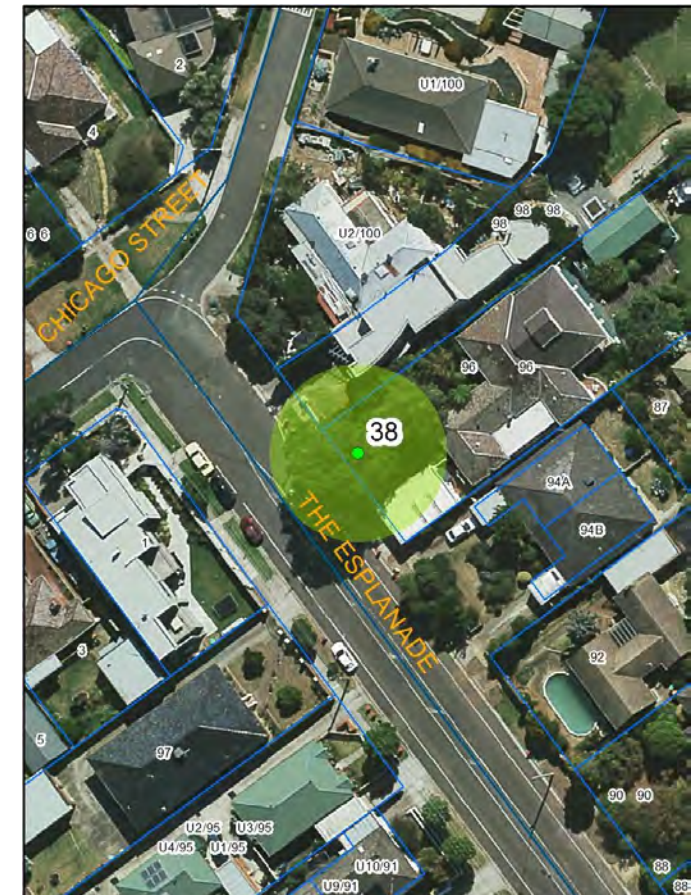
**Asset ID:** 38

**Failure Probability:** 3. Moderate

**Failure Size:** 3. 101-250mm

**Defects:** Deadwood, Codominant trunks

**Comments:** Extensive landscaping in front yard, including excavation, roots may have been damaged

**Recommended Works:** Structural pruning, Deadwood removal

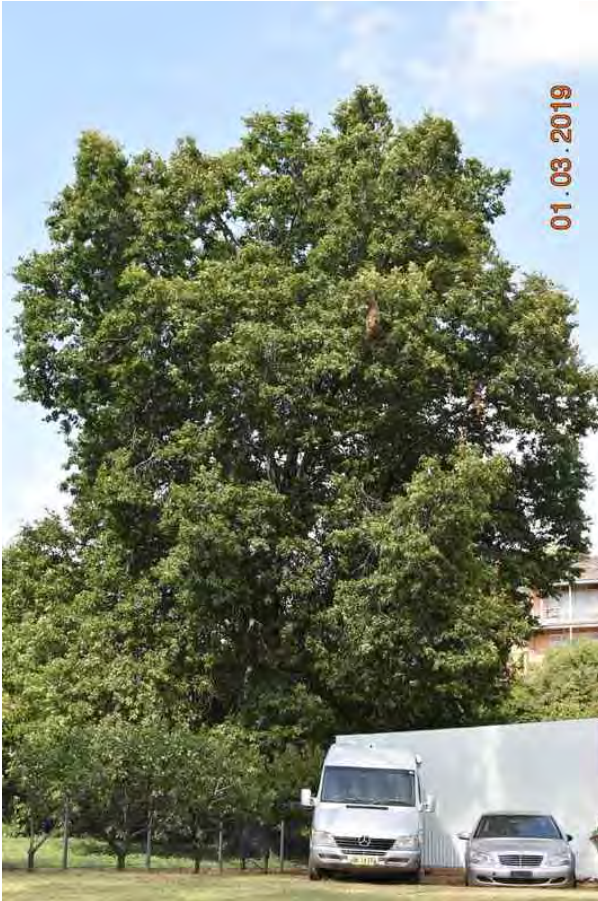
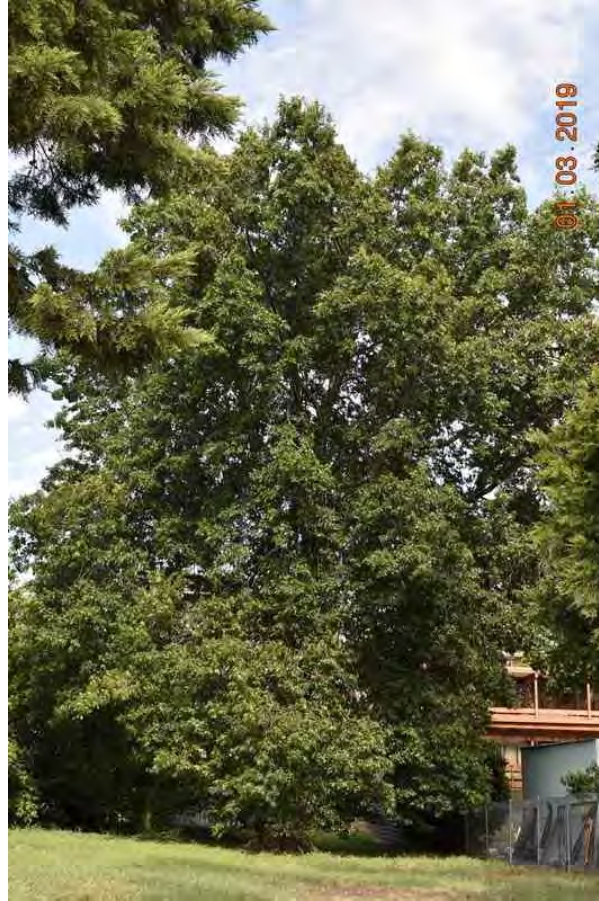
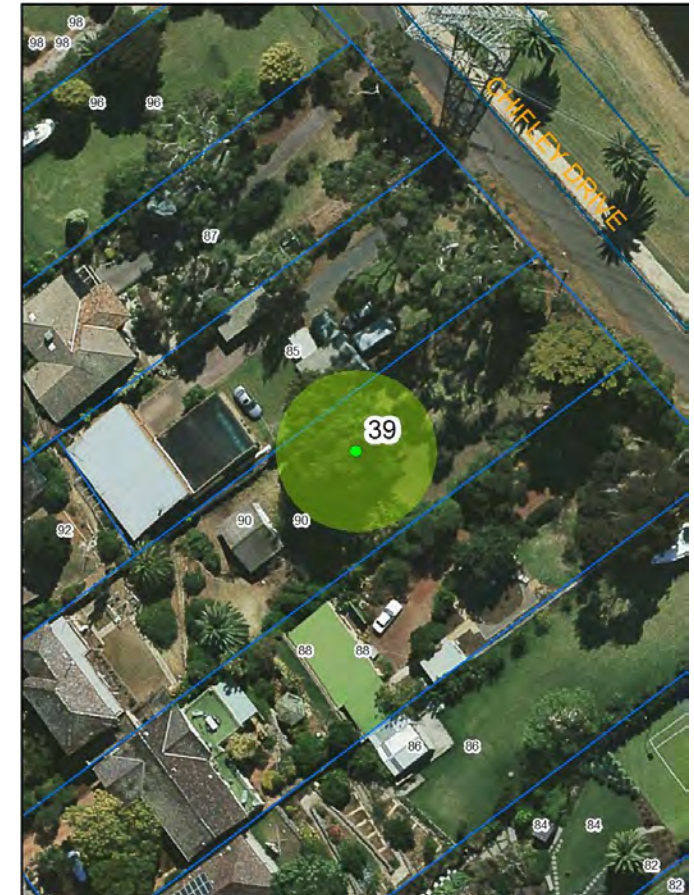
**Asset ID:** 39

**Failure Probability:** 3. Moderate

**Failure Size:** 3. 101-250mm

**Defects:** Included bark in trunk, Decay in canopy, Codominant trunks

**Recommended Works:** Risk reduction pruning, Structural pruning

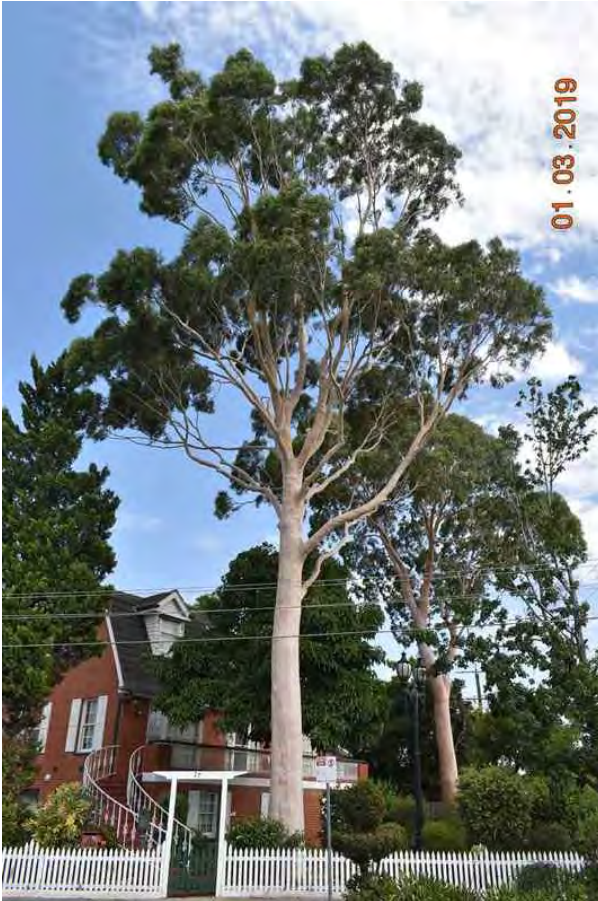
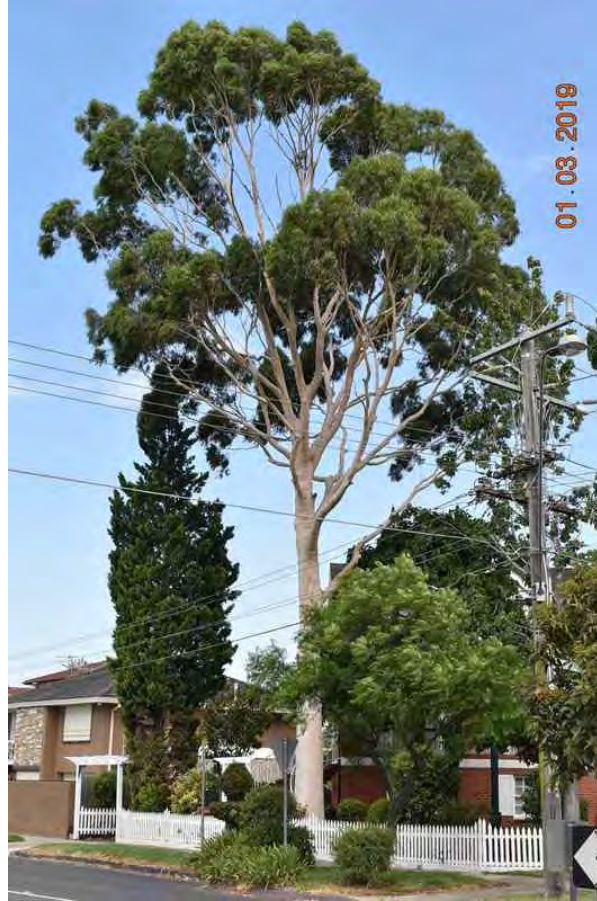
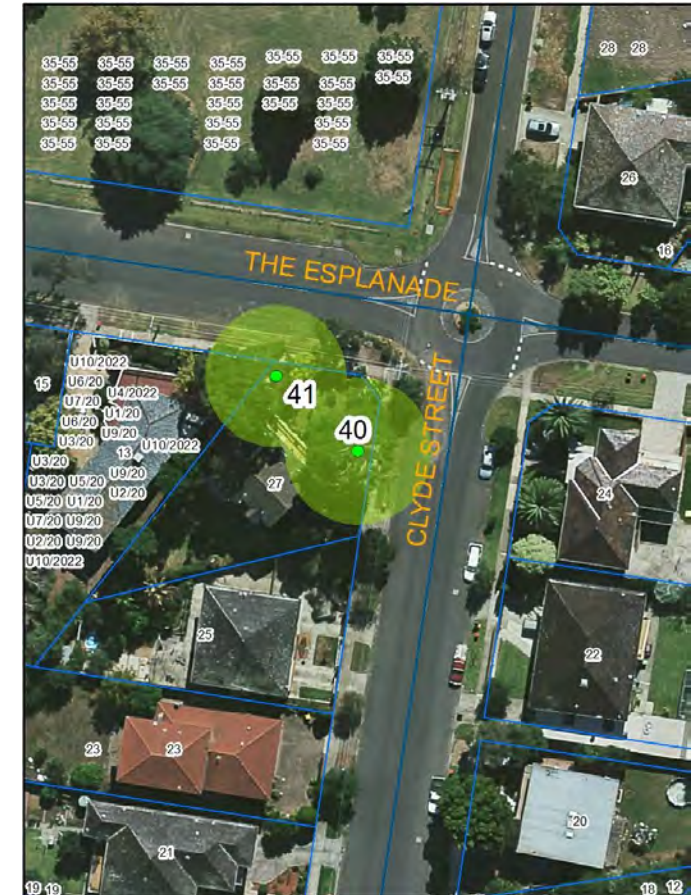
**Asset ID:** 40

**Failure Probability:** 4. Low

**Failure Size:** 3. 101-250mm

**This large specimen is located in a prominent location, is in great condition and is a striking and defining natural feature of the surrounding landscape.**

**Defects:** Codominant stems in canopy

**Recommended Works:** No works

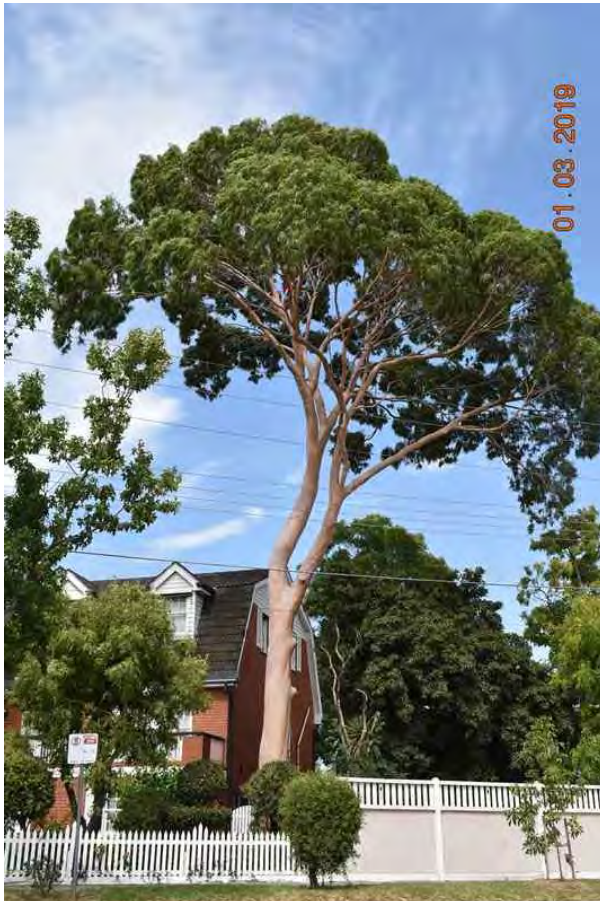
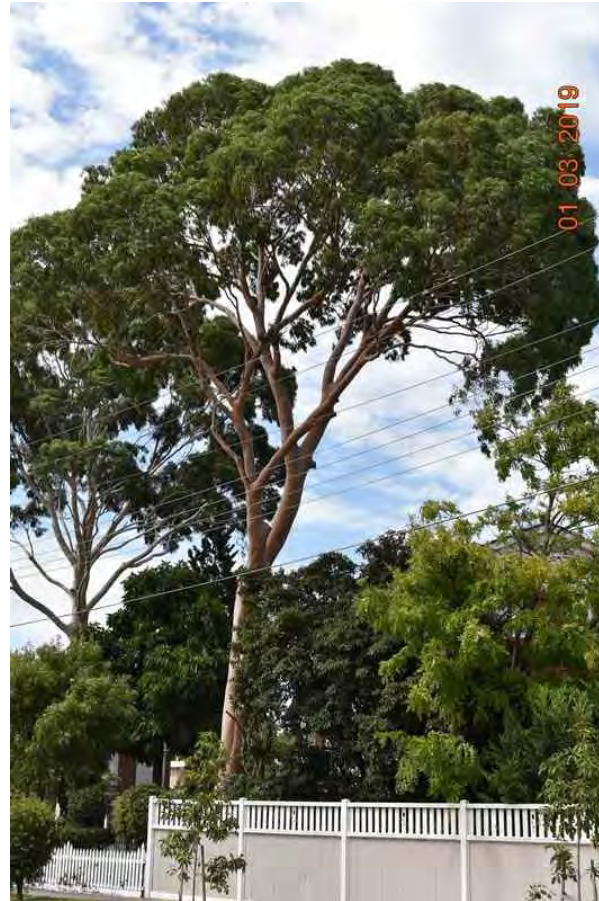
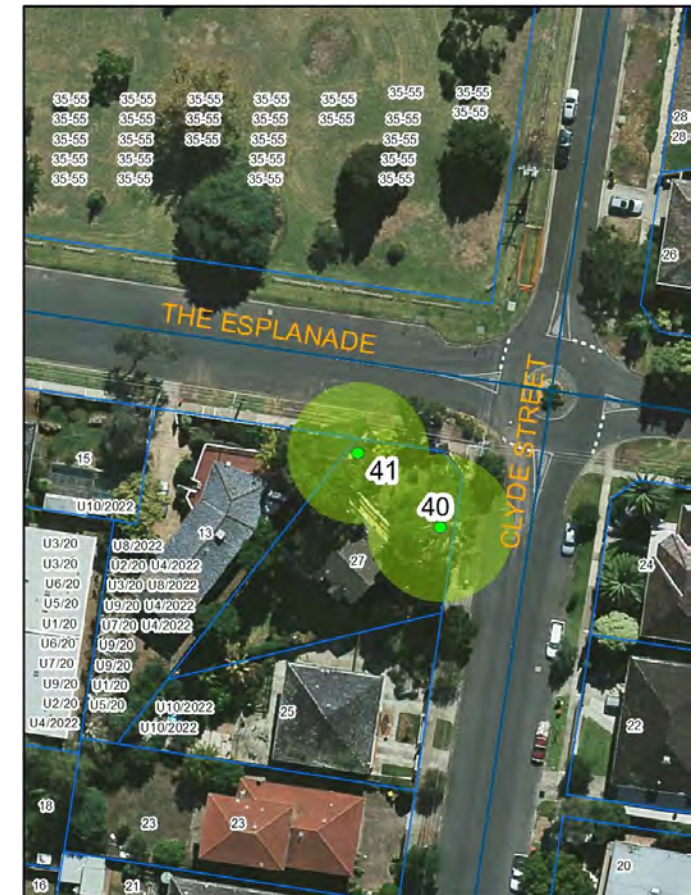
**Asset ID:** 41

**Failure Probability:** 4. Low

**Failure Size:** 3. 101-250mm

**Defects:** Codominant stems in canopy

**Recommended  
Works:** No works

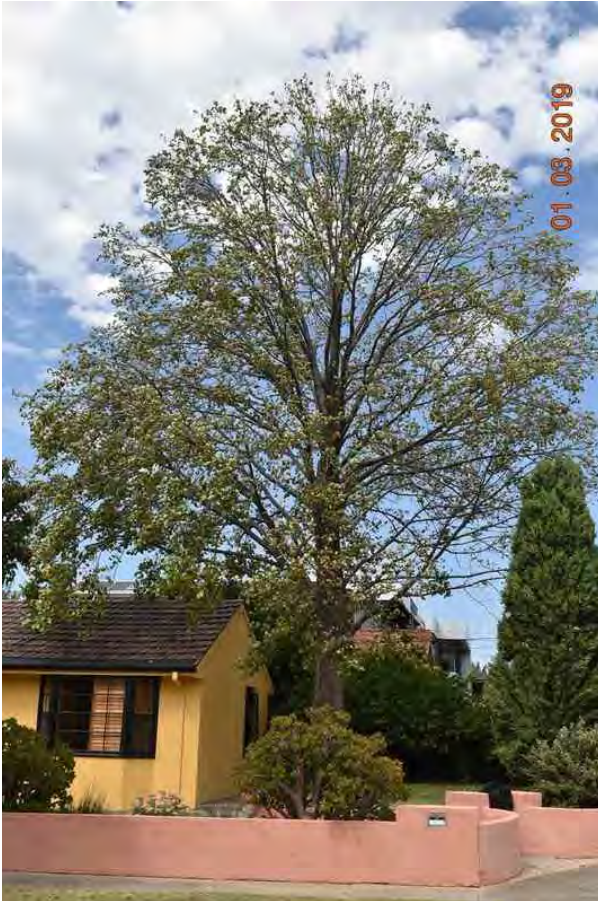
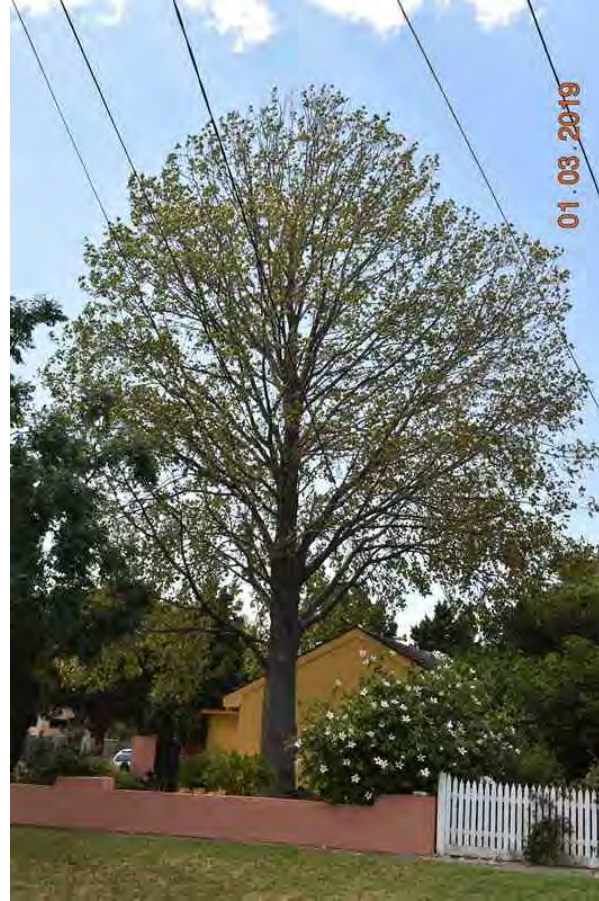
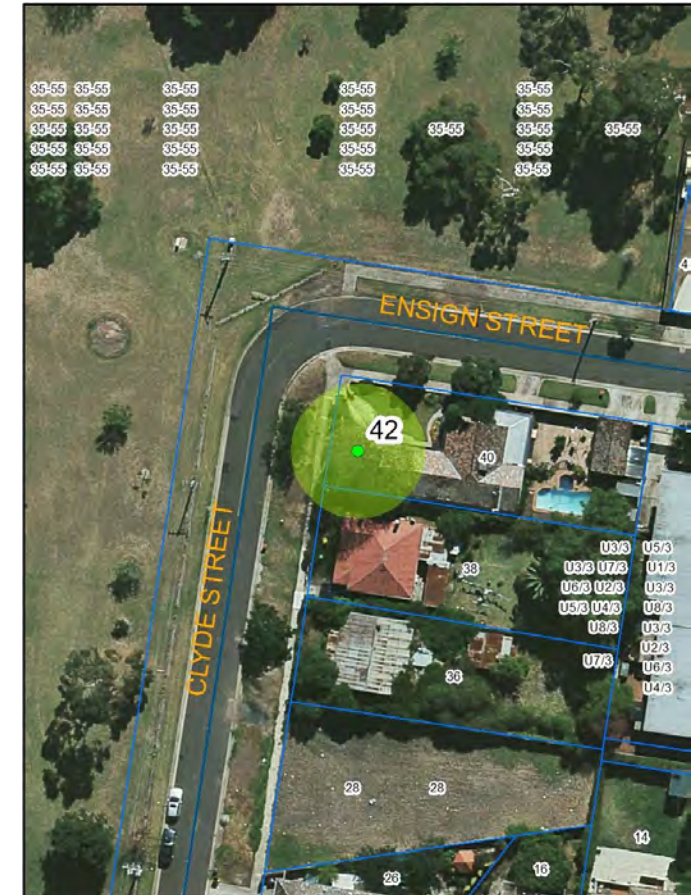
**Asset ID:** 42

**Failure Probability:** 3. Moderate

**Failure Size:** 3. 101-250mm

**Defects:** None

**Comments:** Sparse canopy. Mulch, fertiliser and irrigation would improve condition.

**Recommended Works:** No works

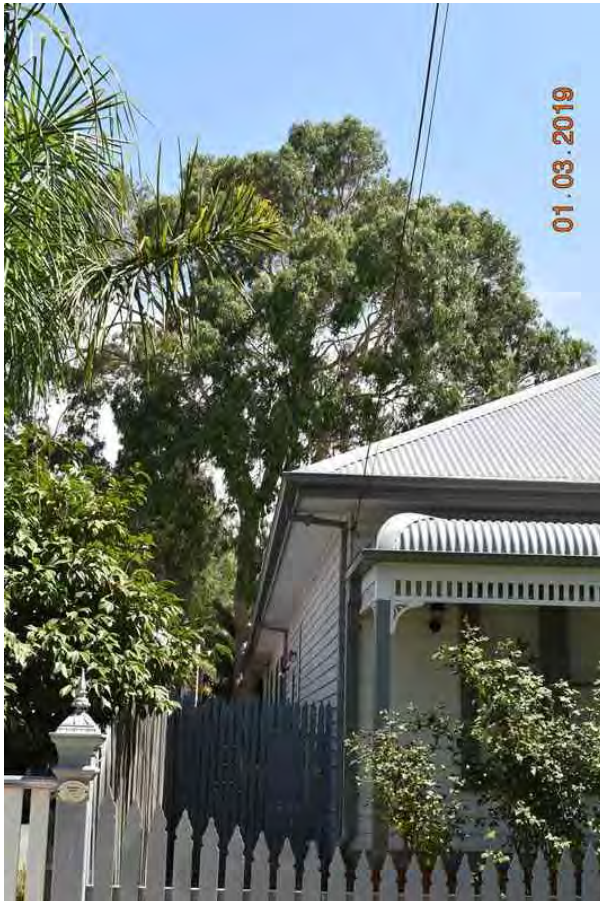
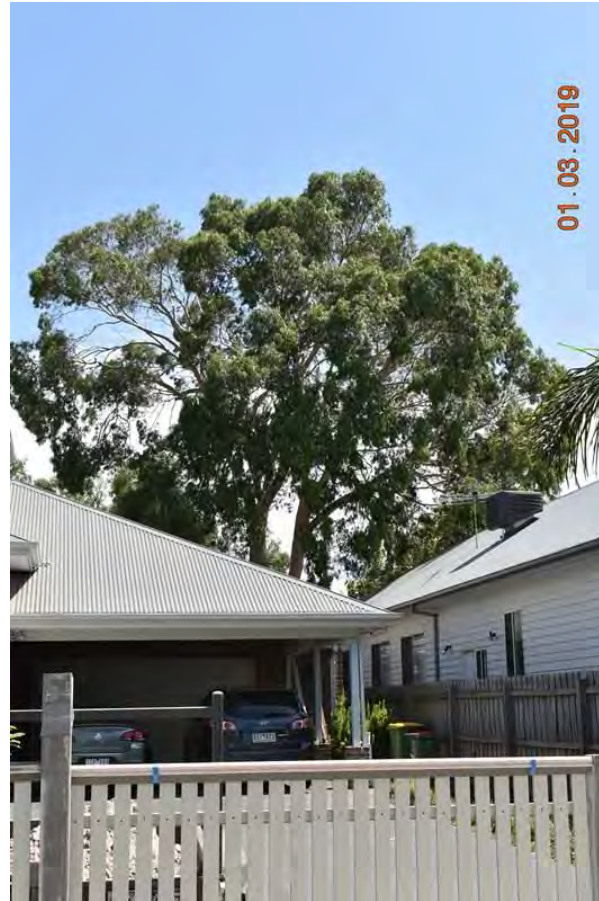
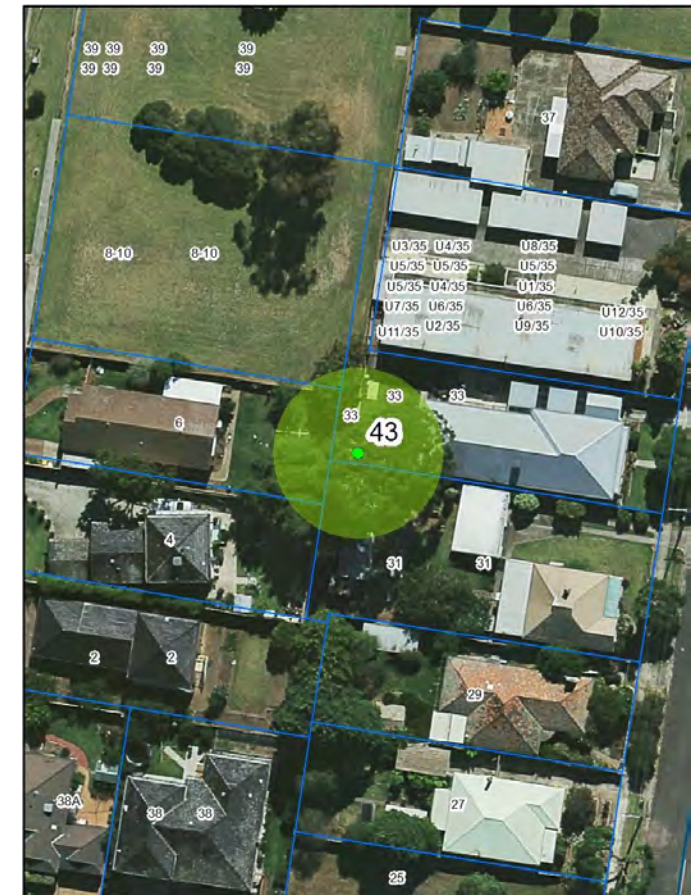
**Asset ID:** 43

**Failure Probability:** 3. Moderate

**Failure Size:** 3. 101-250mm

**Defects:** Codominant trunks

**Recommended Works:** Risk reduction pruning

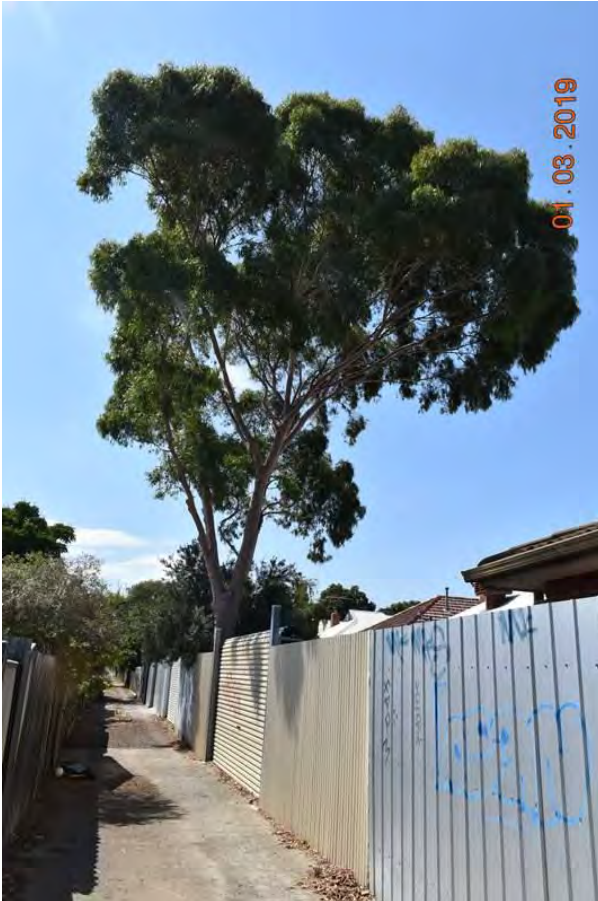
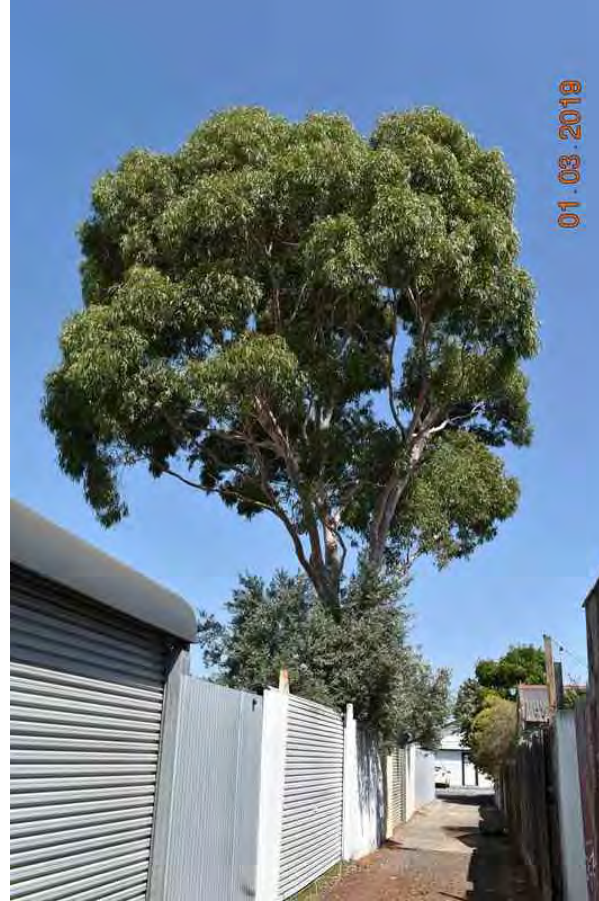
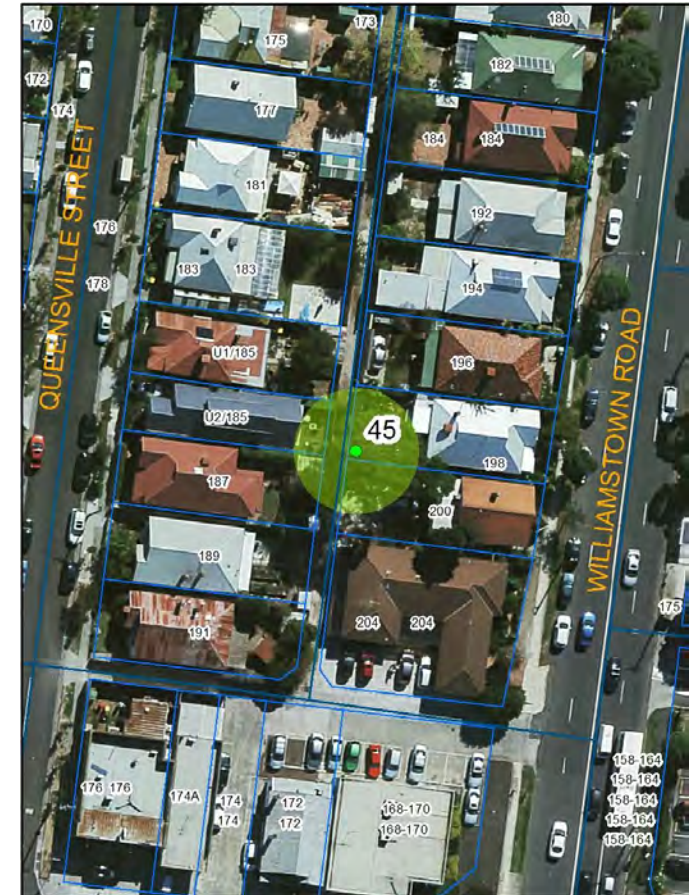
**Asset ID:** 45

**Failure Probability:** 4. Low

**Failure Size:** 3. 101-250mm

**Significance Statement:** This is a large tree in an urban context in good condition. Its canopy is elevated over its surrounds making it a striking feature of the landscape.

**Defects:** Codominant stems in canopy, Codominant trunks

**Recommended Works:** No works
