# Maribyrnong City Council Significant Tree Register 2019 Draft for Consultation

**Homewood Consulting Pty Ltd**

**Maribyrnong City Council**

December 2019

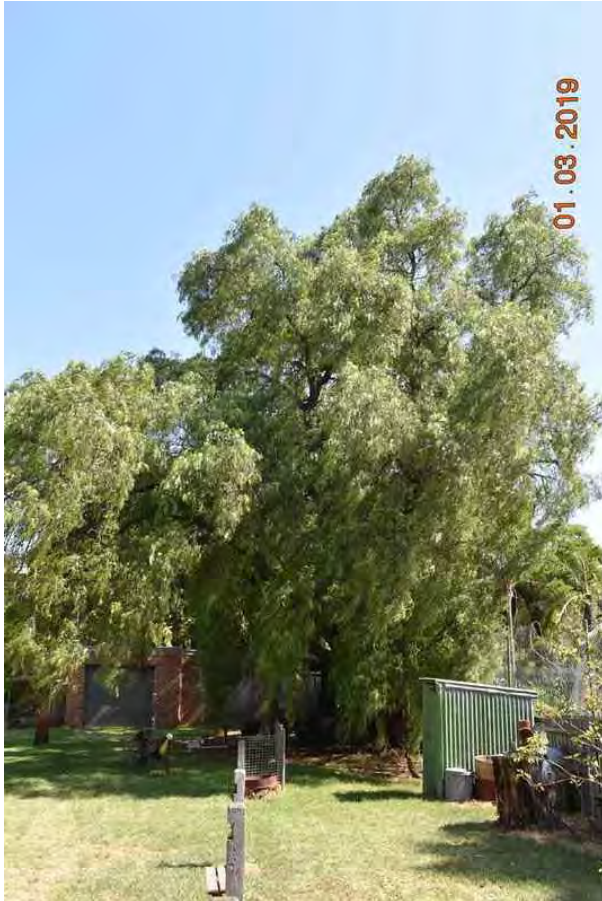
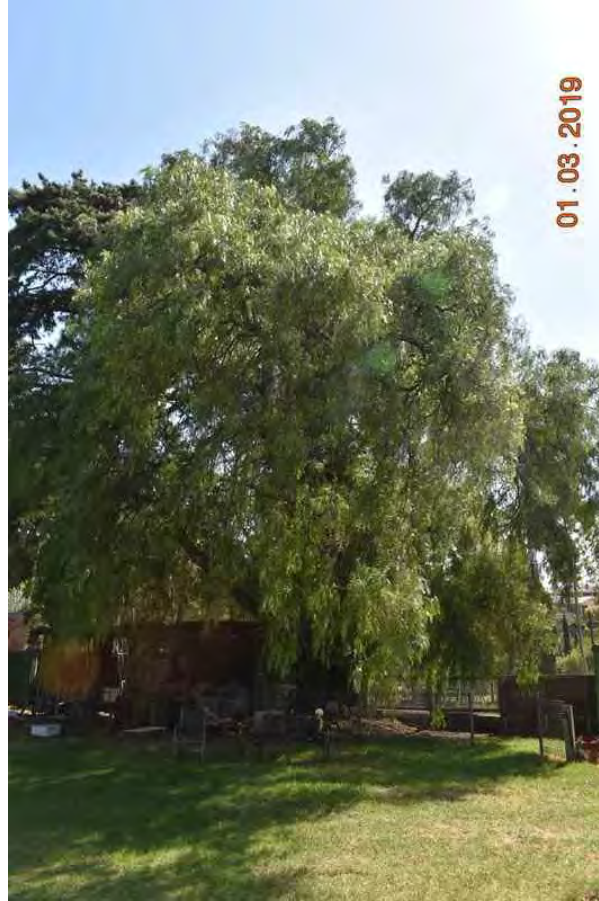
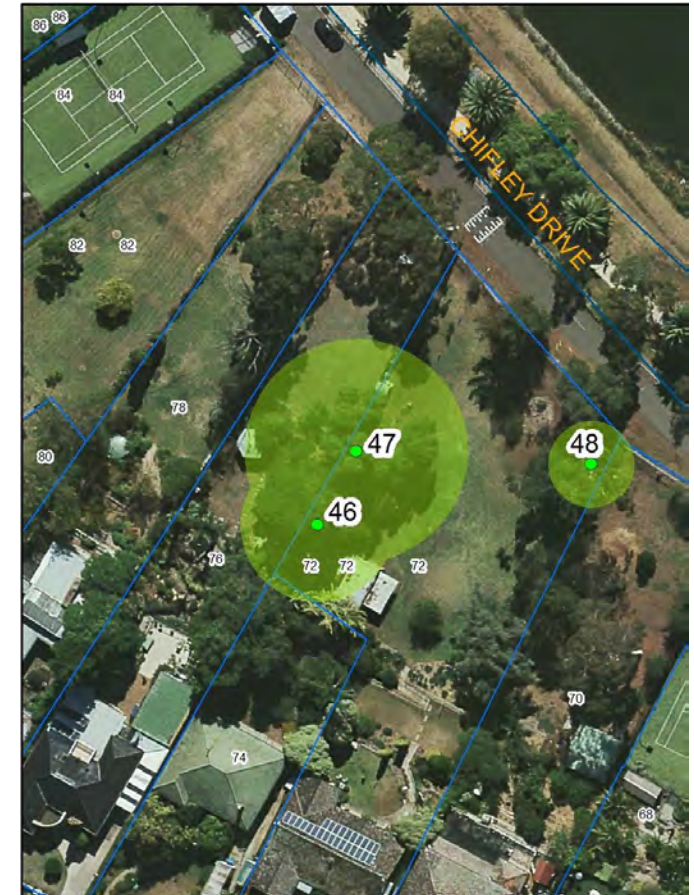
**Asset ID:** 47

**Defects:** Decay in canopy

**Recommended Works:** Risk reduction pruning

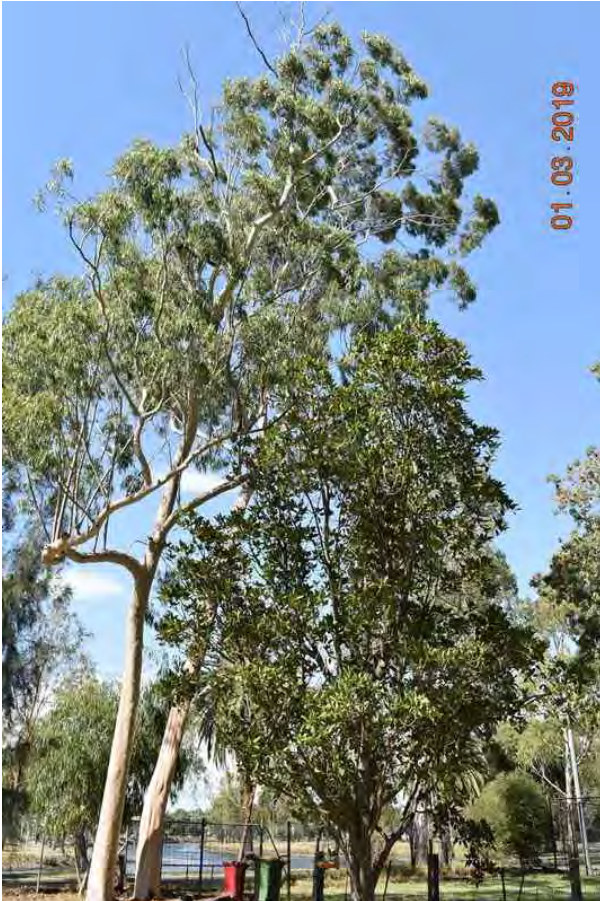
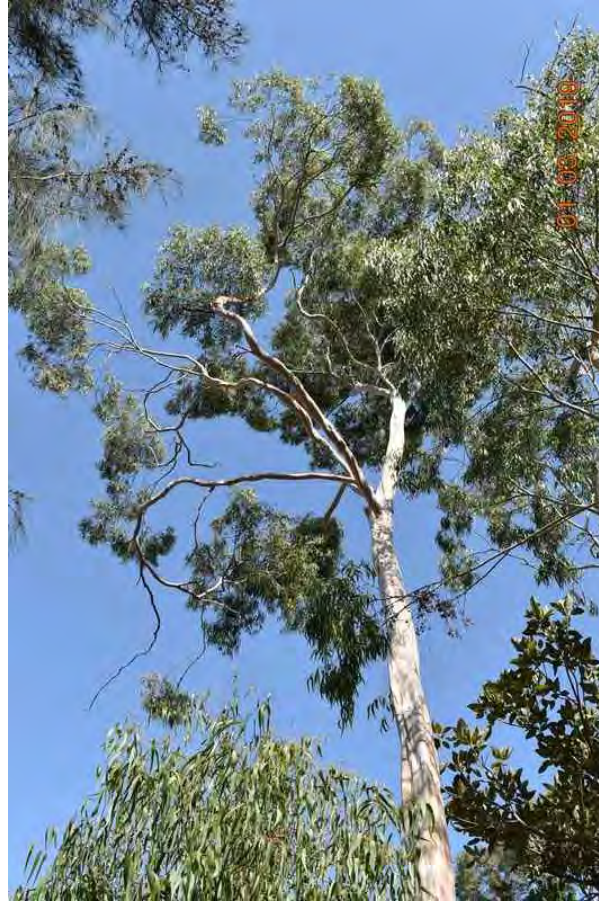
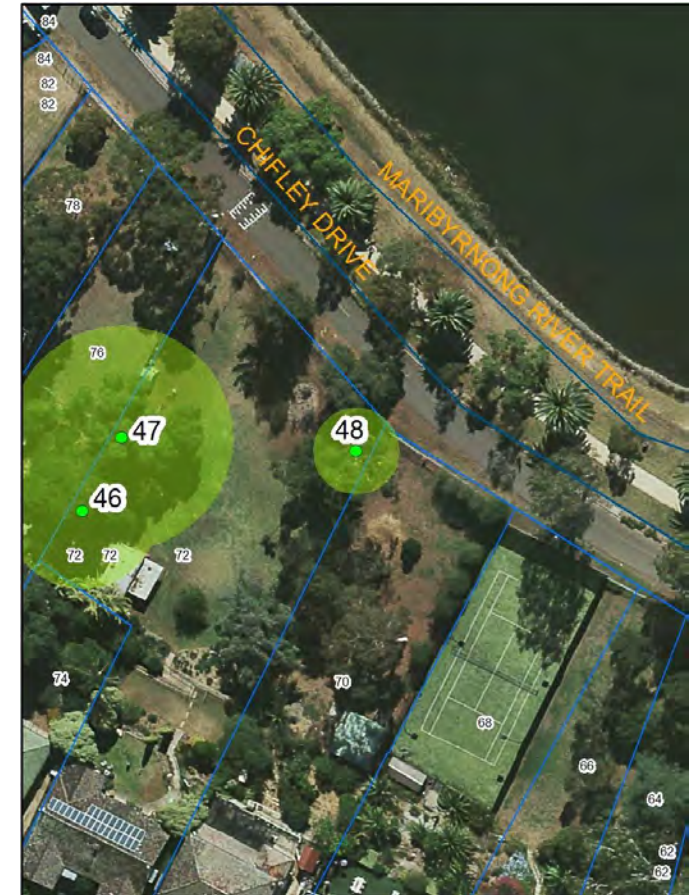
**Asset ID:** 48

**Defects:** Codominant stems in canopy

**Recommended Works:** Risk reduction pruning

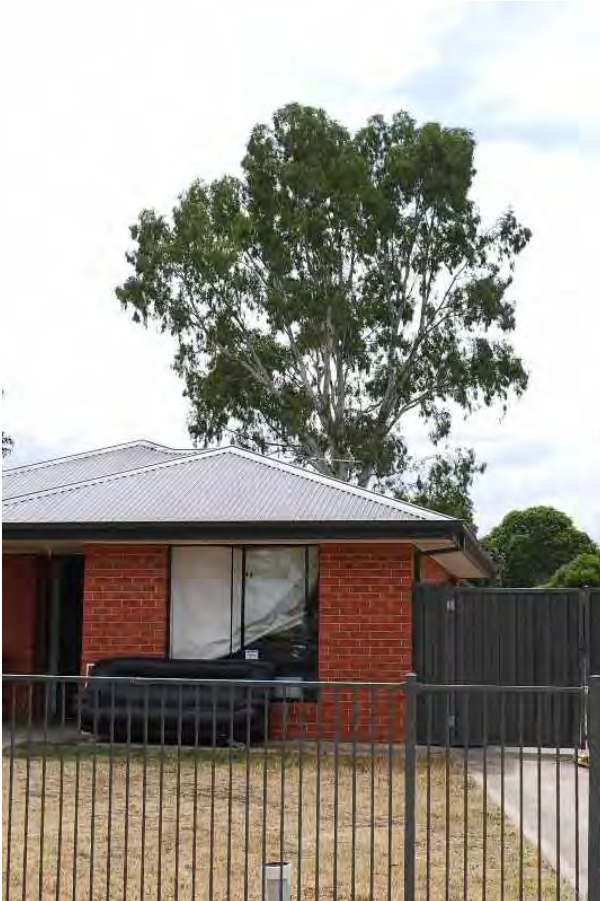
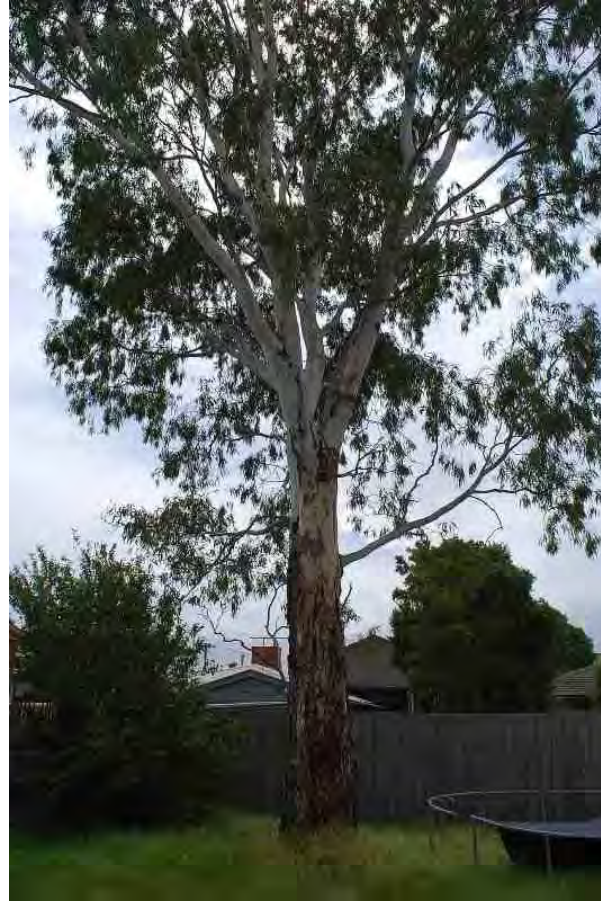
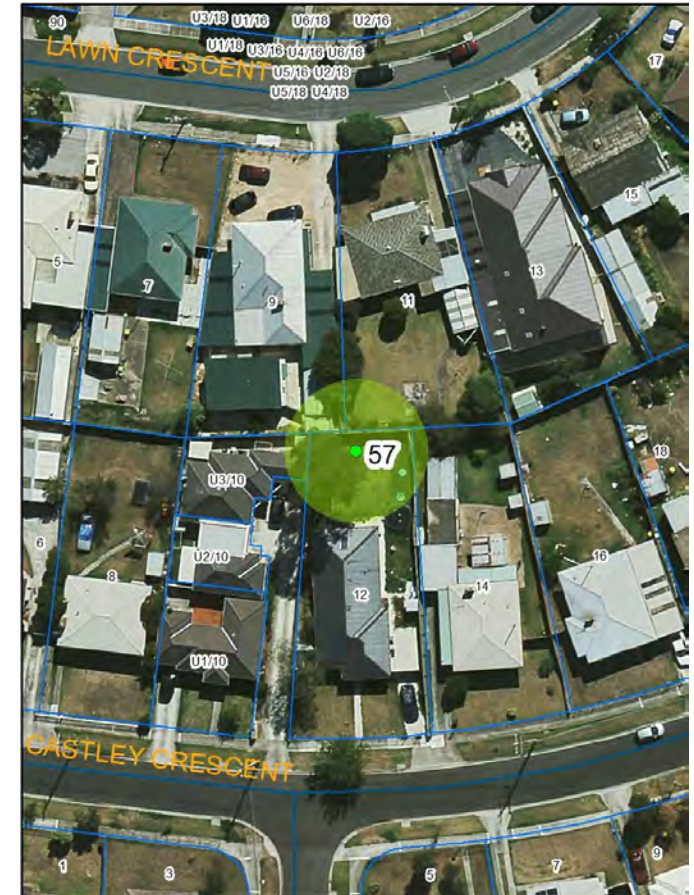
**Asset ID:** 57

**Defects:** Codominant trunks, Included bark in trunk

**Recommended Works:** Risk reduction pruning

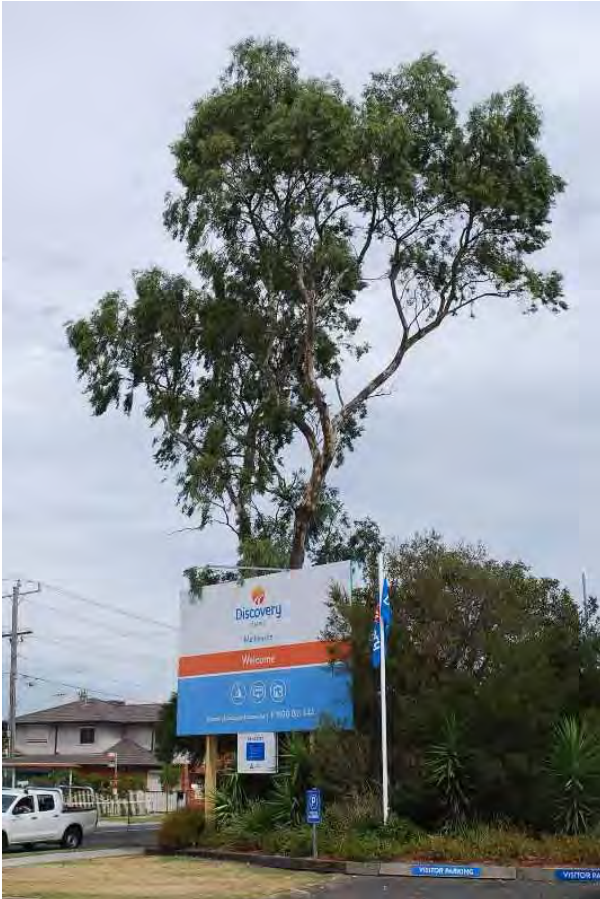
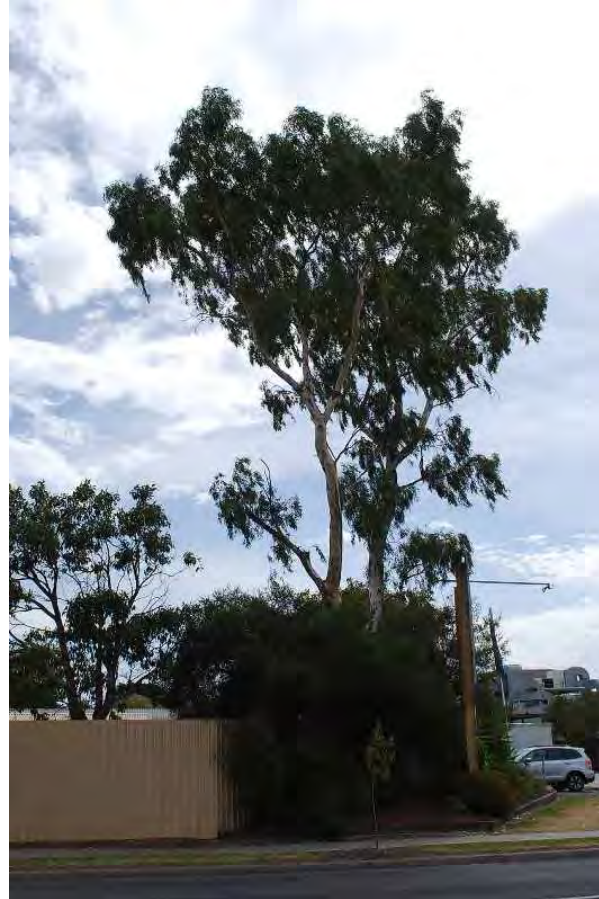
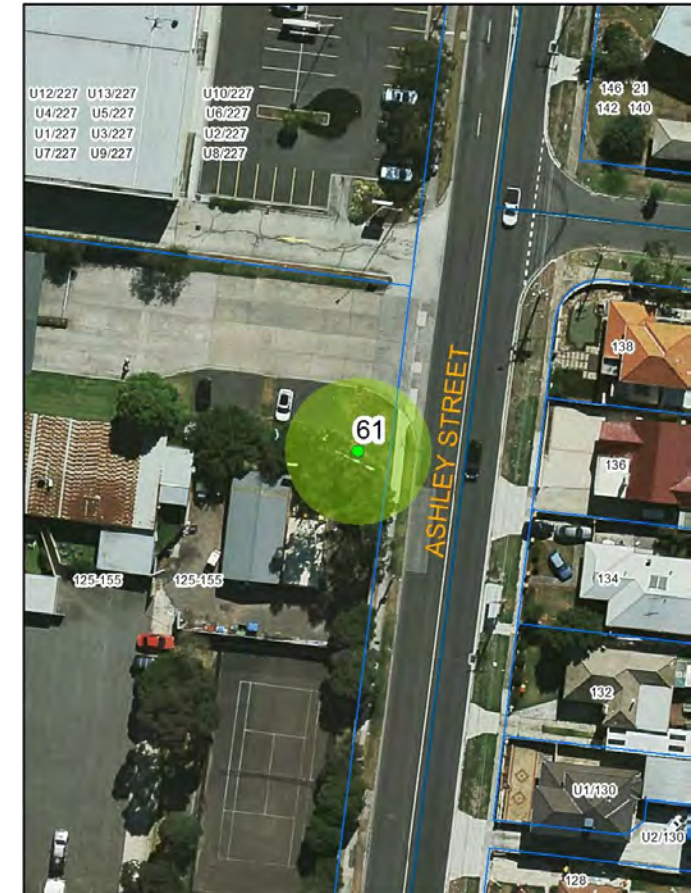
**Asset ID:** 61

**Defects:** Codominant trunks

**Recommended Works:** Deadwood removal

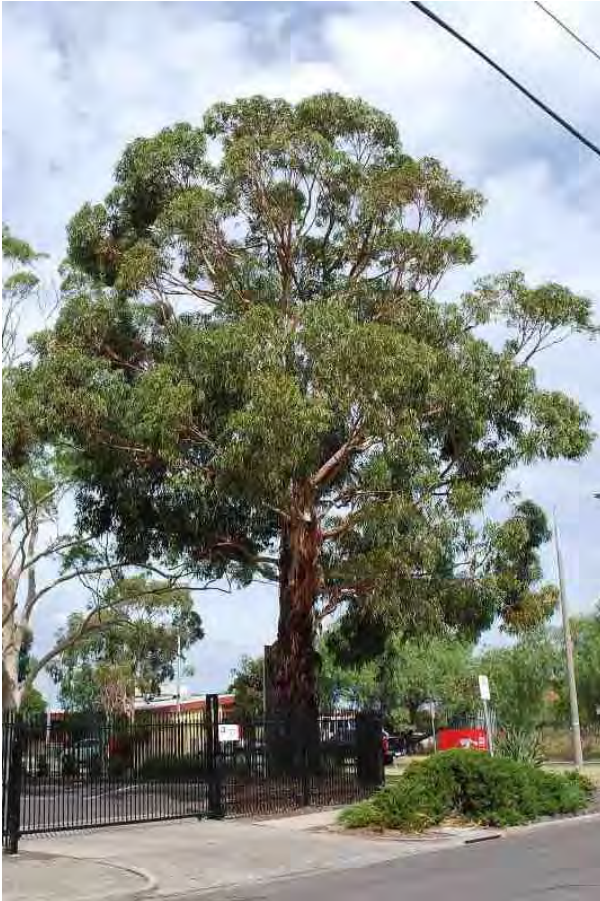
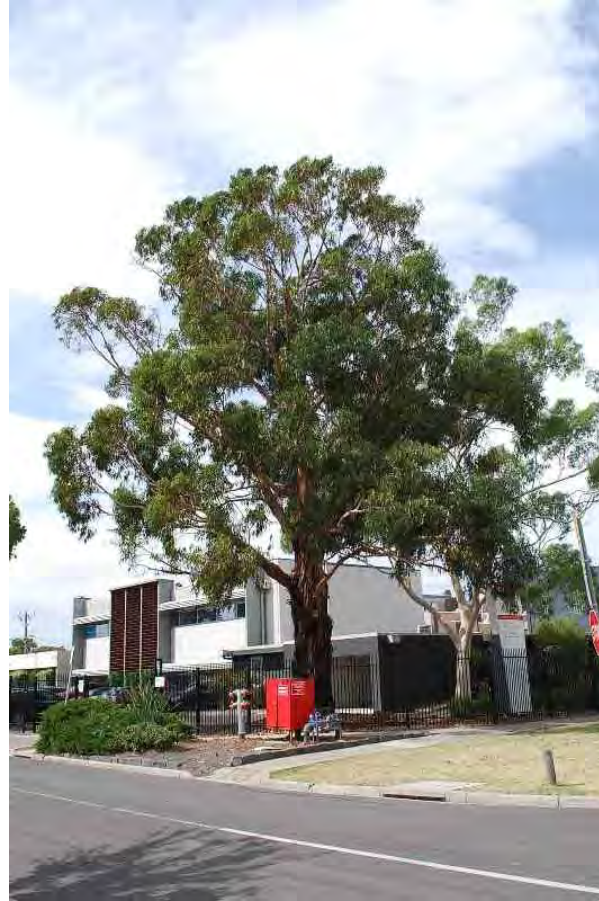
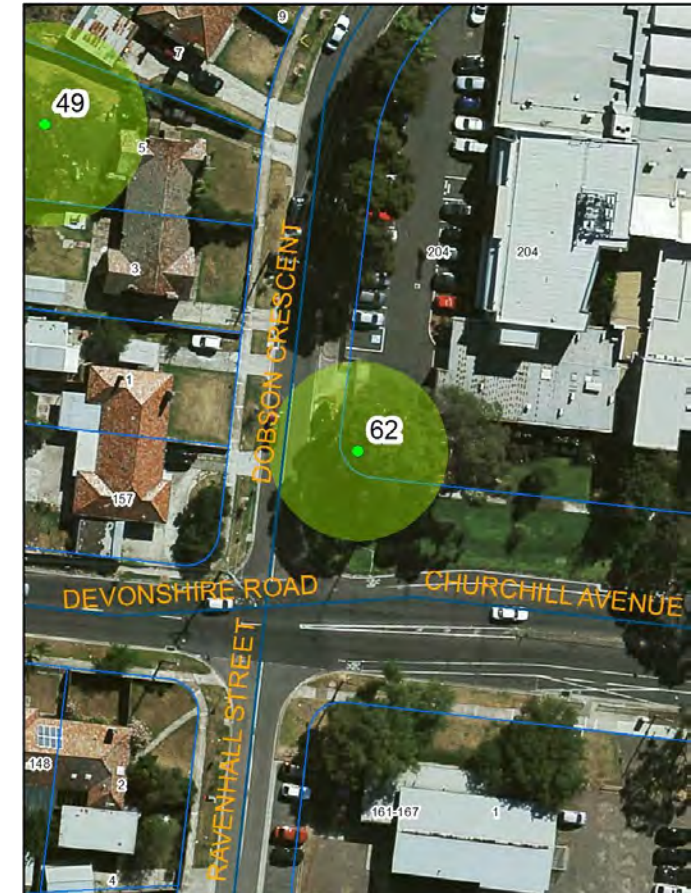
**Asset ID:** 62

**Defects:** Bracket fungi on trunk

**Comments:** Planning permit on site. Tree in good condition at the present time. Has bracket fungi on trunk

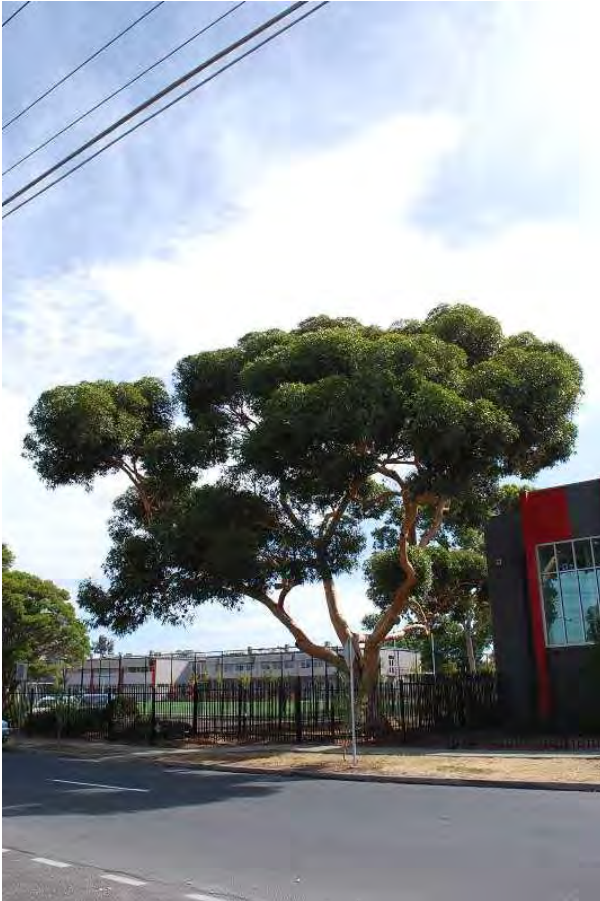
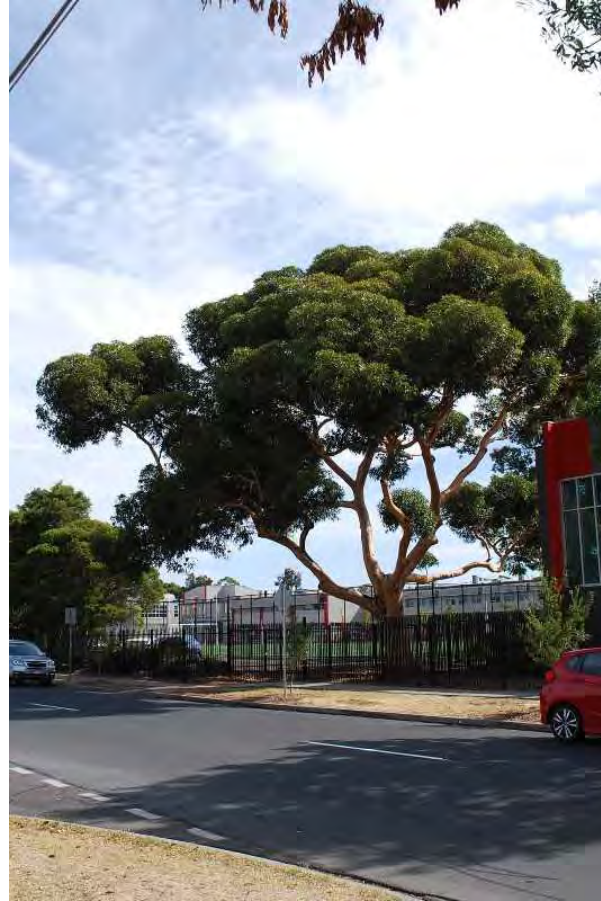
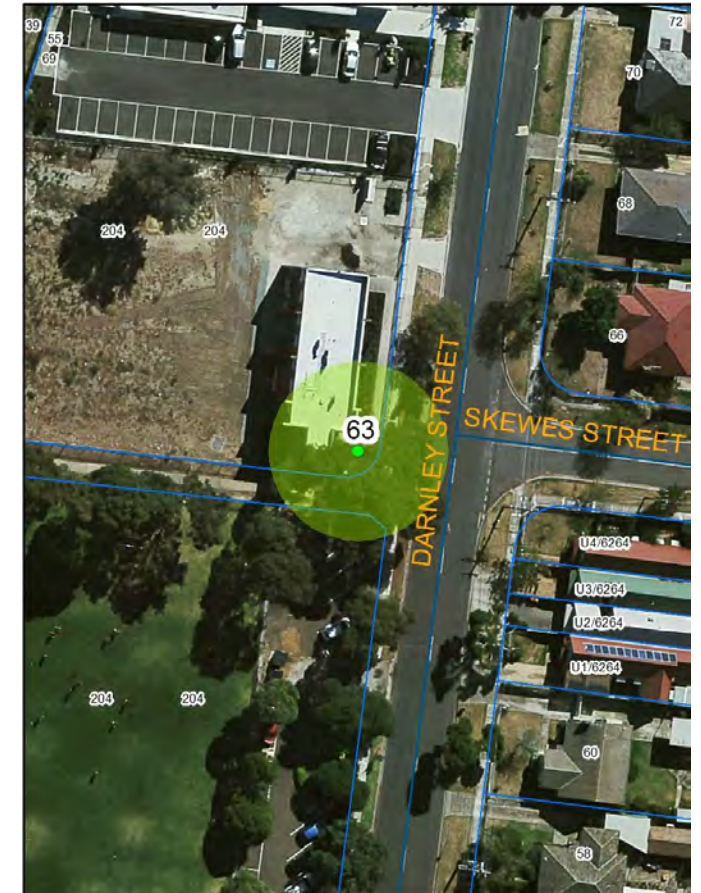
**Asset ID:** 63

**Defects:** Decay in canopy, Decay in trunk

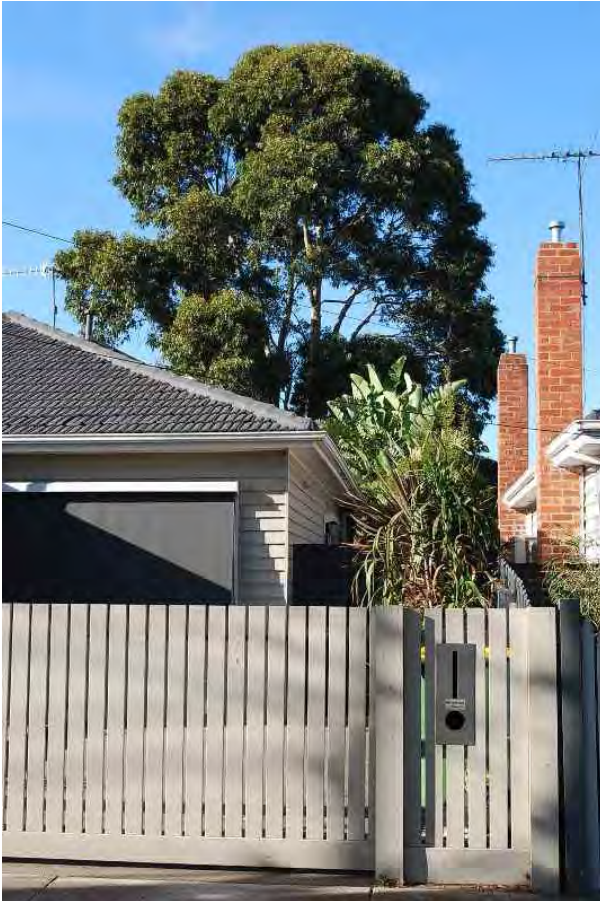
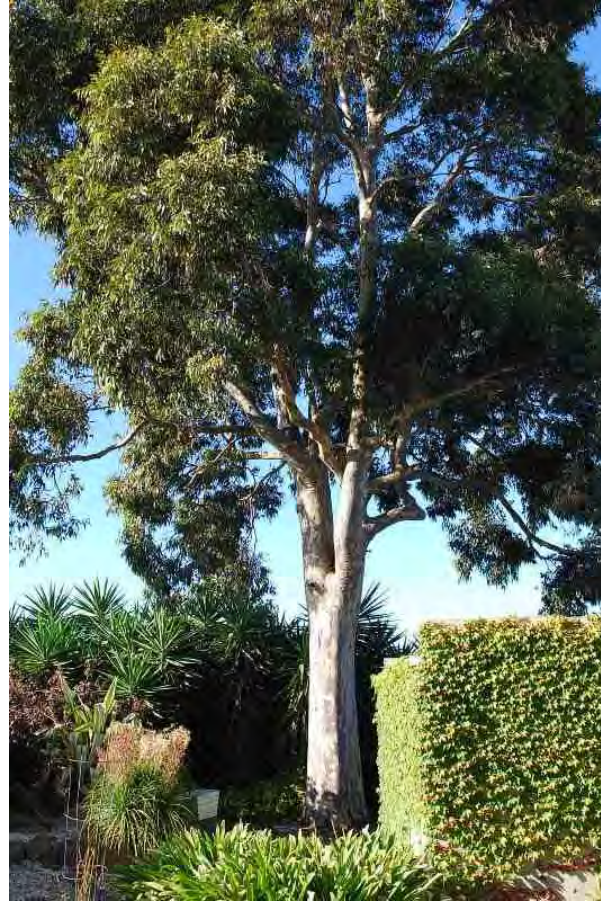
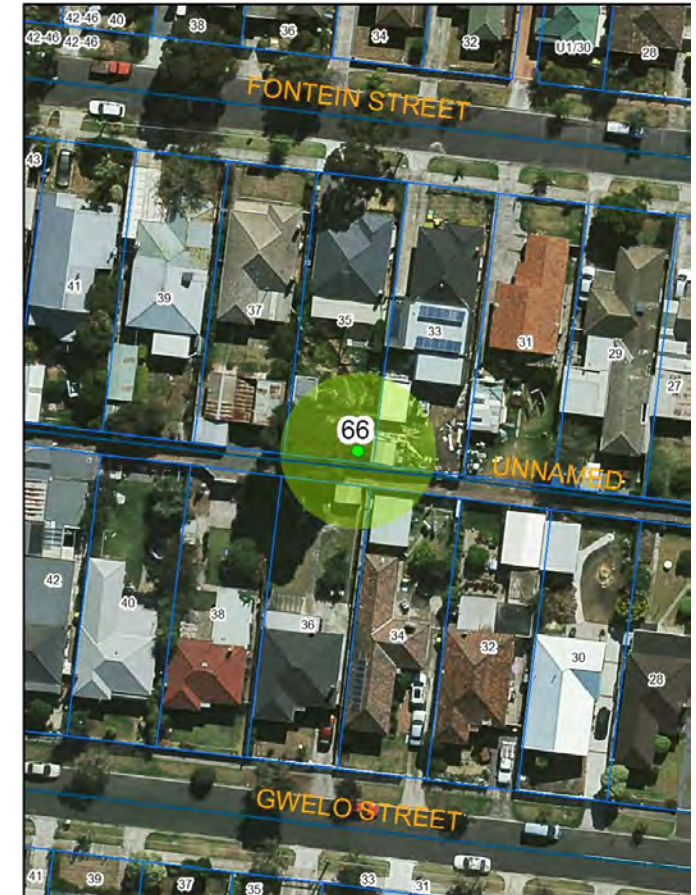
**Asset ID:** 72

**Approximate Age:** 81-100 years  
**ULE:** 21-40 years  
**Health:** Good  
**Structure:** Fair  
**Failure Probability:** 3. Moderate  
**Failure Size:** 2. 251-450mm  
**Target:** 3. Pedestrians, 2-7/hr  
**Risk Score:** 1 in 100000  
**Risk Category:** Moderate  
**Significance Statement:** This is a large tree with a wide spreading and weeping canopy, adding character and aesthetic value to the local landscape.

**Defects:** Decay in canopy  
**Recommended Works:** No works  
**Works Priority:** None  
**Comments:** Planning permit on site. Good tree and well located.  
**Record Type:** Single Tree  
**No. of Trees:** 1

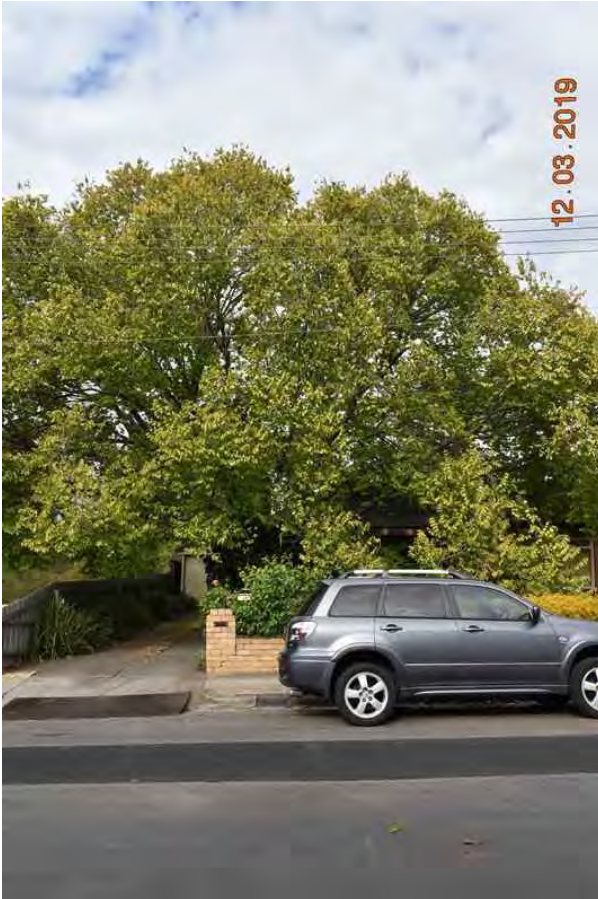
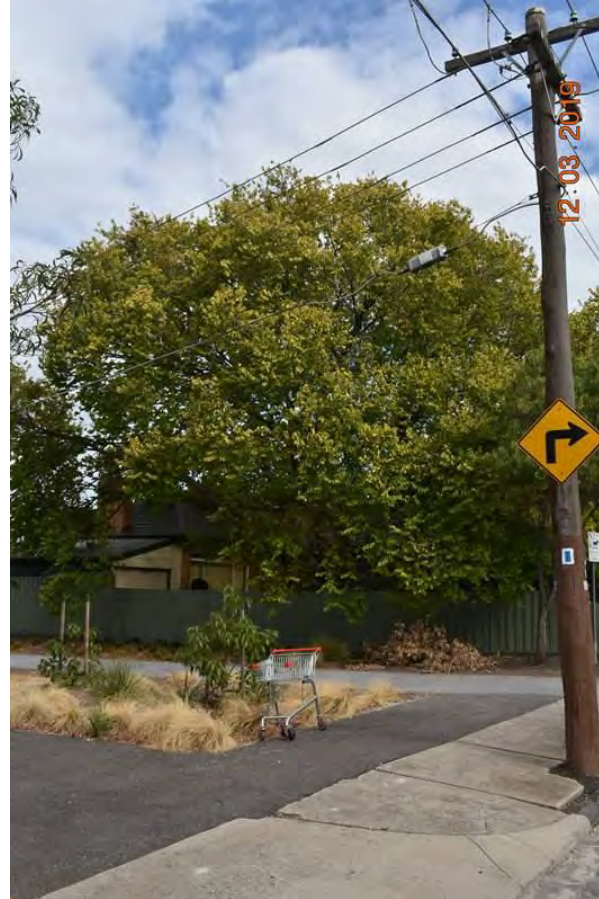
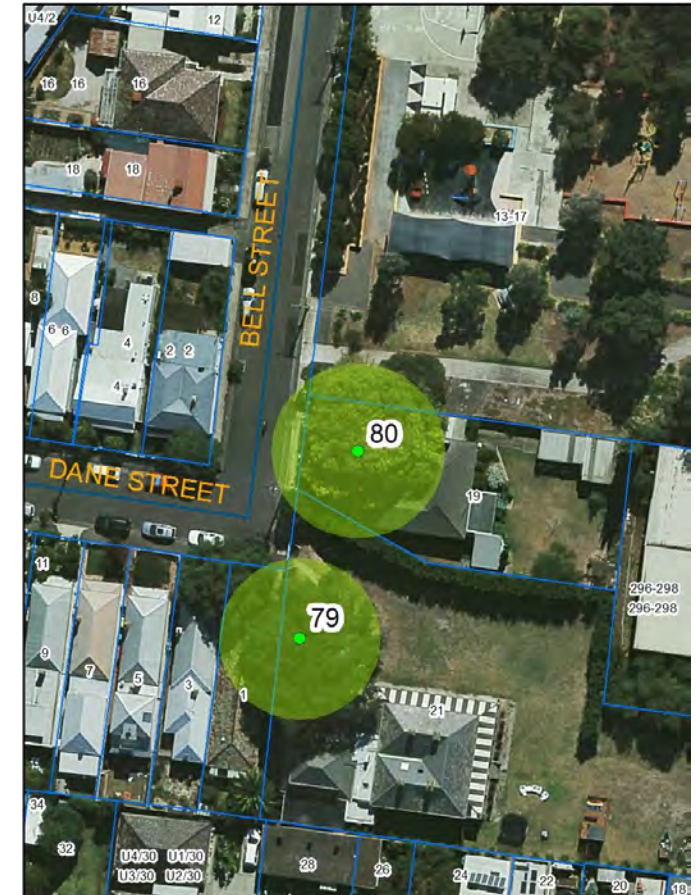
**Asset ID:** 81

**Approximate Age:** 61-80 years  
**ULE:** 11-20 years  
**Health:** Good  
**Structure:** Fair  
**Failure Probability:** 4. Low  
**Failure Size:** 3. 101-250mm  
**Target:** 4. Pedestrians, 3/day to 1/hr  
**Risk Score:** 1 in 50000000  
**Risk Category:** Very low  
**Significance Statement:** This is a large specimen in good condition, particularly in context with its built surrounds

**Defects:** Codominant trunks  
**Recommended Works:** Risk reduction pruning  
**Works Priority:** Low  
**Comments:**  
**Record Type:** Single Tree  
**No. of Trees:** 1

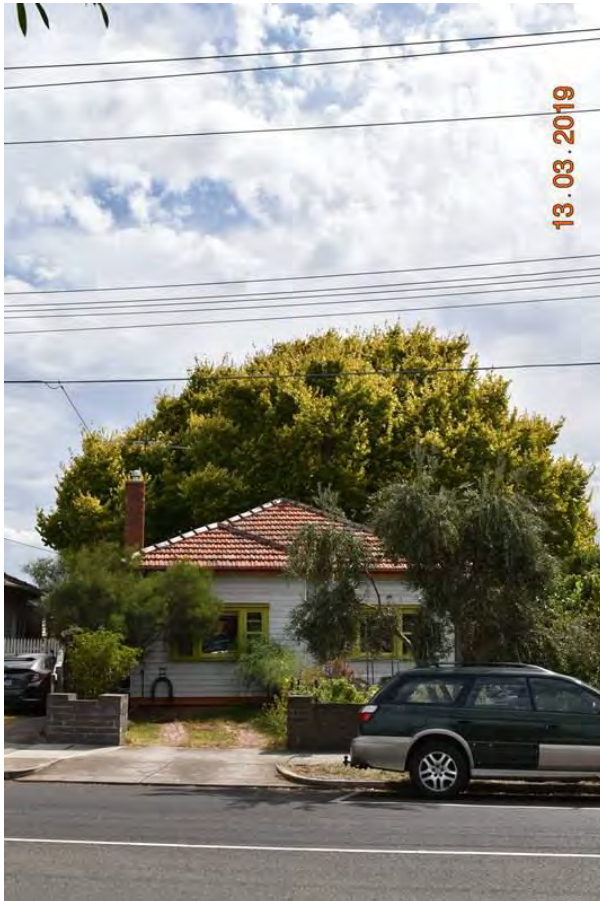
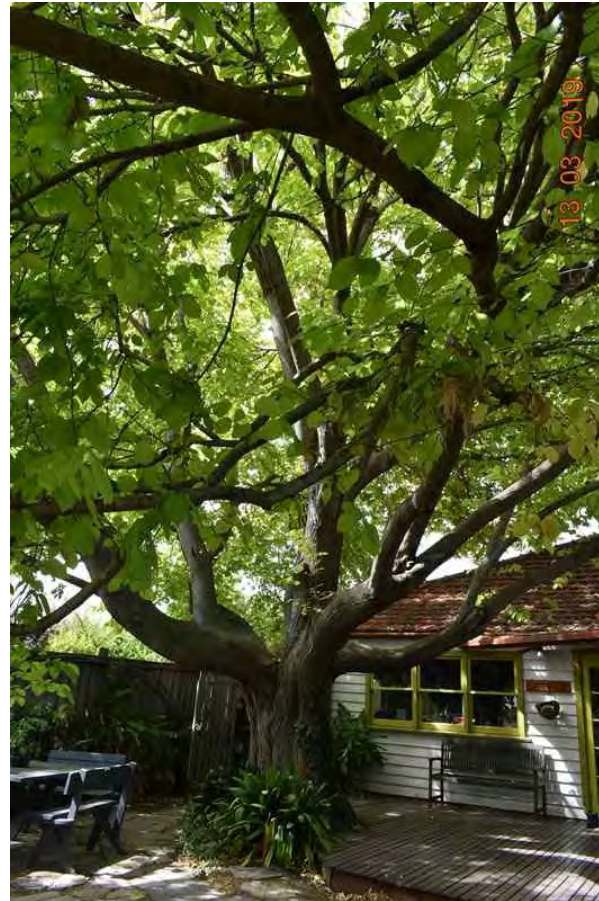
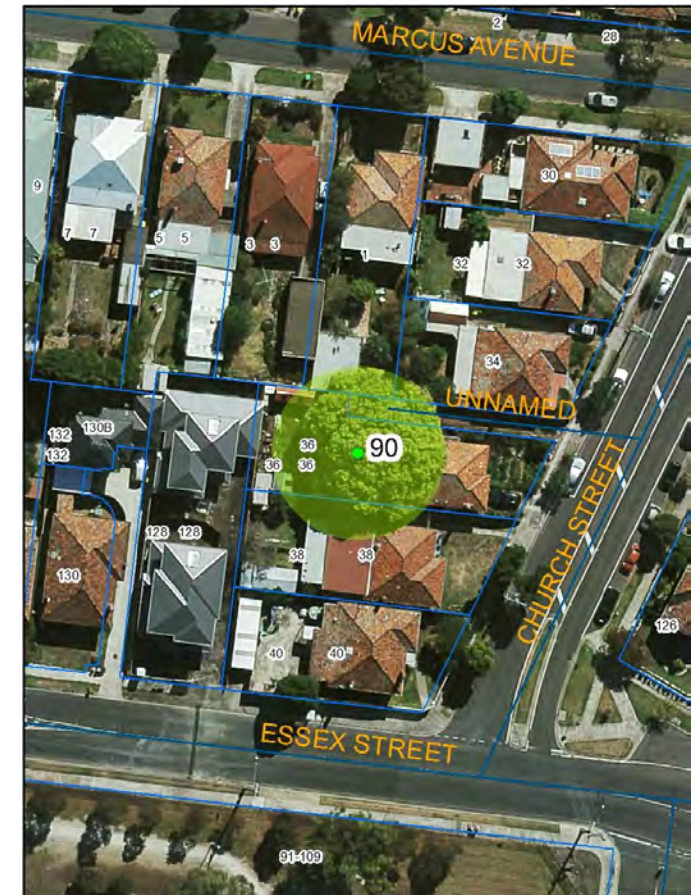
**Asset ID:** 91

**Failure Probability:** 4. Low

**Failure Size:** 3. 101-250mm

**Defects:** None

**Comments:** Very minor Elm Leaf Beetle damage

**Recommended Works:** No works

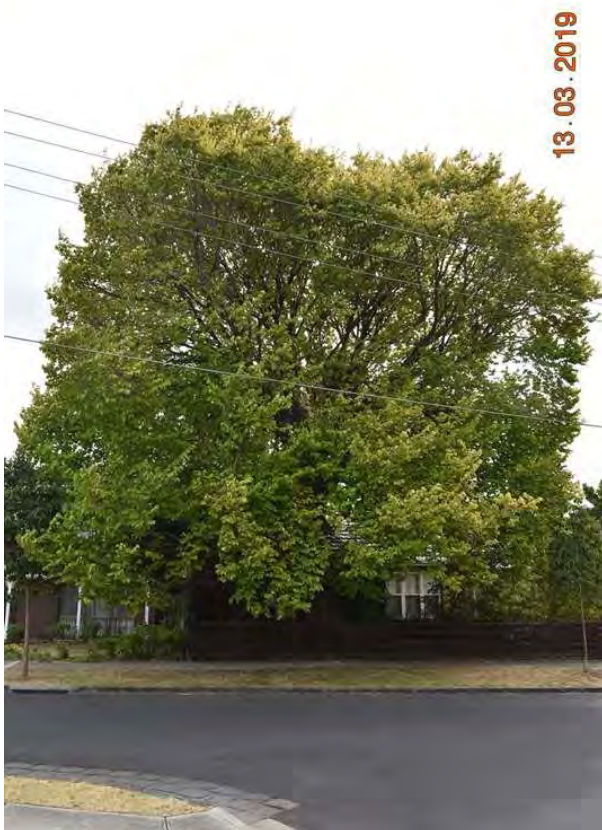
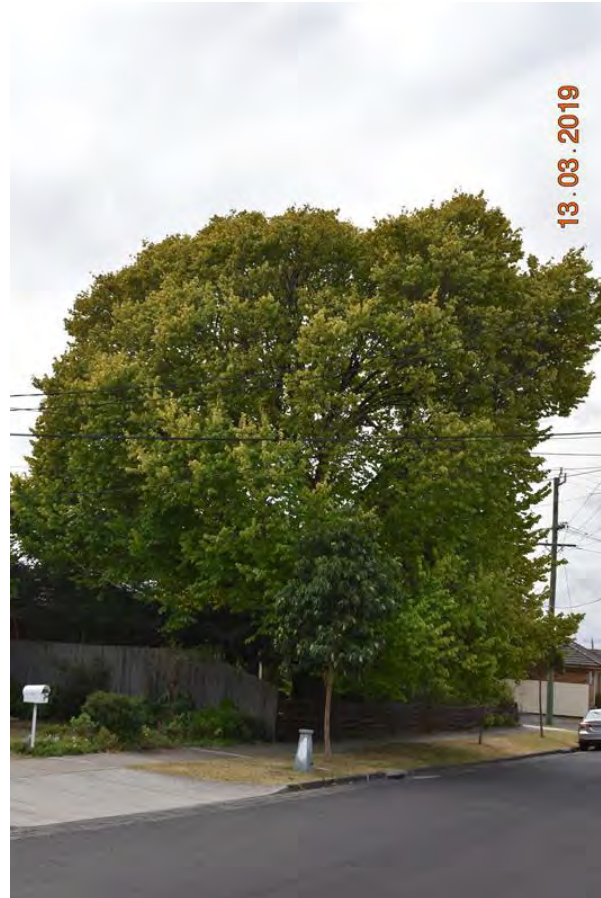
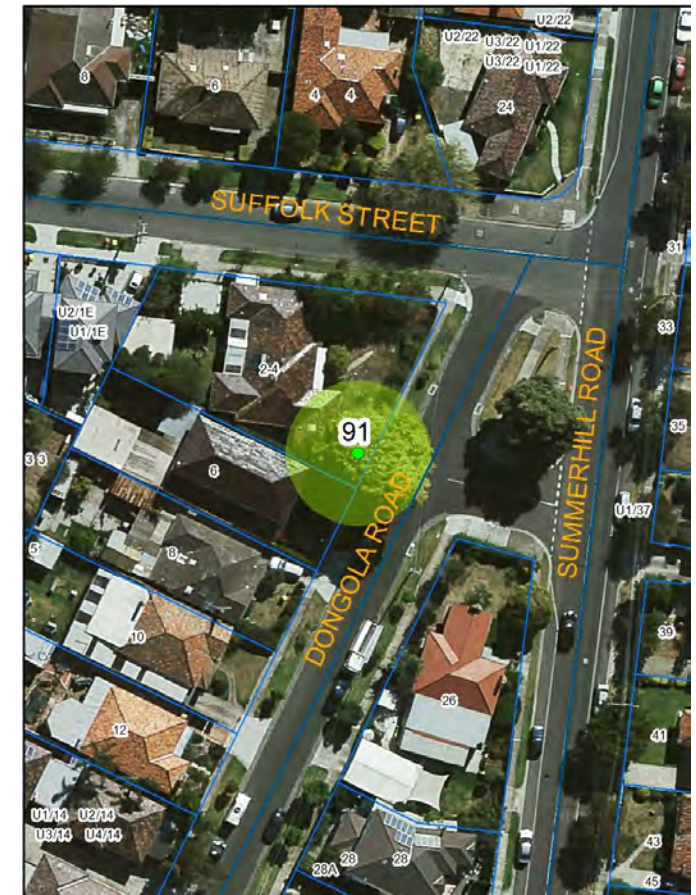
**Asset ID:** 92

**Failure Probability:** 3. Moderate

**Failure Size:** 3. 101-250mm

**Defects:** None

**Recommended Works:** No works

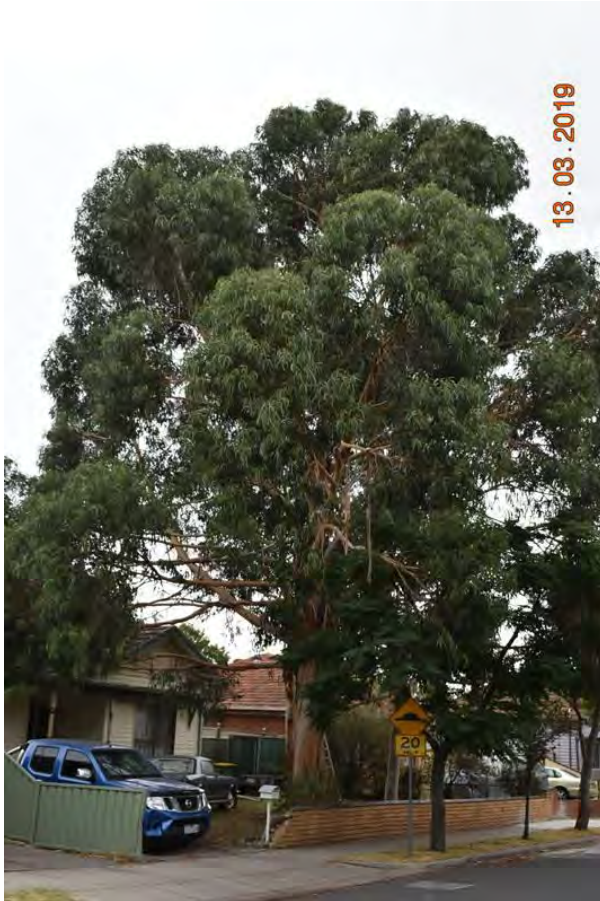
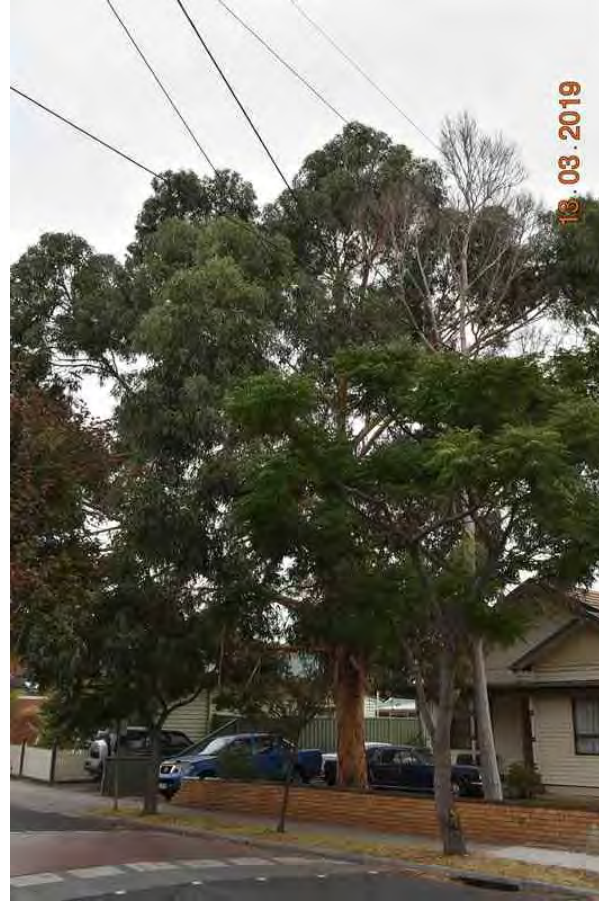
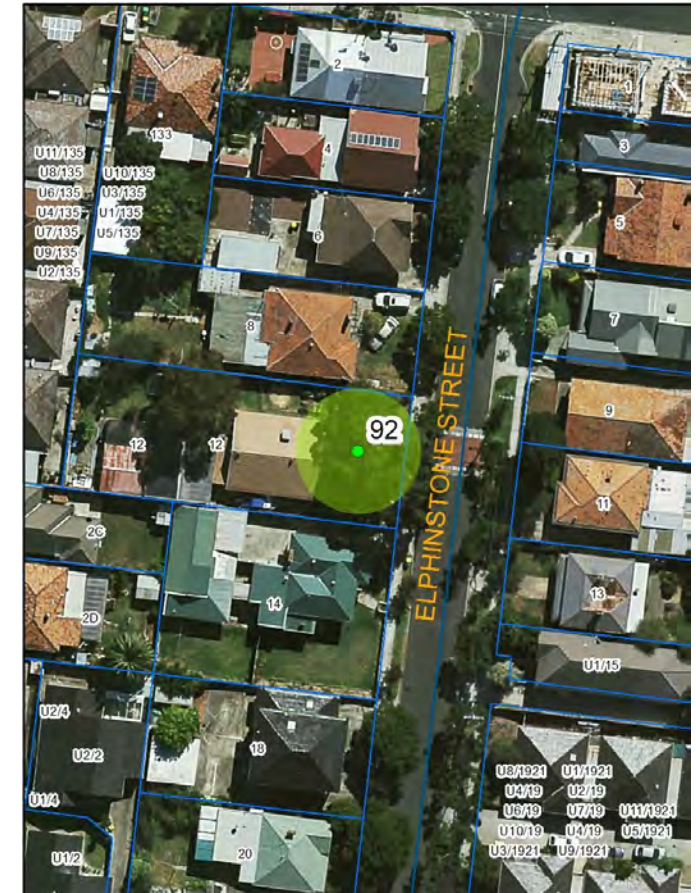
**Asset ID:** 93

**Failure Probability:** 3. Moderate

**Failure Size:** 3. 101-250mm

**Defects:** Codominant trunks

**Recommended Works:** No works

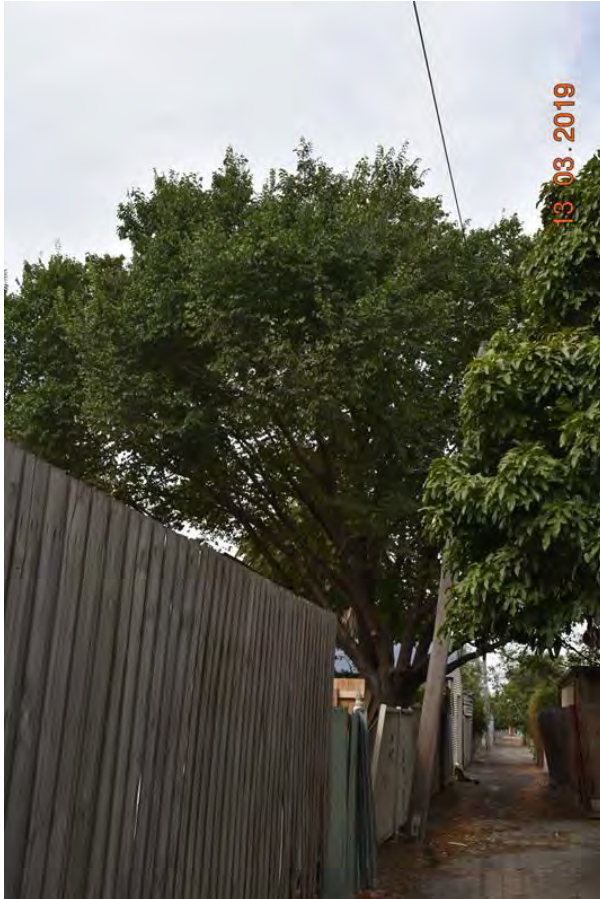
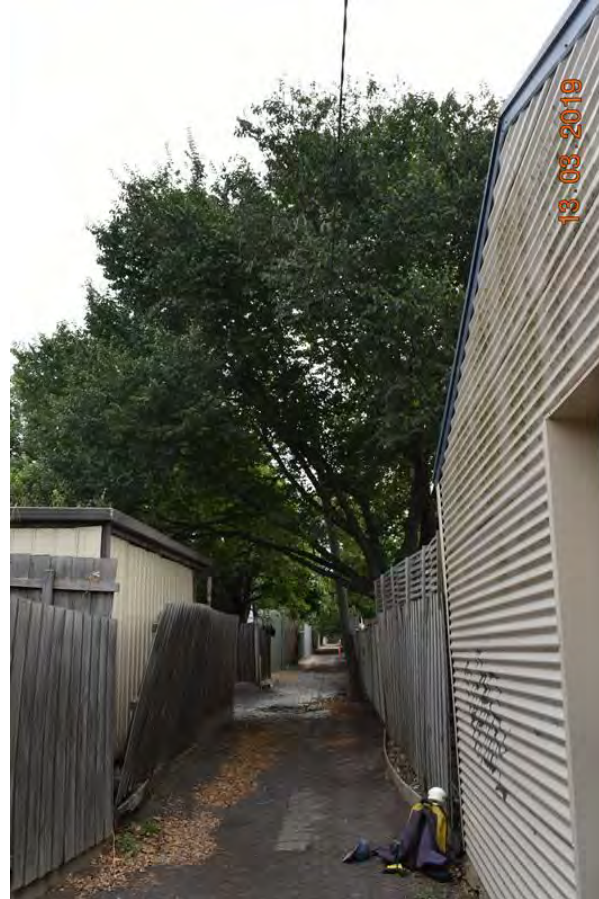
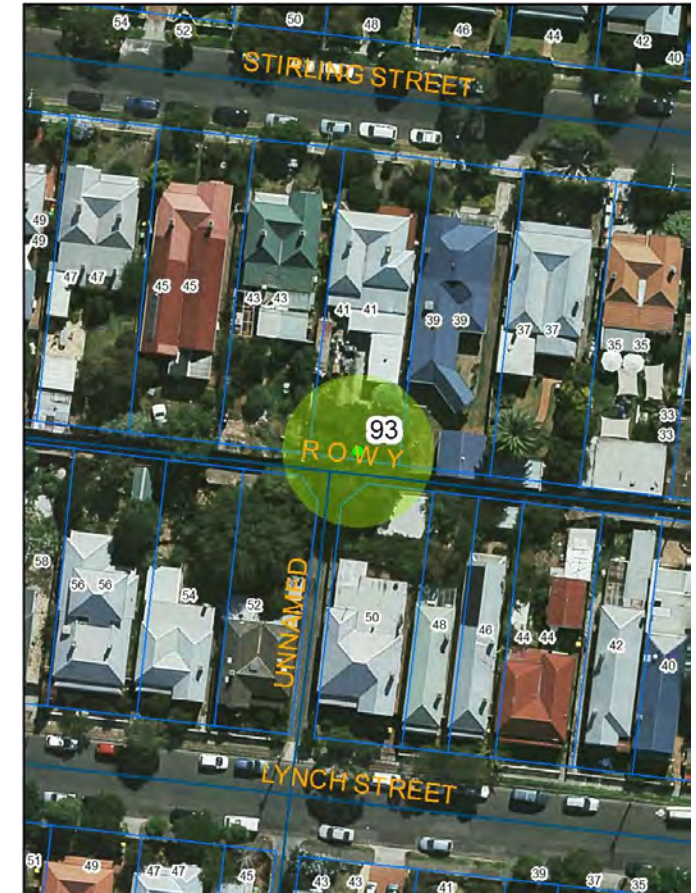
**Asset ID:** 95

**Failure Probability:** 3. Moderate

**Failure Size:** 3. 101-250mm

**Defects:** Included bark in trunk, Codominant trunks

**Recommended Works:** Structural pruning

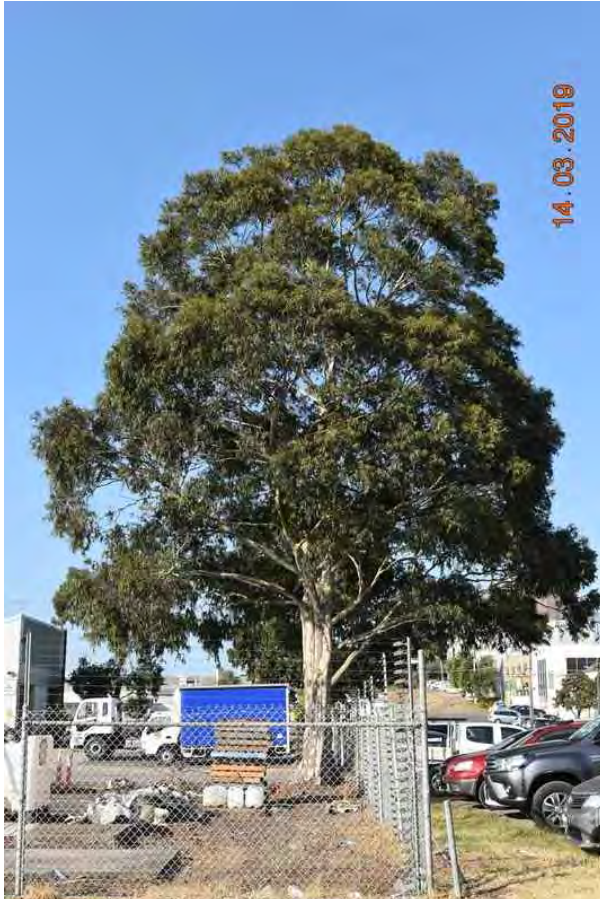
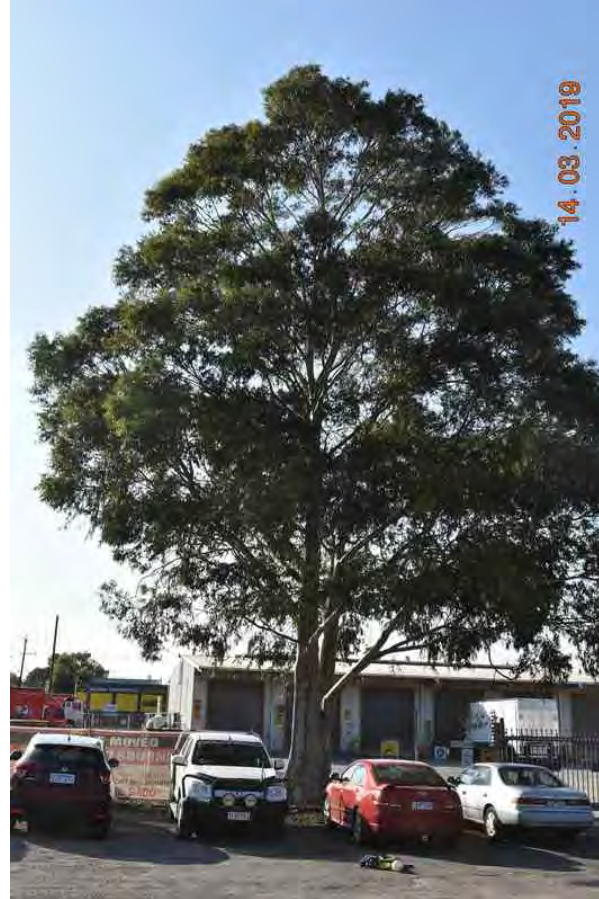
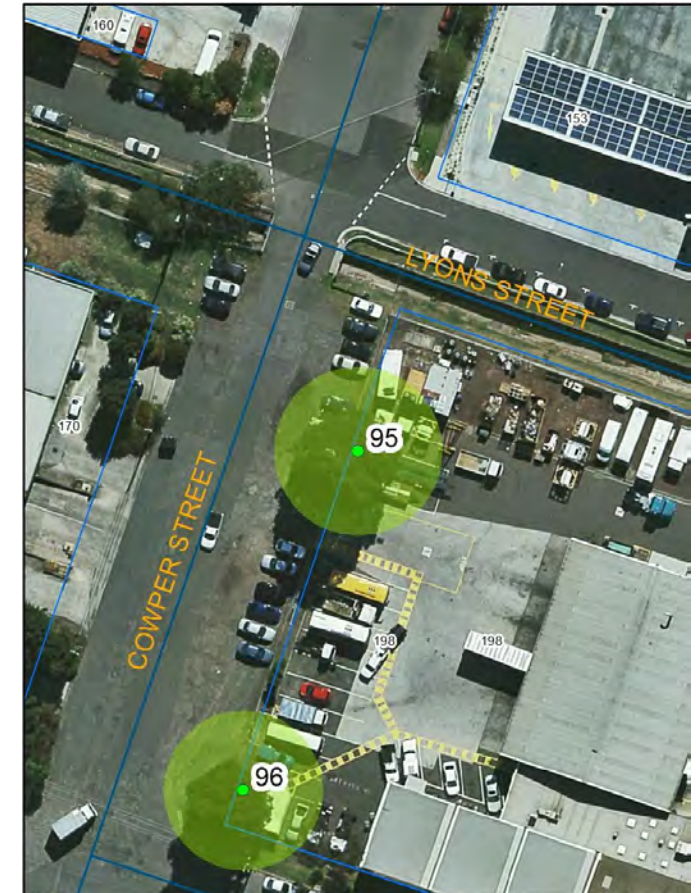
**Asset ID:** 96

**Failure Probability:** 3. Moderate

**Failure Size:** 3. 101-250mm

**Defects:** Codominant trunks

**Recommended Works:** Structural pruning
