# Maribyrnong City Council Significant Tree Register 2019 Draft for Consultation

**Homewood Consulting Pty Ltd**

**Maribyrnong City Council**

December 2019

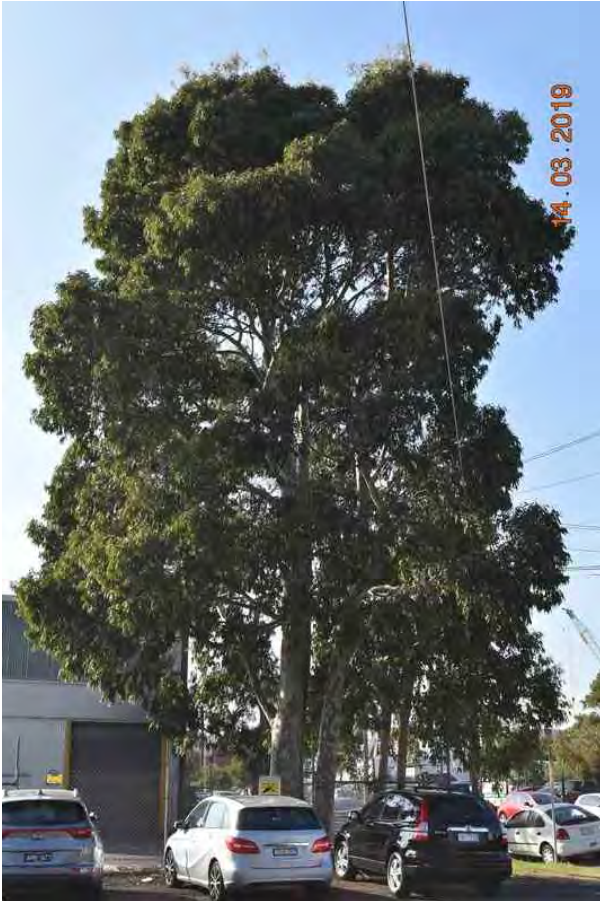
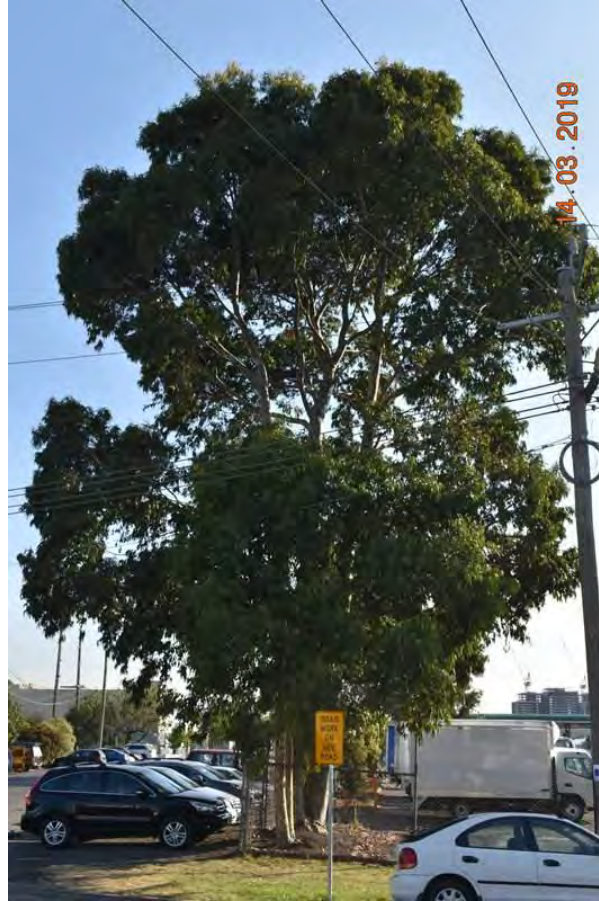
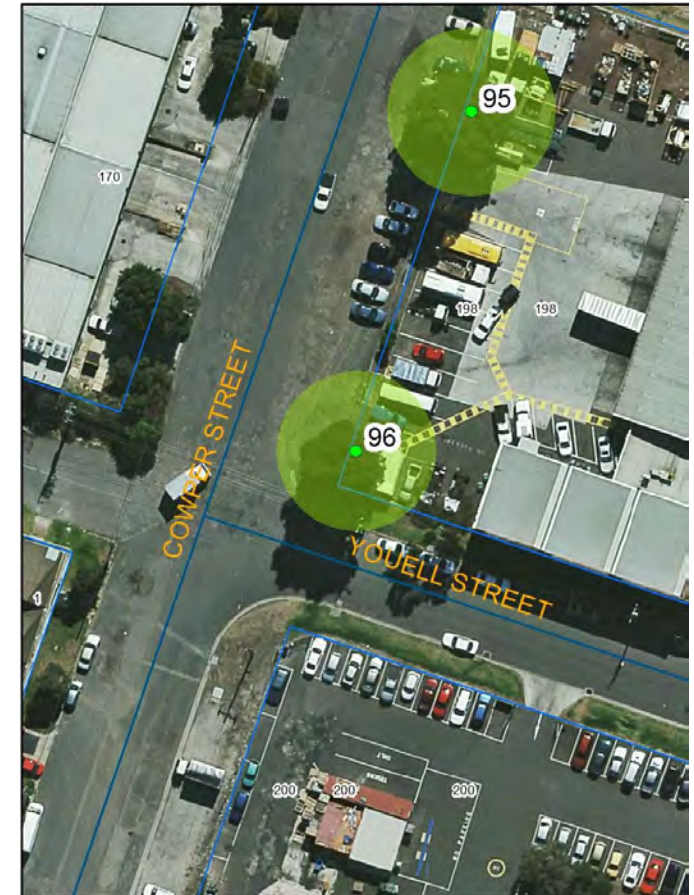
**Asset ID:** 99

**Failure Probability:** 3. Moderate

**Failure Size:** 3. 101-250mm

**Defects:** Decay in canopy, Codominant trunks

**Recommended Works:** Structural pruning

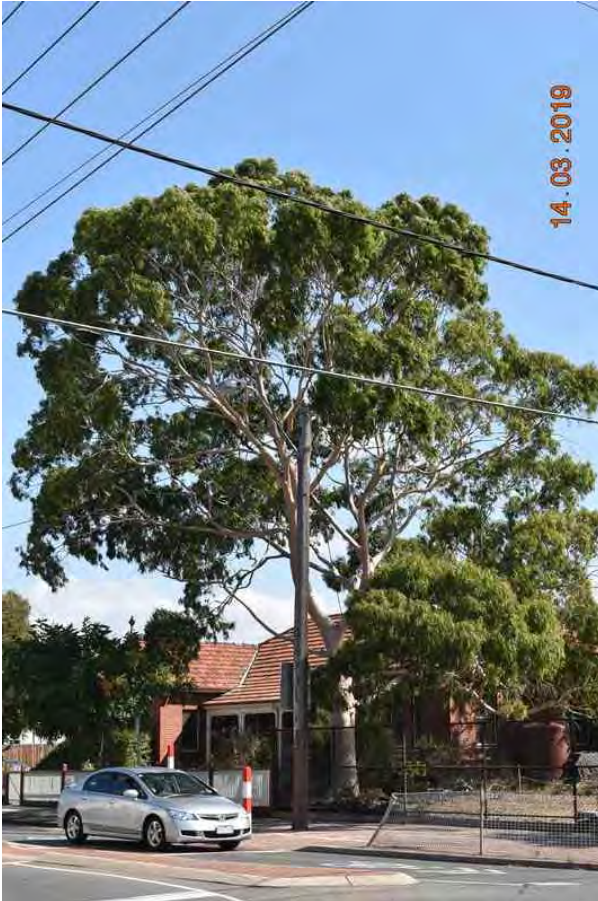
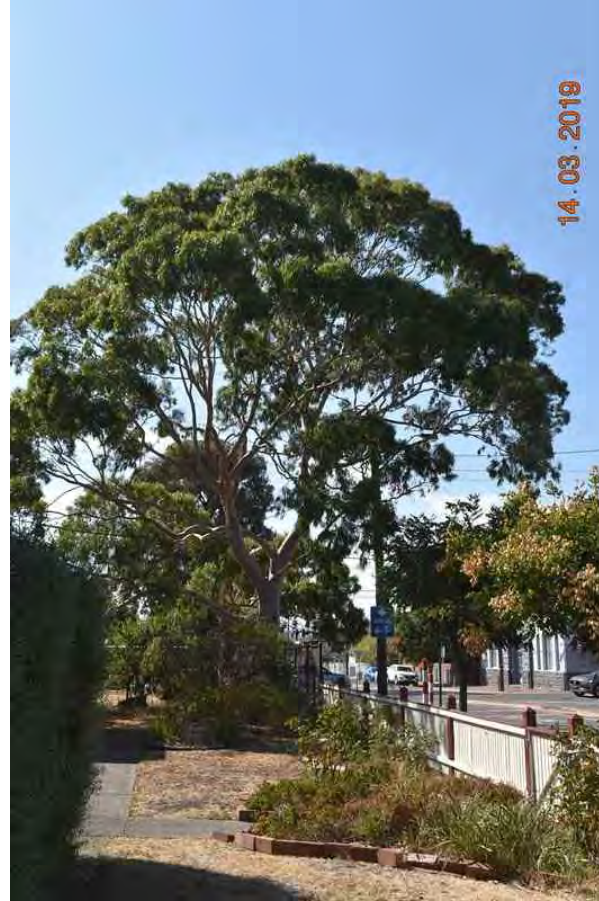
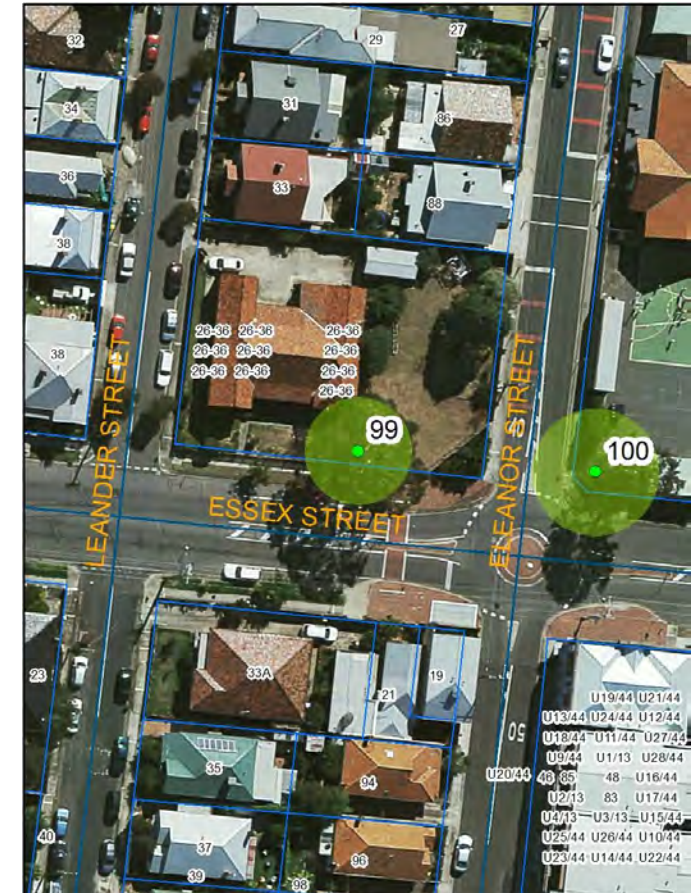
**Asset ID:** 100

**Failure Probability:** 3. Moderate

**Failure Size:** 3. 101-250mm

**Defects:** None

**Recommended Works:** No works

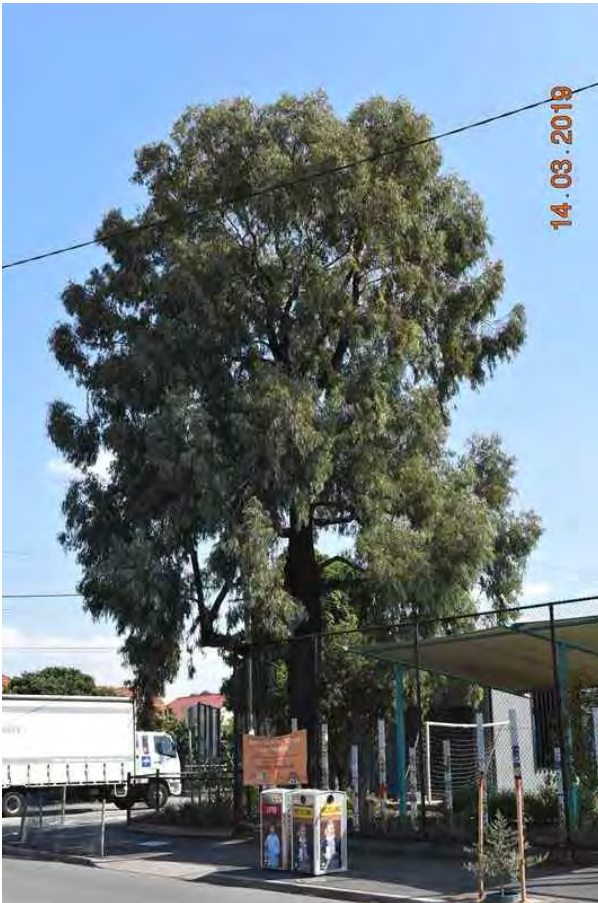
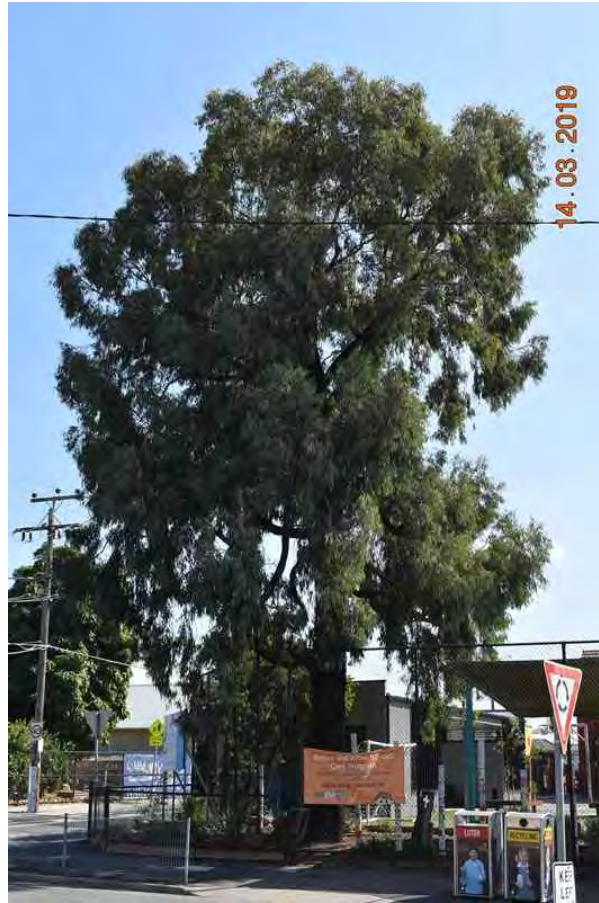
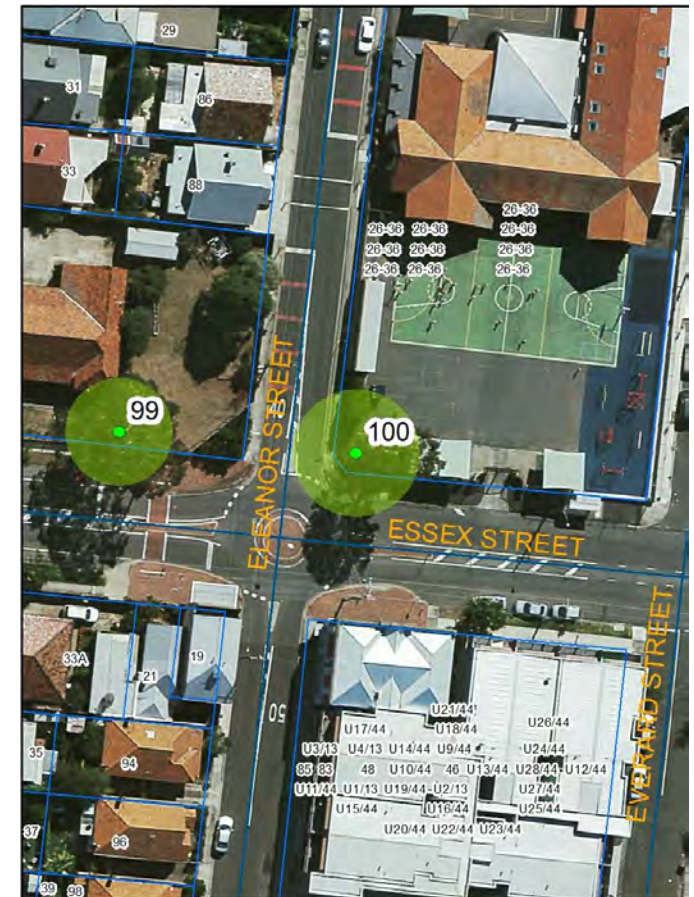
**Asset ID:** 102

**Failure Probability:** 3. Moderate

**Failure Size:** 3. 101-250mm

**Defects:** Codominant trunks, Canopy lopped

**Recommended Works:** Risk reduction pruning

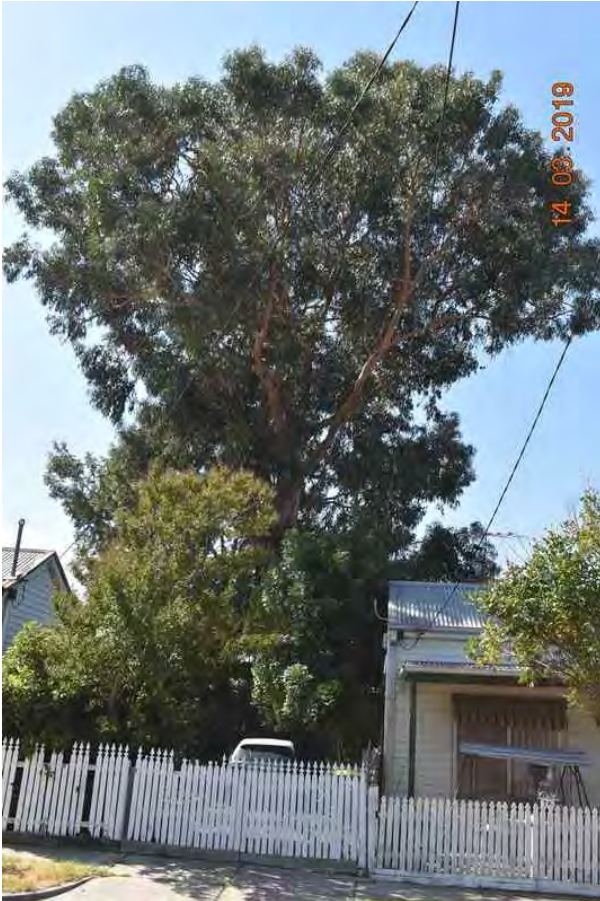
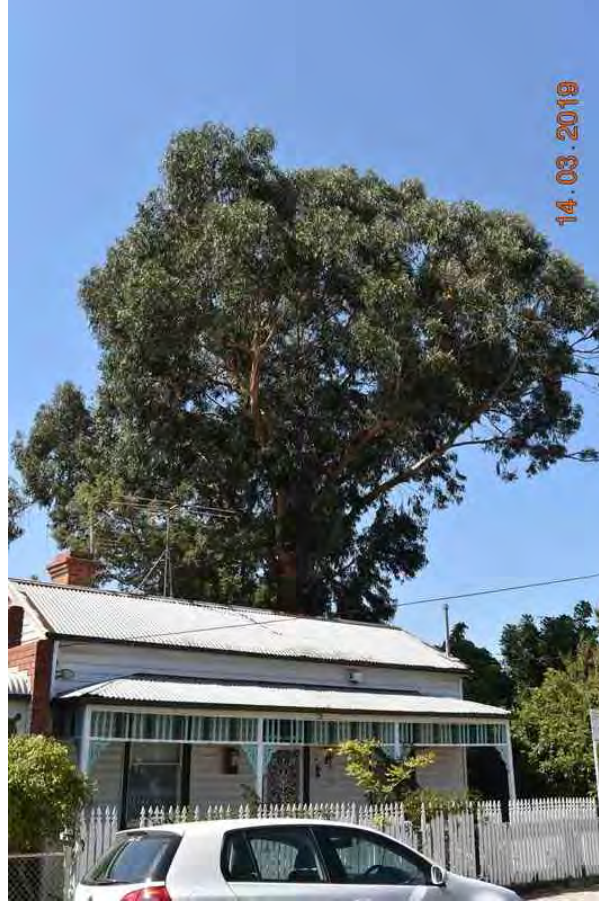
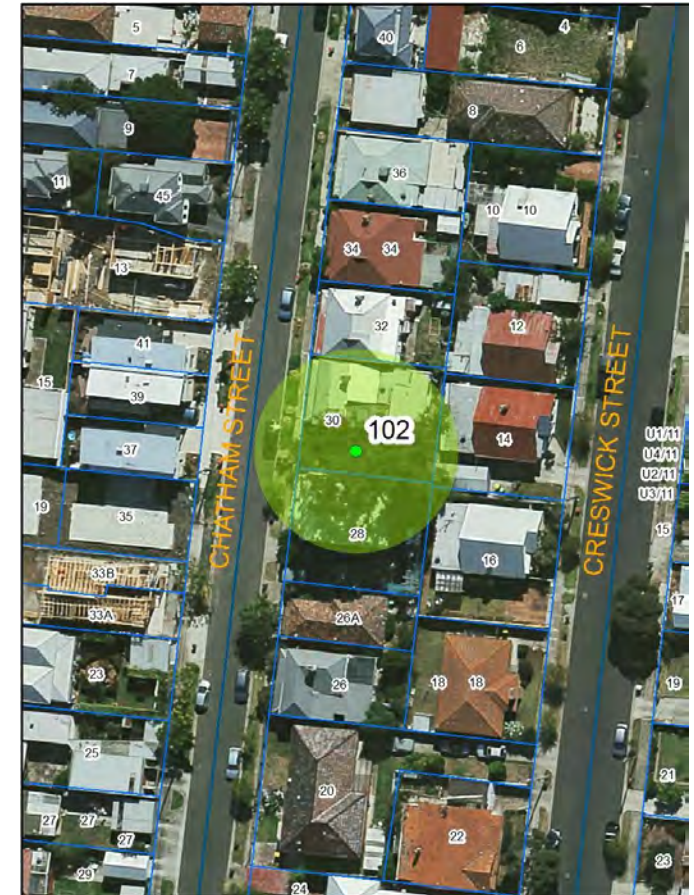
**Asset ID:** 103

**Failure Probability:** 3. Moderate

**Failure Size:** 3. 101-250mm

**Defects:** None

**Recommended Works:** No works

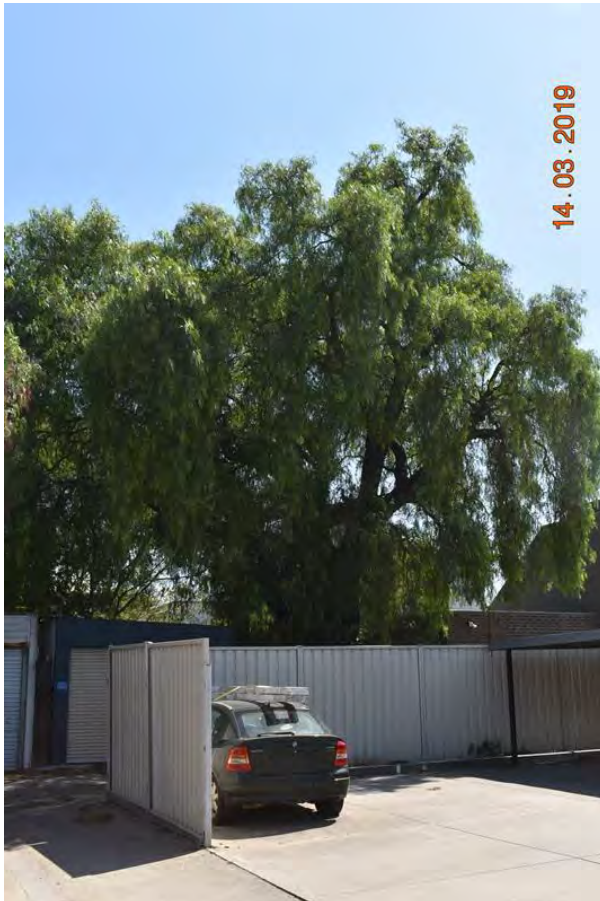
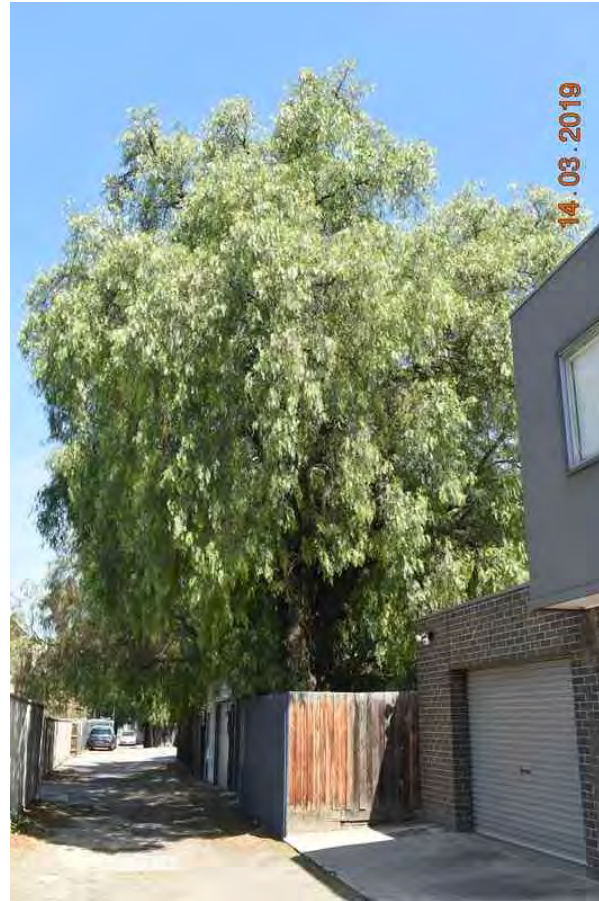
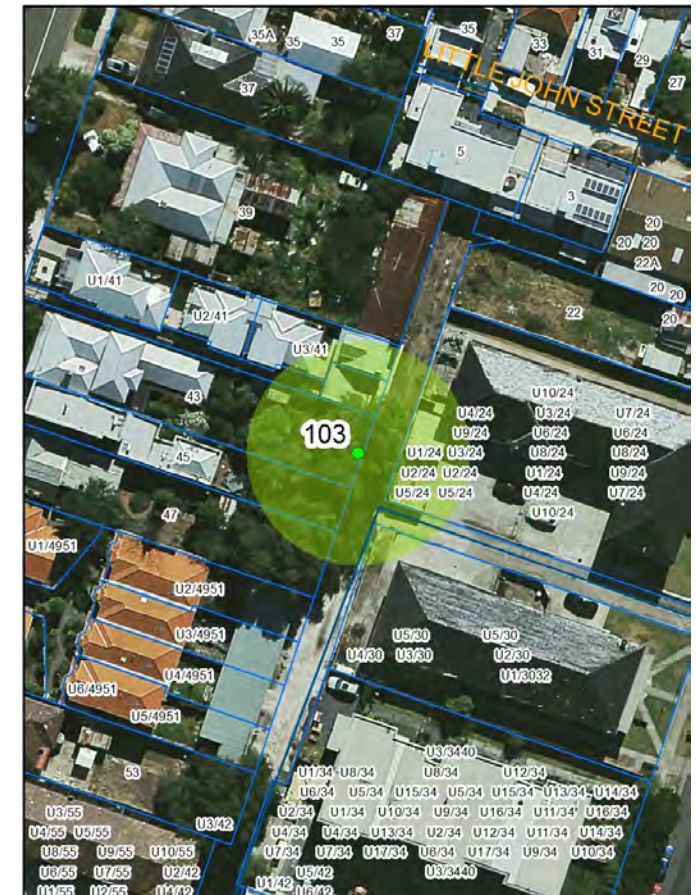
**Asset ID:** 108

**Failure Probability:** 4. Low

**Failure Size:** 3. 101-250mm

**Defects:** Mechanical damage to trunk, Decay in canopy, Included bark in trunk, Codominant

**Recommended Works:** No works

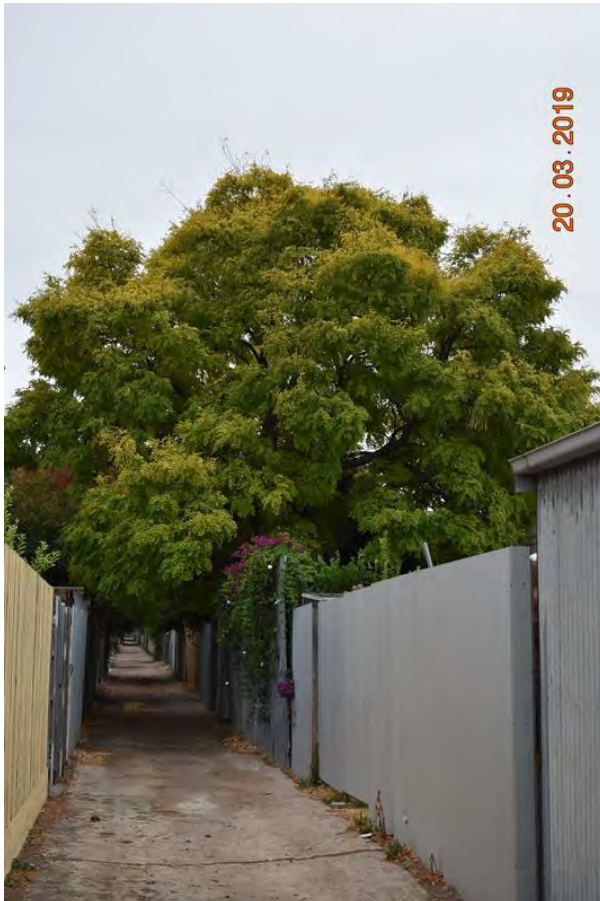
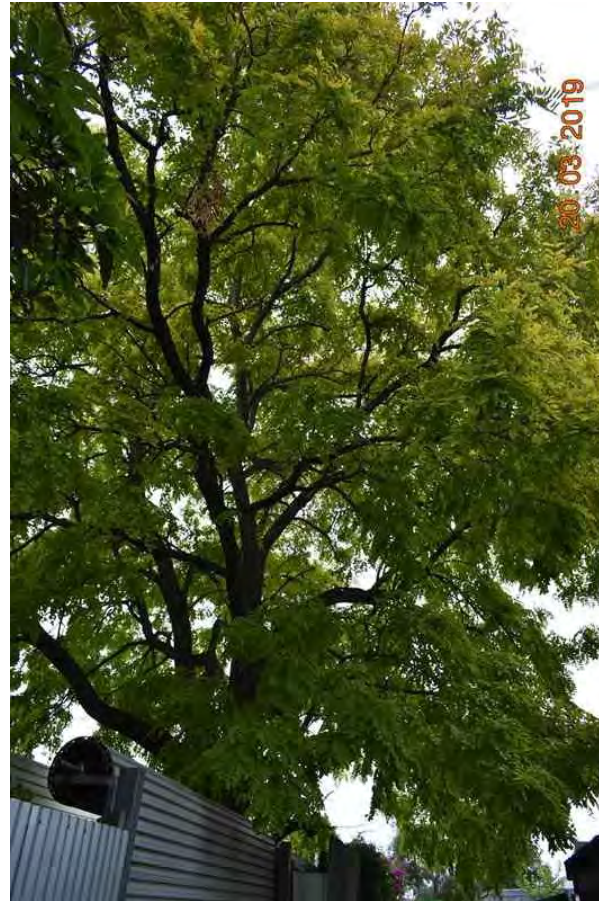
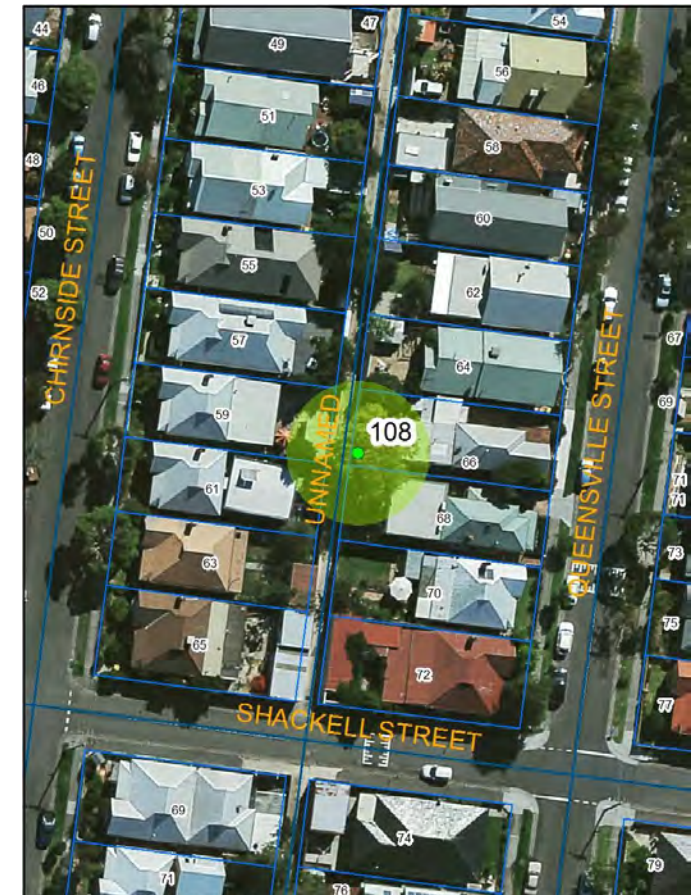
**Asset ID:** 109

**Failure Probability:** 4. Low

**Failure Size:** 3. 101-250mm

**Defects:** None

**Comments:** Some borer damage - minor

**Recommended Works:** Risk reduction pruning

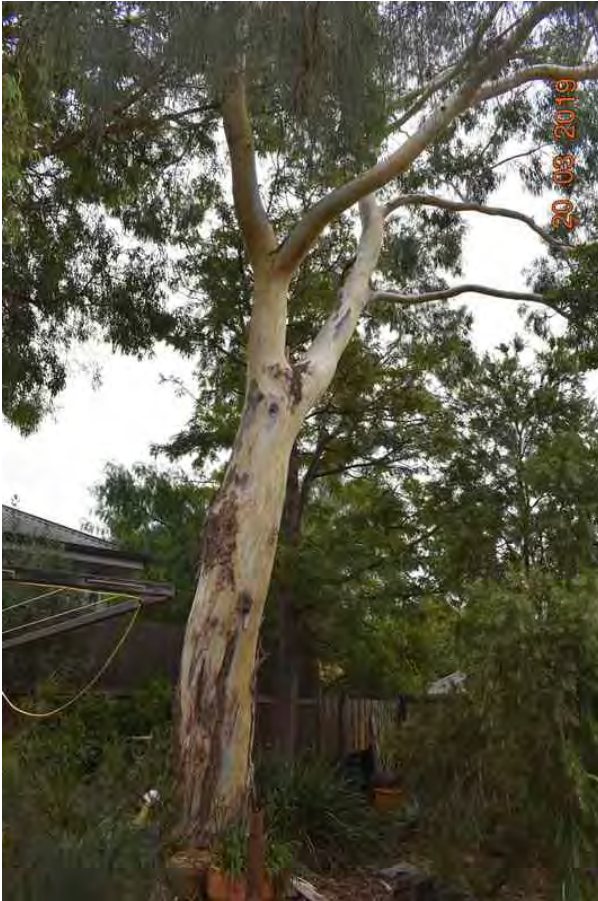
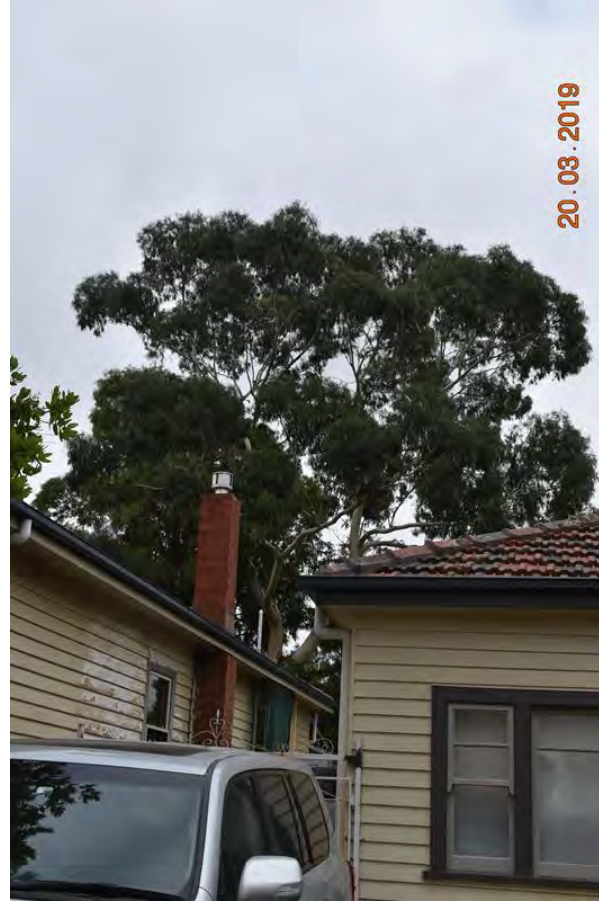
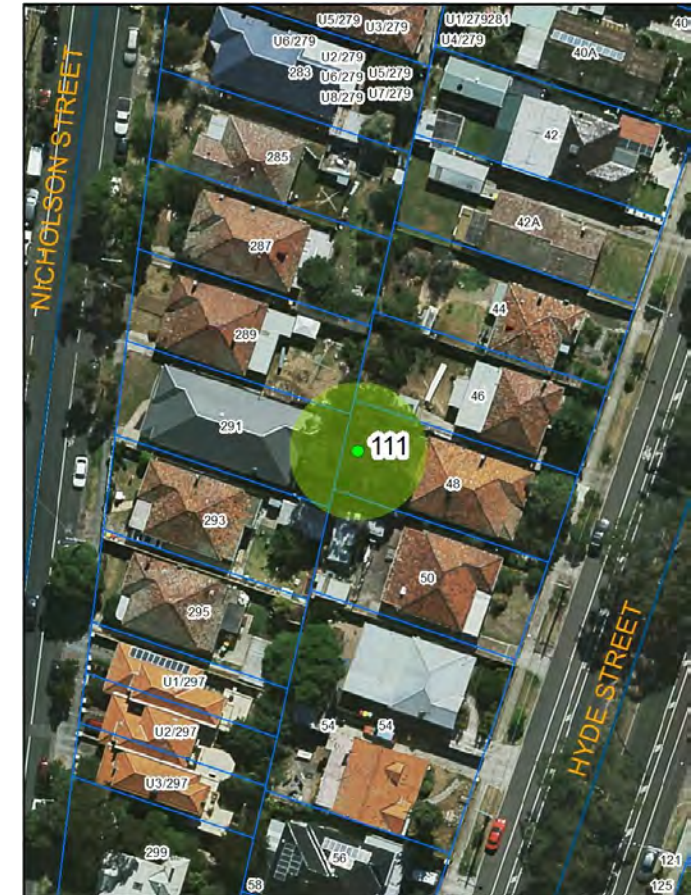
**This is a large specimen in good condition, centrally located in the rear yard and has a wide spreading canopy the width of the site making it an asset within the broader landscape.**

**Defects:** None

**Recommended Works:** No works

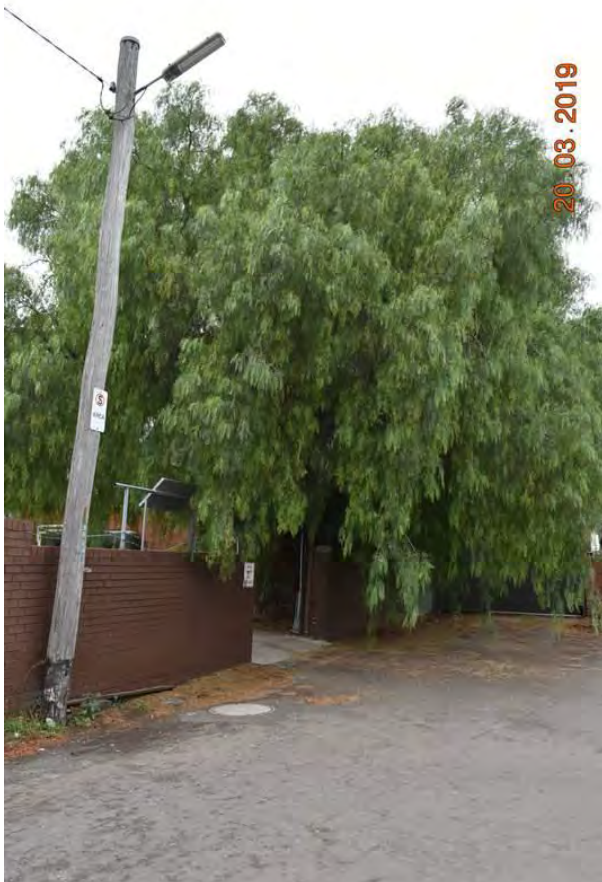
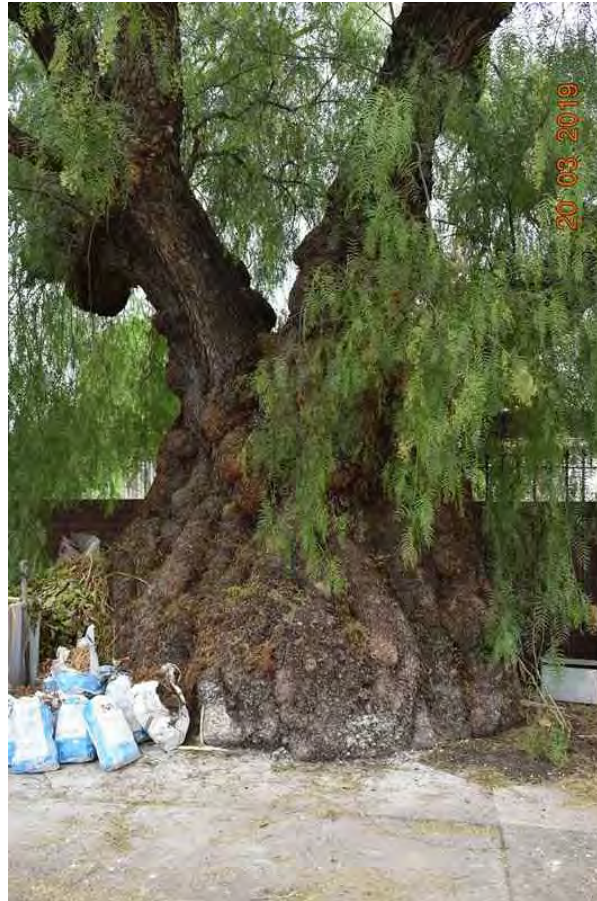
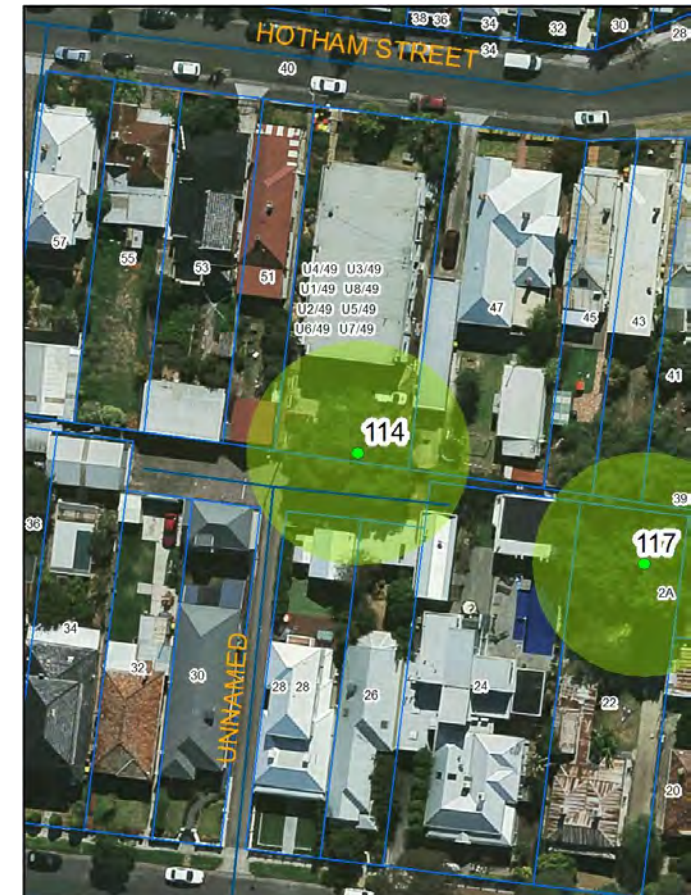
**Asset ID:** 114

**Failure Probability:** 4. Low

**This is a large old specimen in good condition with a strikingly large trunk diameter that is growing within a heavily paved area to the rear of the site away from existing buildings.**

**Defects:** None

**Recommended Works:** No works

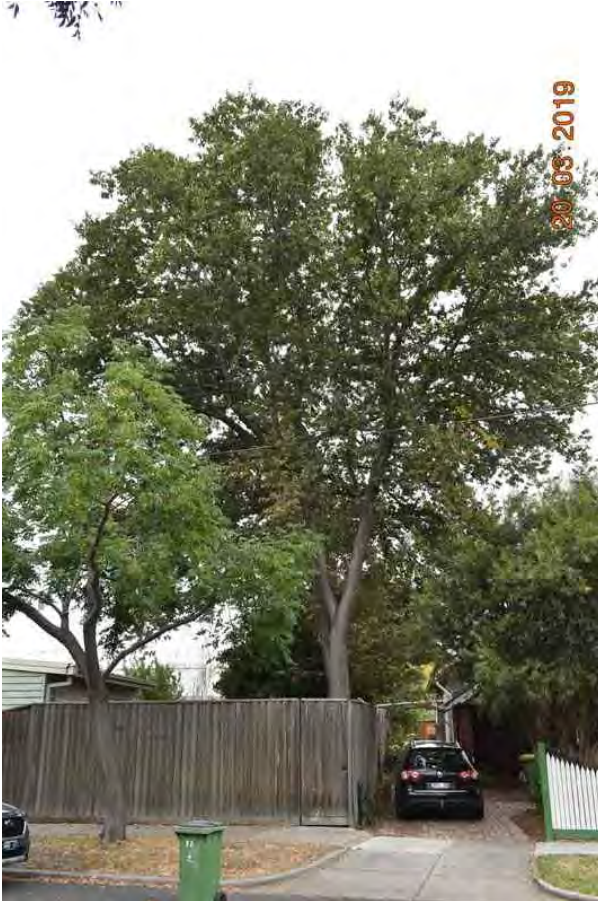
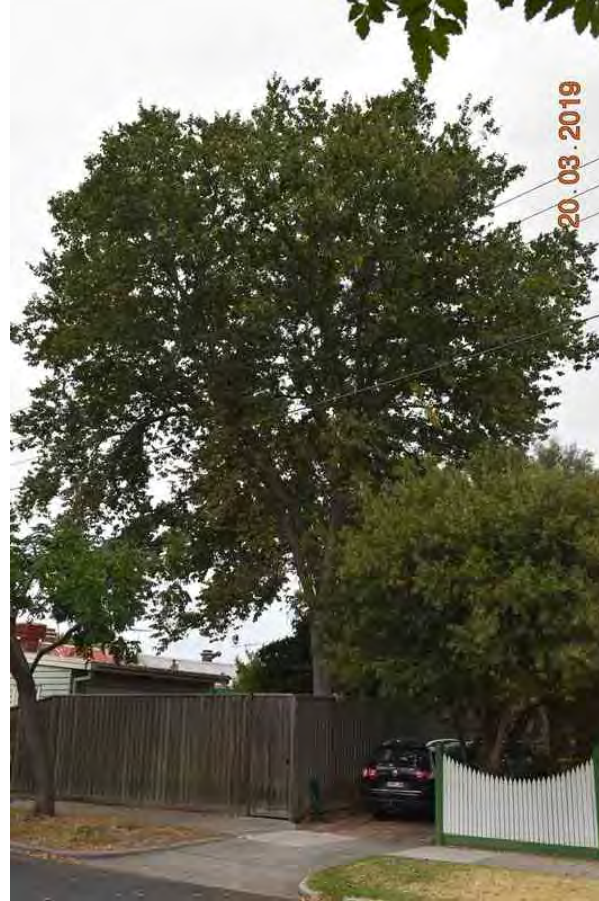
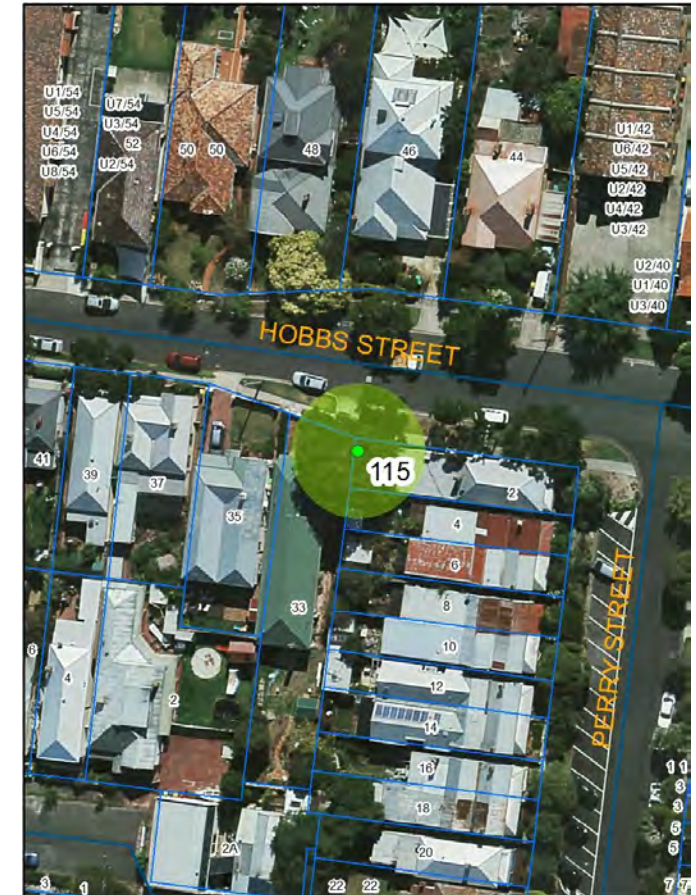
**Asset ID:** 115

**Failure Probability:** 3. Moderate

**Significance Statement:** **This is a large multi-stemmed specimen in good condition that provides form and character to the streetscape.**

**Defects:** Codominant trunks, Pest and disease

**Recommended Works:** No works

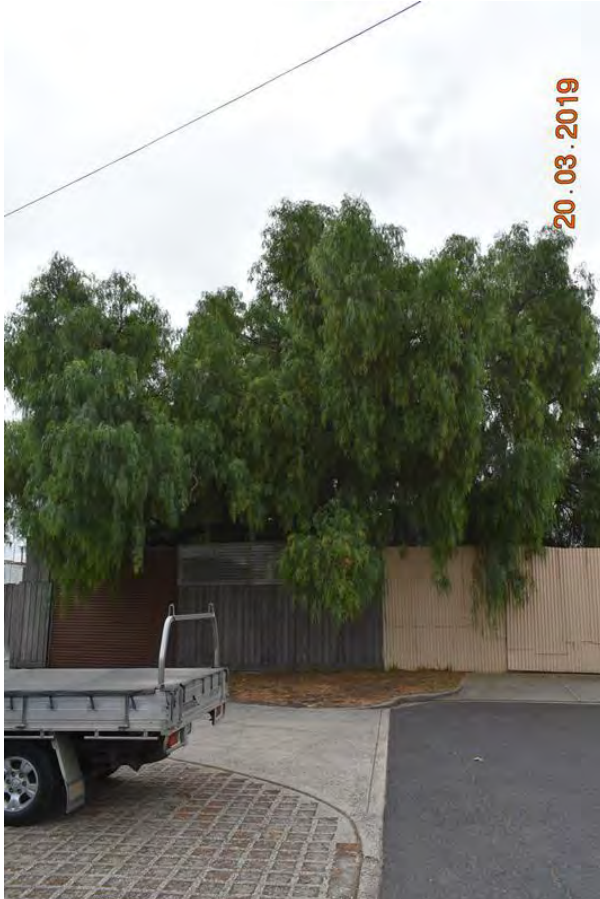
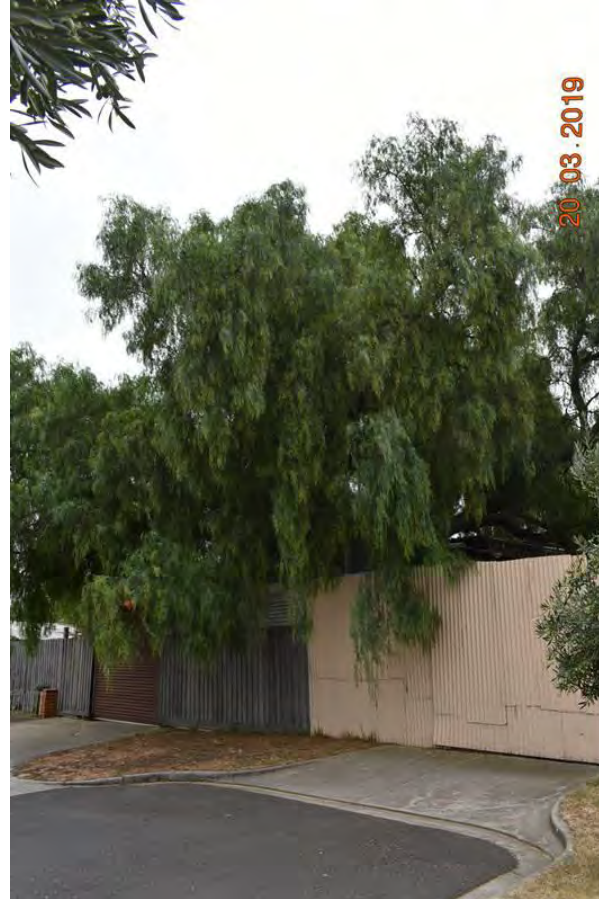
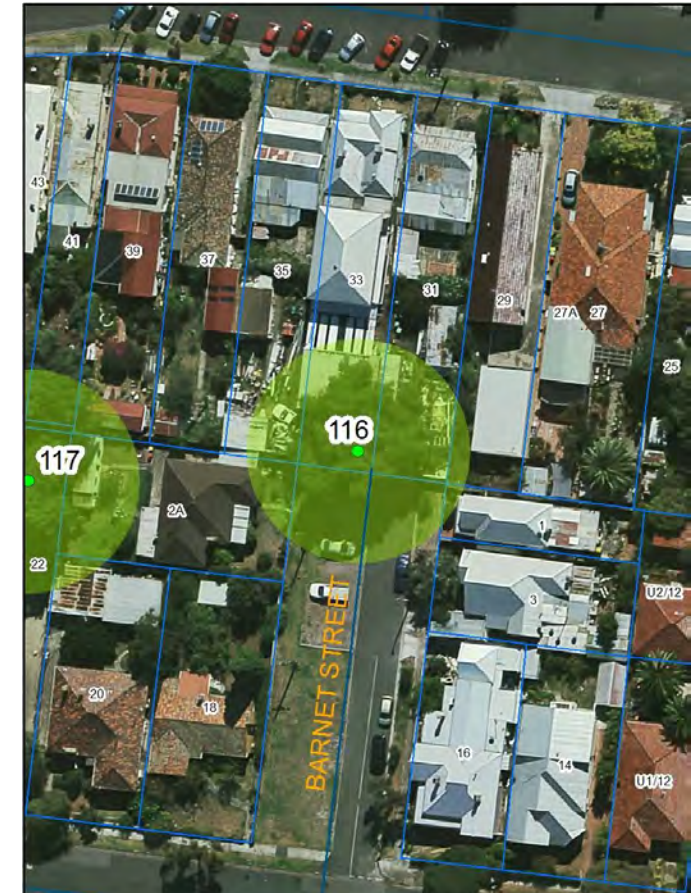
**Asset ID:** 116

**Failure Probability:** 3. Moderate

**Significance Statement:** This is a large specimen in good condition with a wide spreading canopy, particularly in context with its built surrounds.

**Defects:** None

**Recommended Works:** Risk reduction pruning

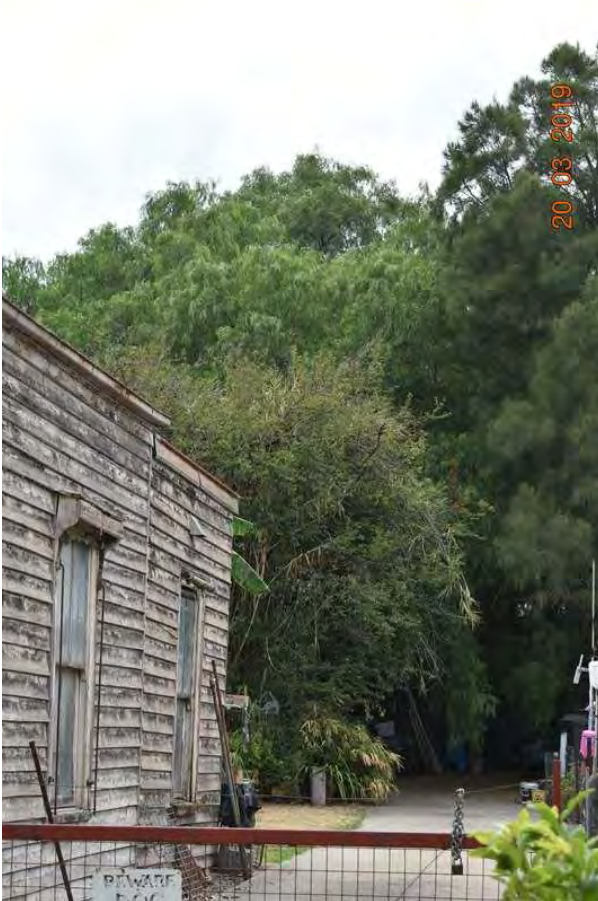
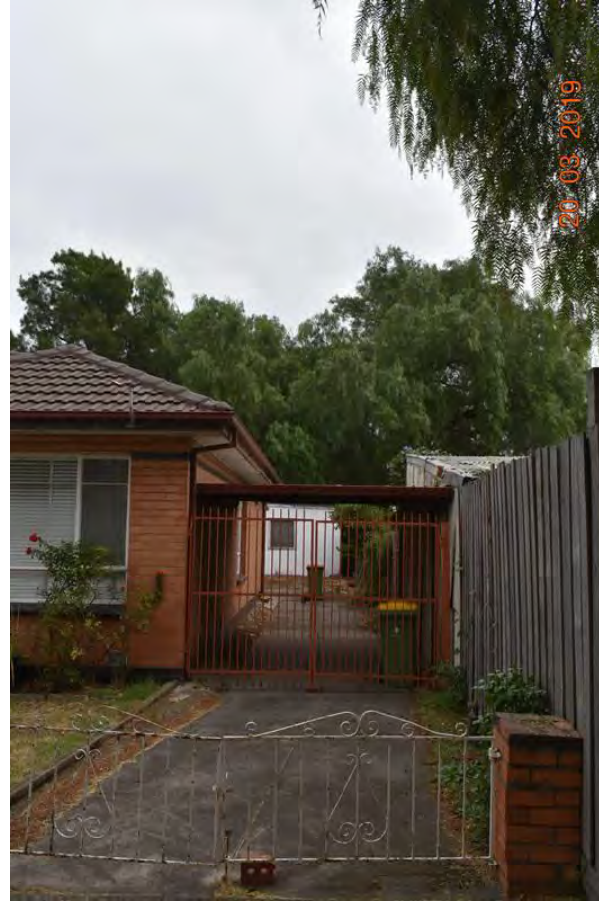
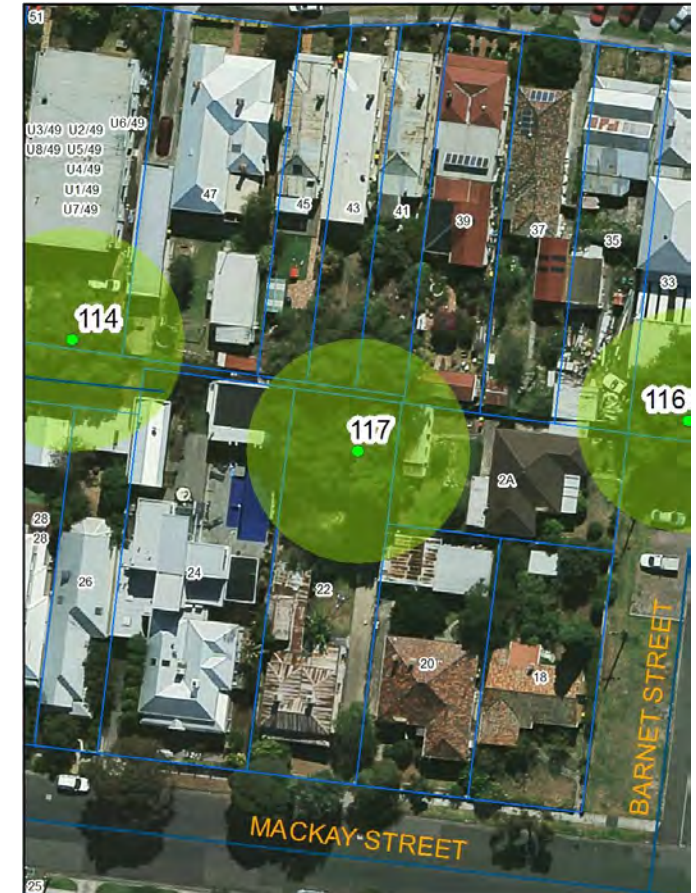
**Asset ID:** 117

**Failure Probability:** 3. Moderate

**Defects:** None

**Recommended Works:** Risk reduction pruning

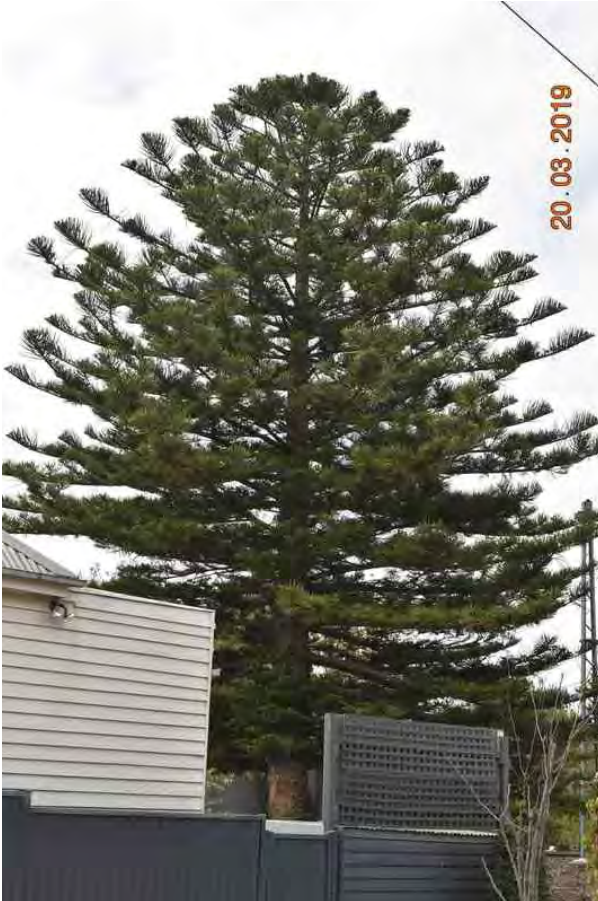
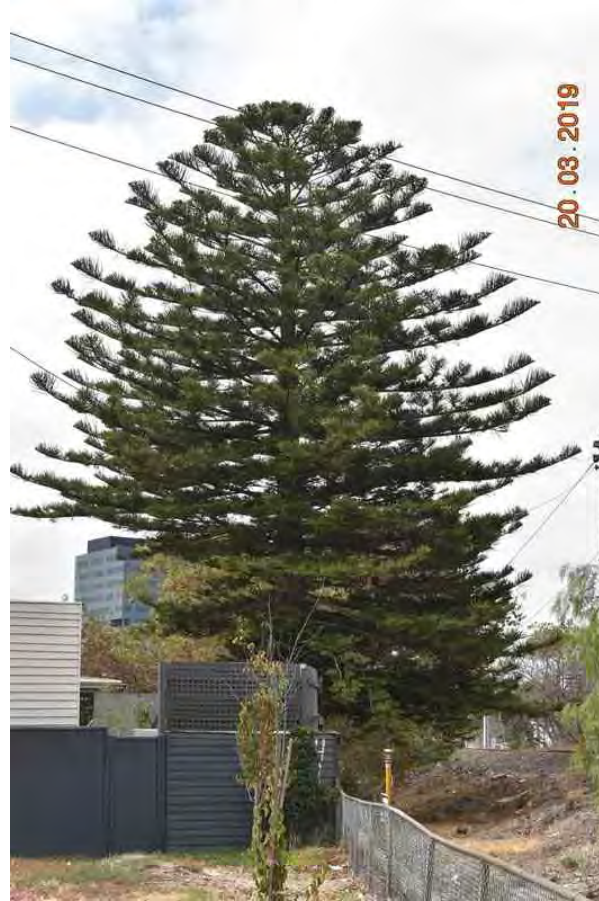
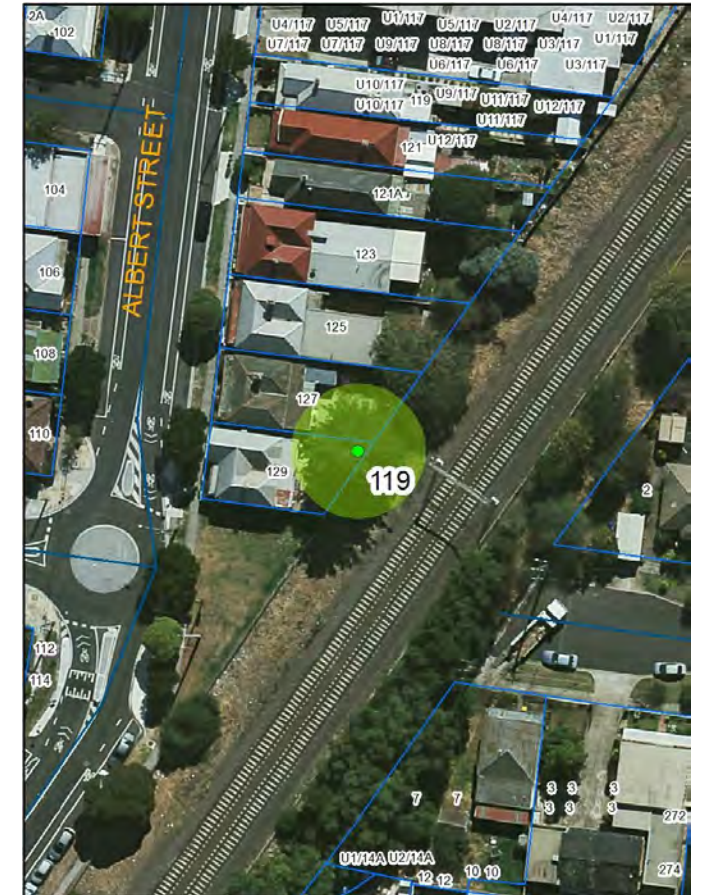
**Asset ID:** 119

**Failure Probability:** 4. Low

**Defects:** None

**Recommended Works:** No works

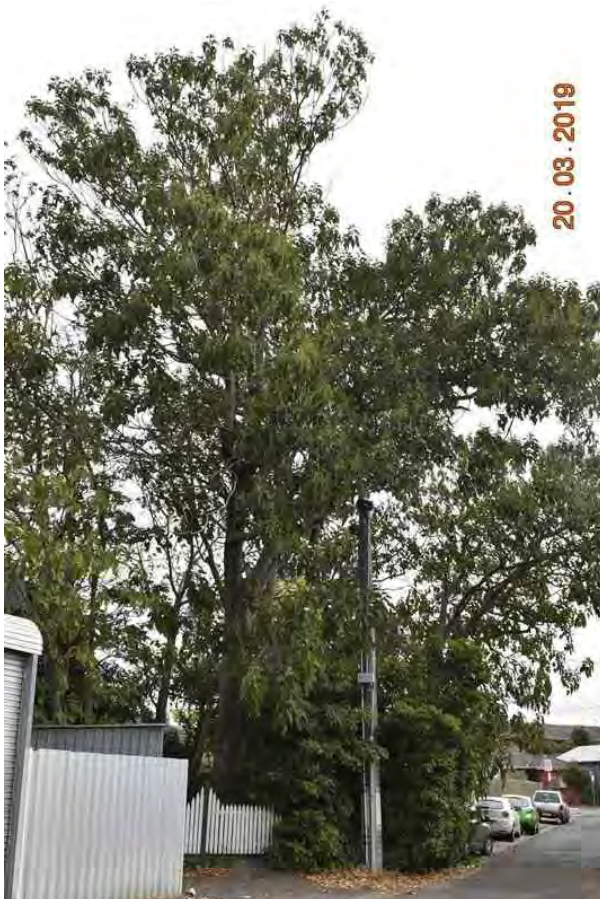
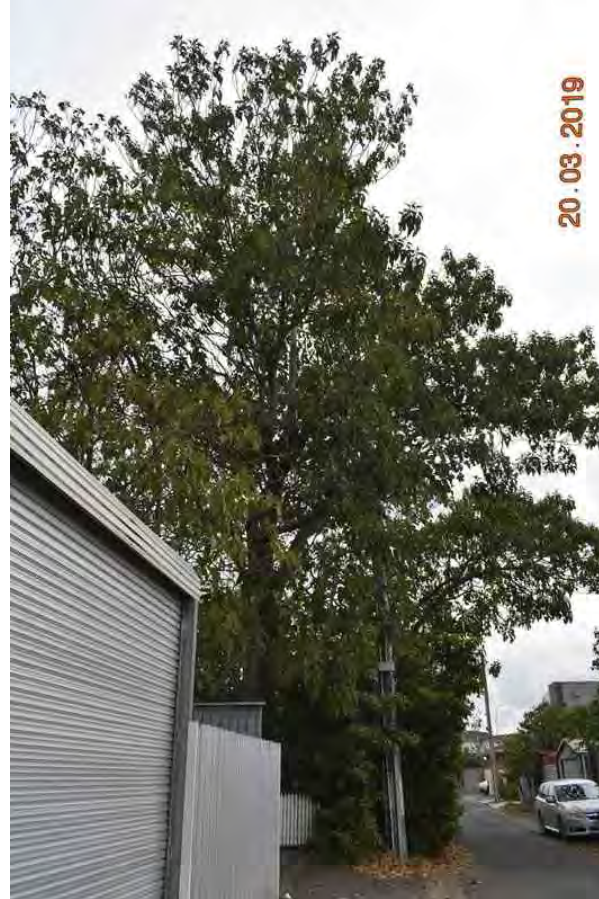
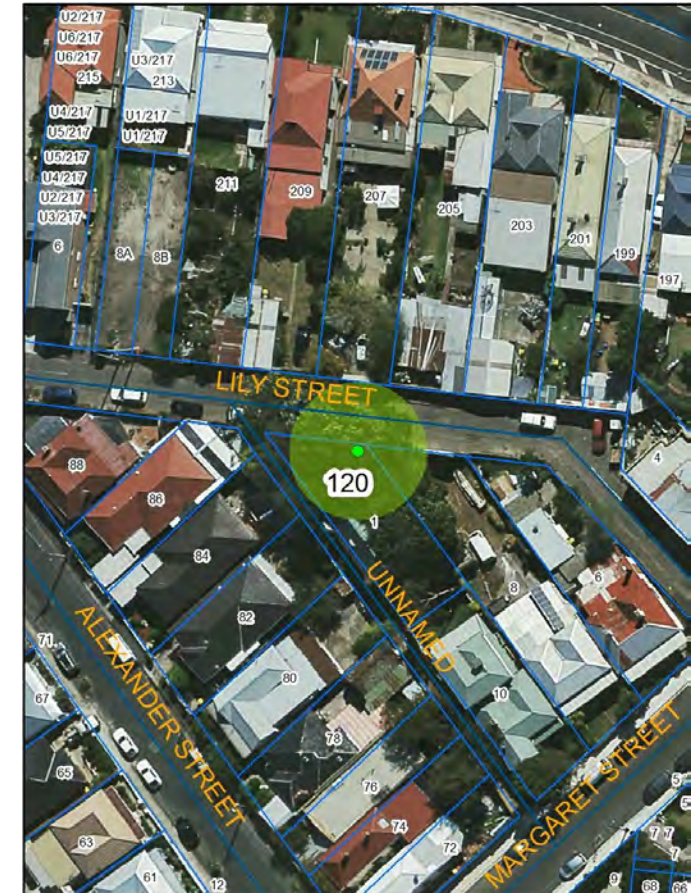
**Asset ID:** 120

**Failure Probability:** 4. Low

**Defects:** Mechanical damage to trunk, Codominant trunks

**Recommended Works:** No works
