# Maribyrnong City Council Significant Tree Register 2019 Draft for Consultation

**Homewood Consulting Pty Ltd**

**Maribyrnong City Council**

December 2019

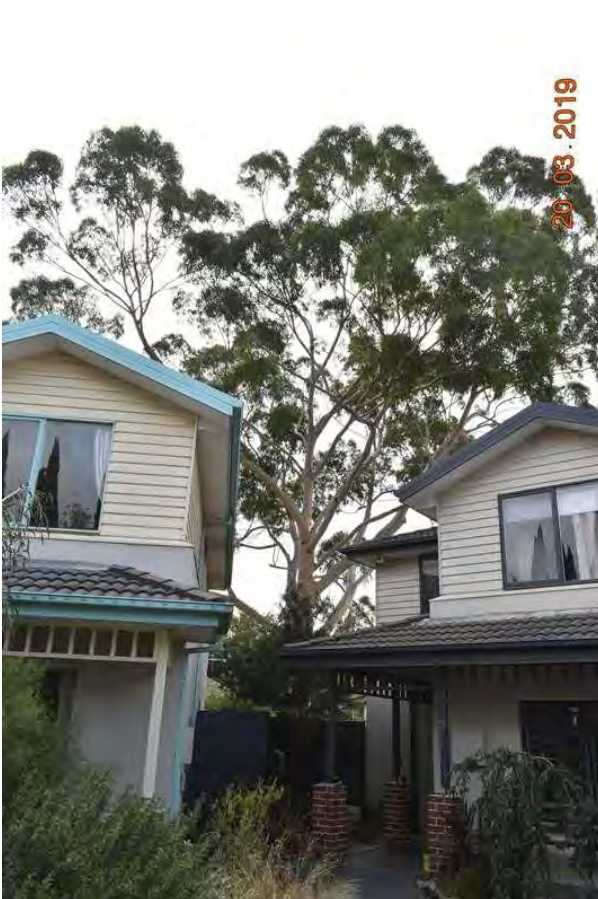
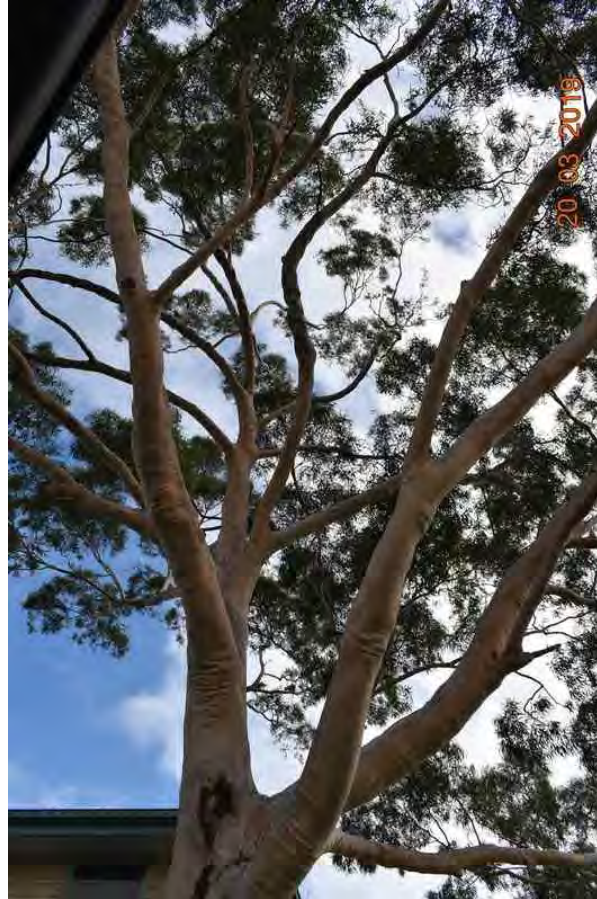
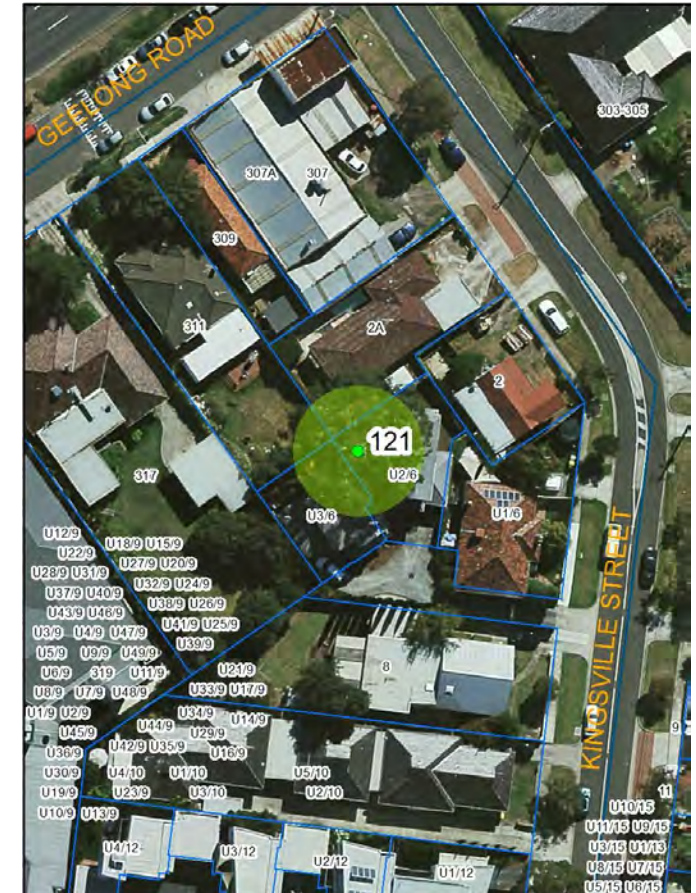
**Asset ID:** 121

**Failure Probability:** 4. Low

**Defects:** Codominant trunks, Decay in trunk

**This is a large tree in an urban context that is a strong feature of the surrounding residential area, the canopy stretches among a number of properties creating a striking vegetated backdrop in this urban context.**

**Recommended Works:** No works

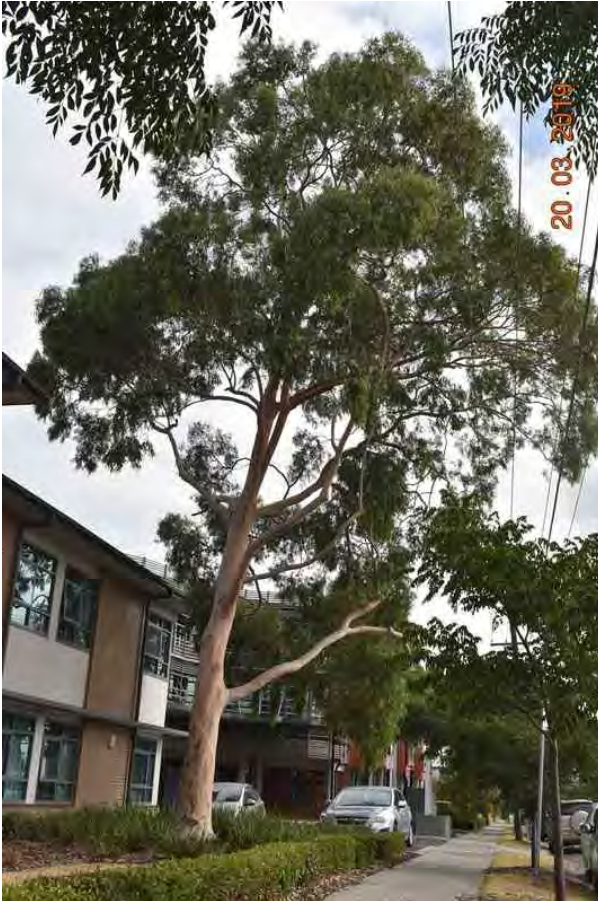
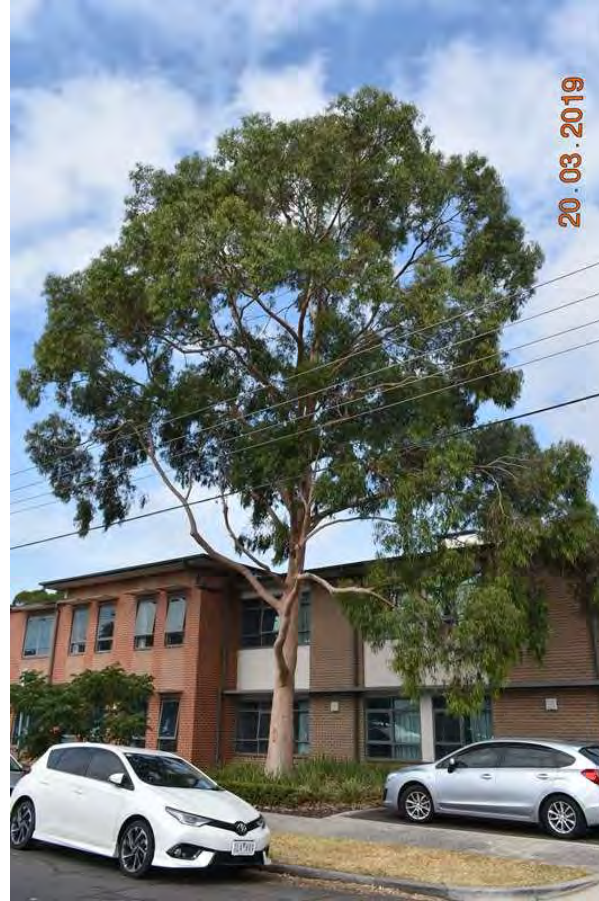
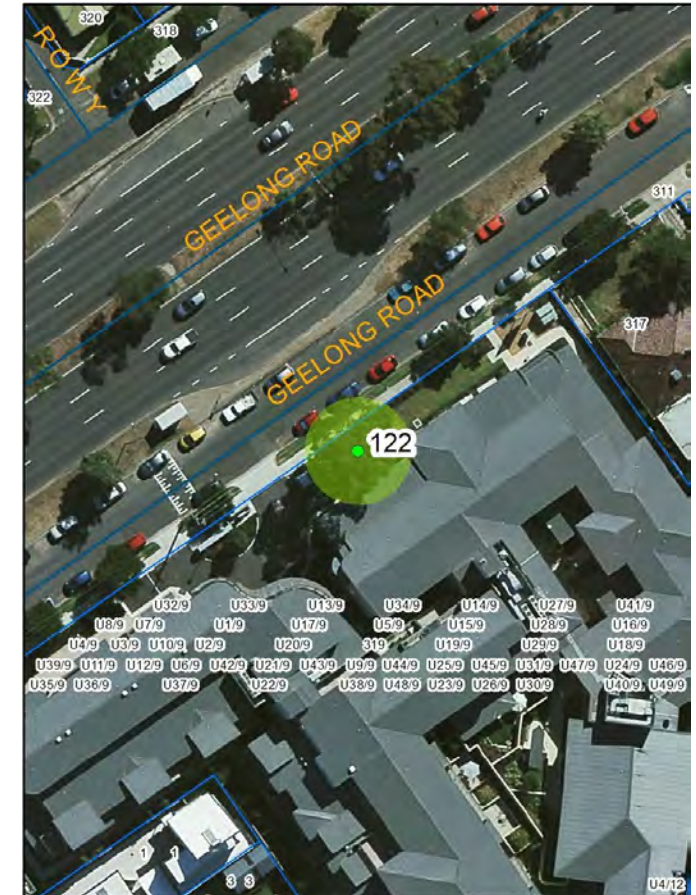
**Asset ID:** 122

**Failure Probability:** 4. Low

**Defects:** None

**Recommended Works:** No works

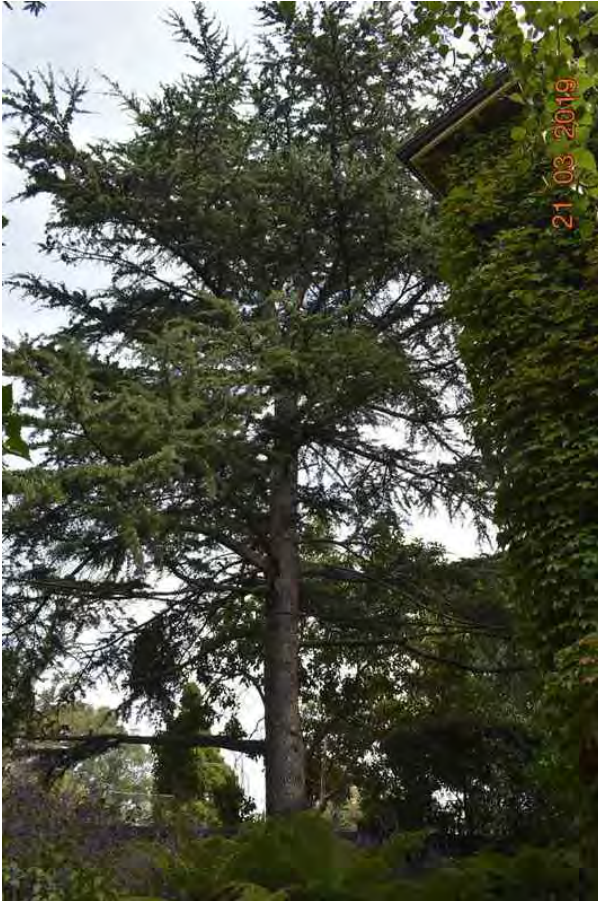
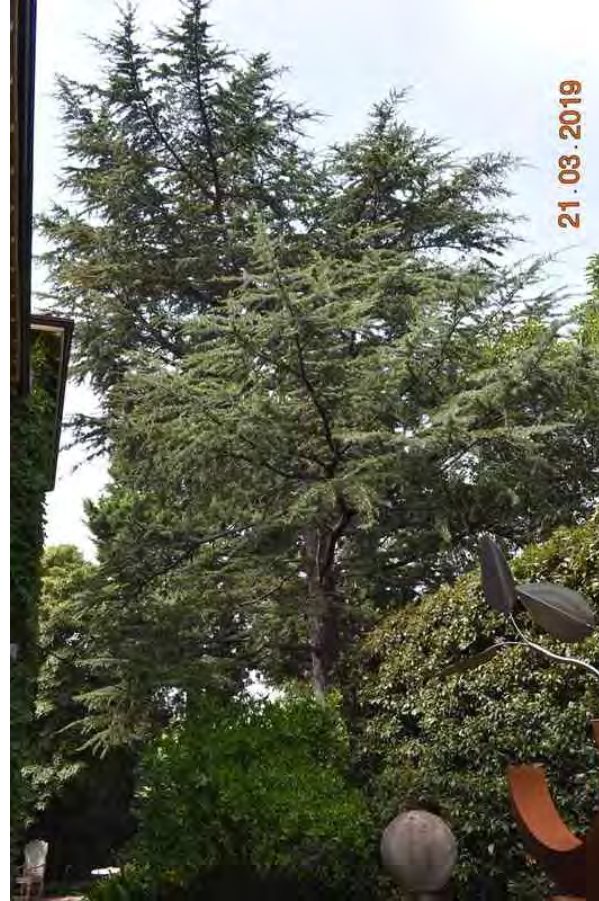
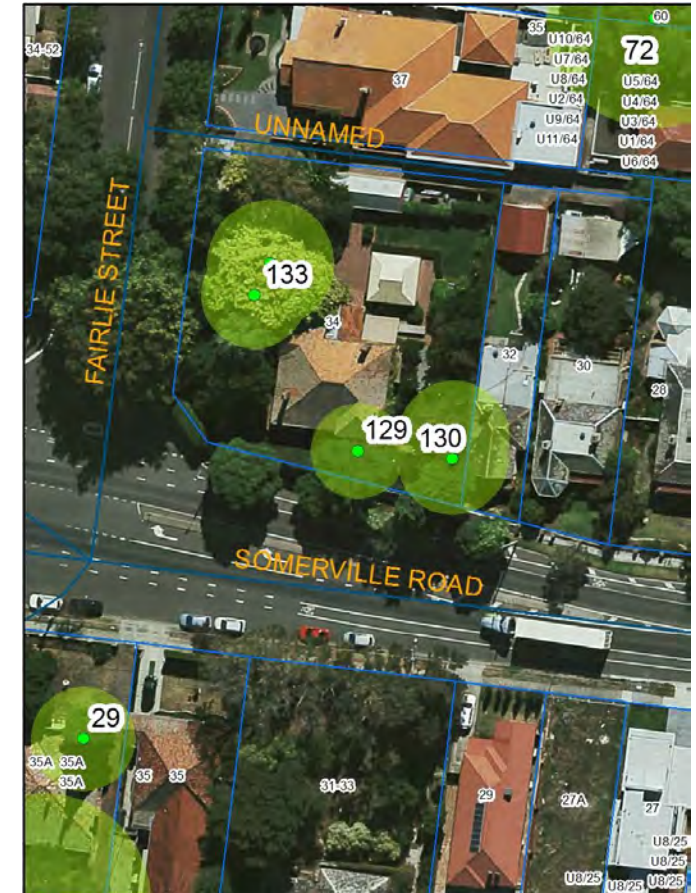
**Asset ID:** 129

**Failure Probability:** 4. Low

**Planted in 1942, this specimen is in good condition, particularly in context with its built surrounds, and has a strong contribution to the streetscape.**

**Defects:** None

**Recommended Works:** No works

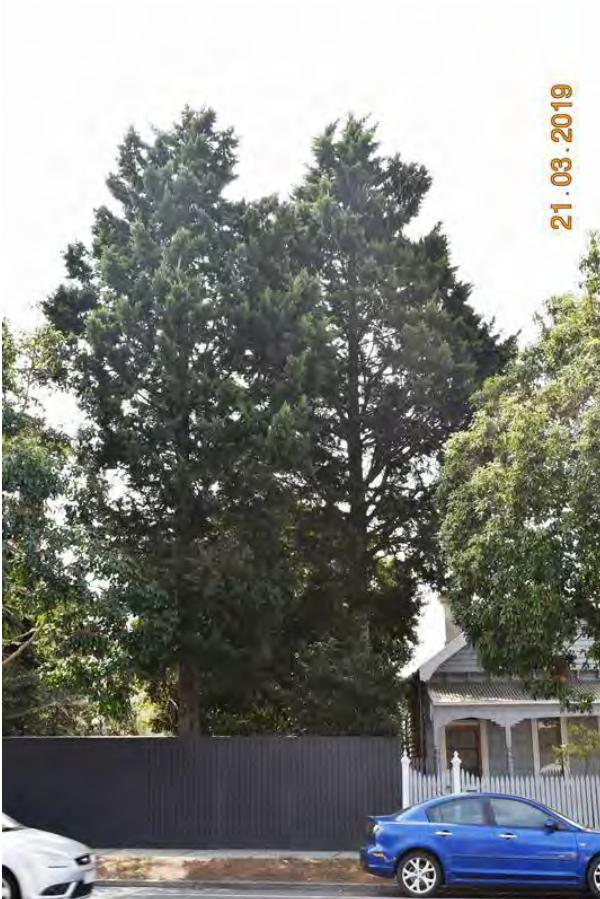
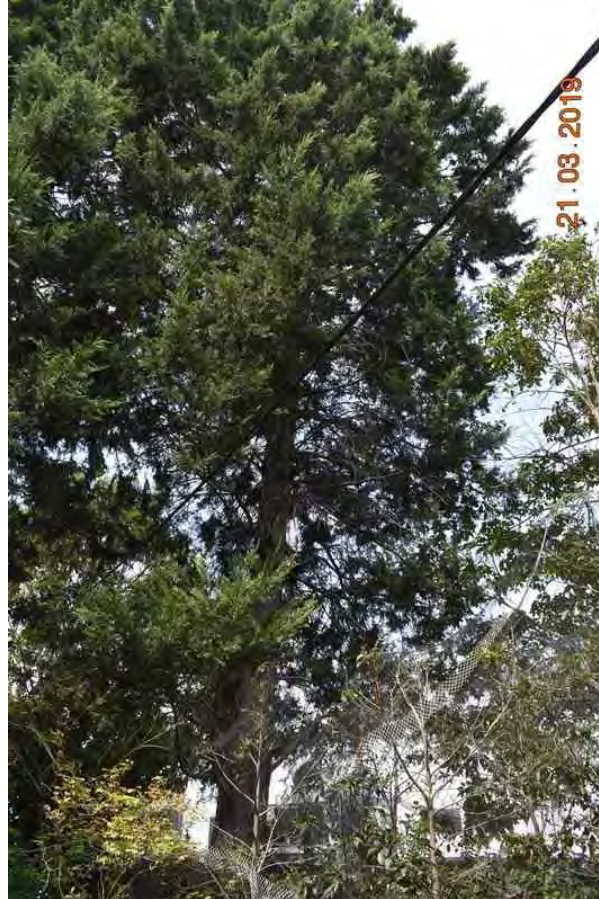
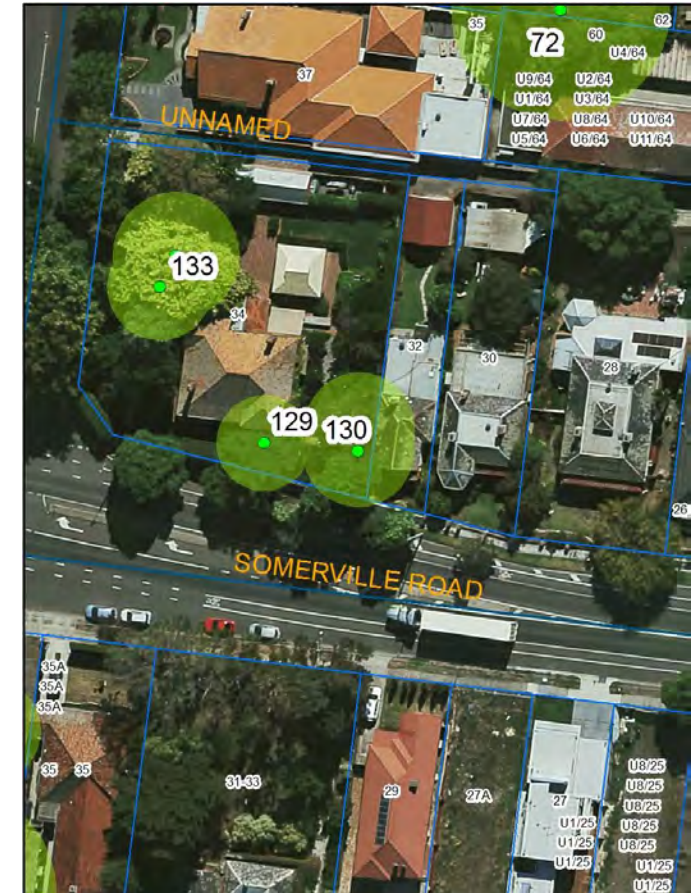
**Asset ID:** 130

**Failure Probability:** 4. Low

**Defects:** None

**Recommended Works:** No works

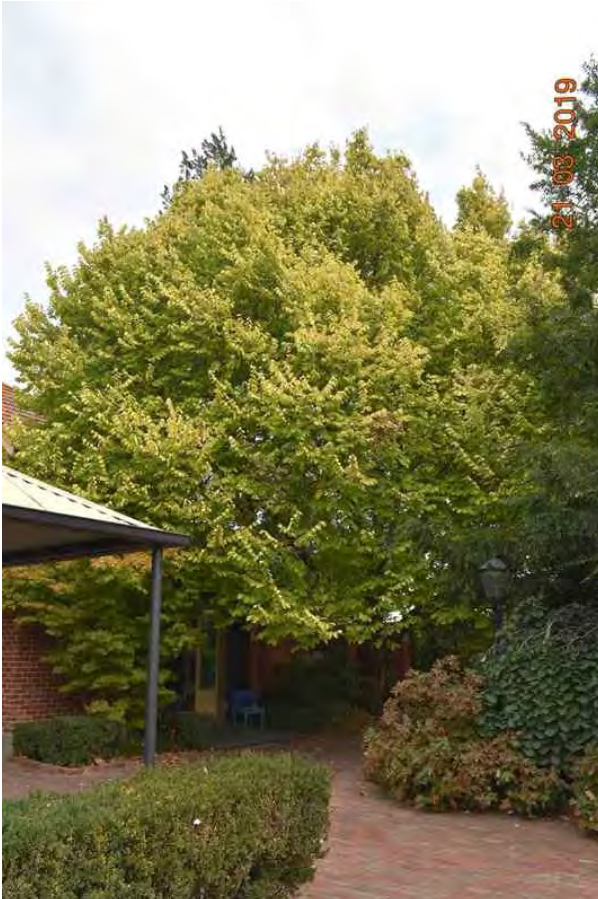
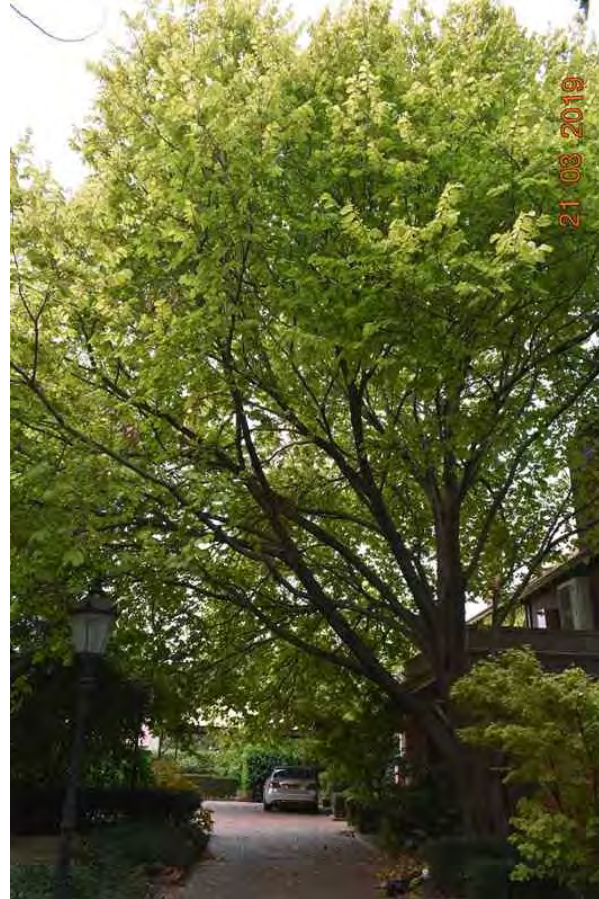
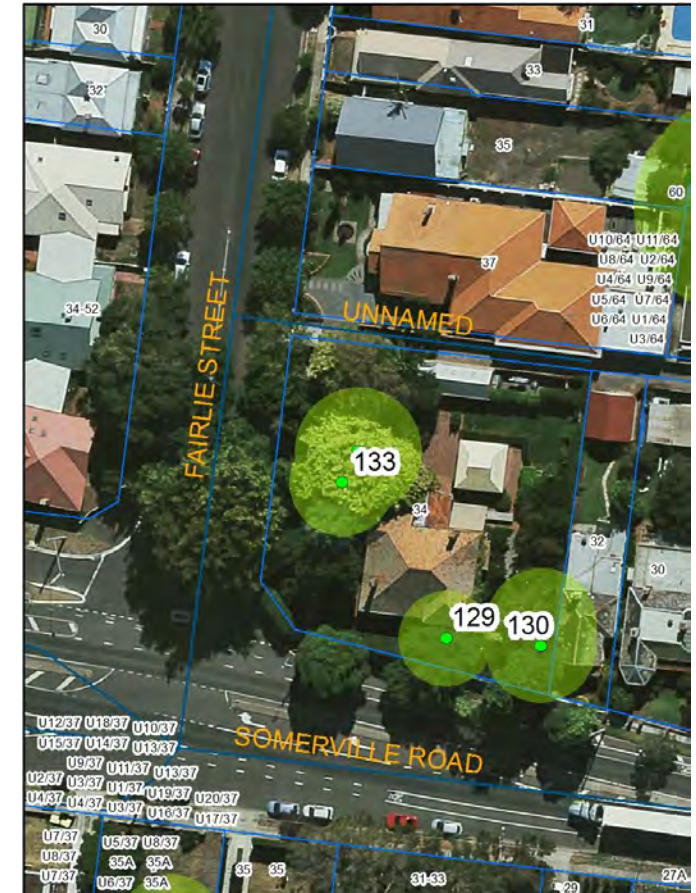
**Asset ID:** 132

**Failure Probability:** 4. Low

**Defects:** None

**Recommended Works:** No works

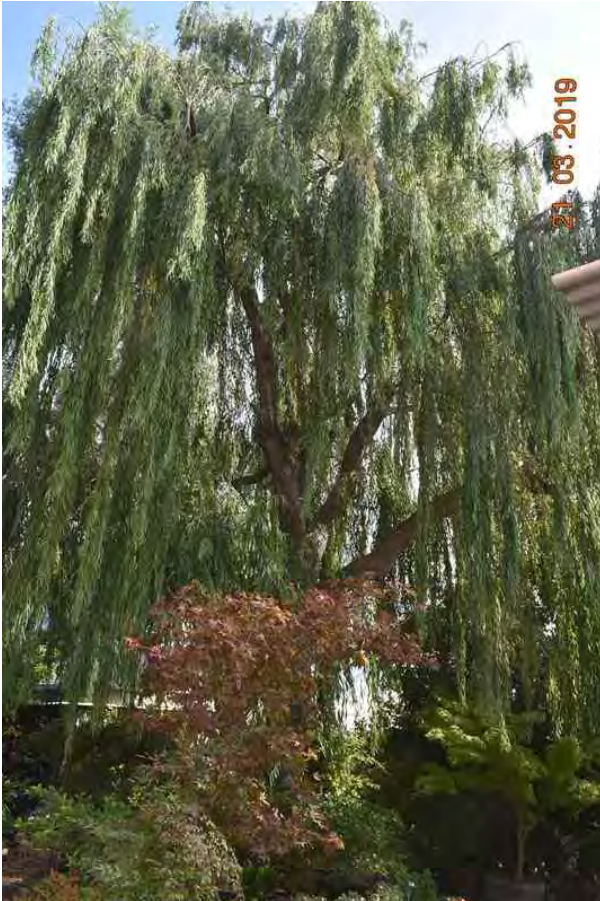
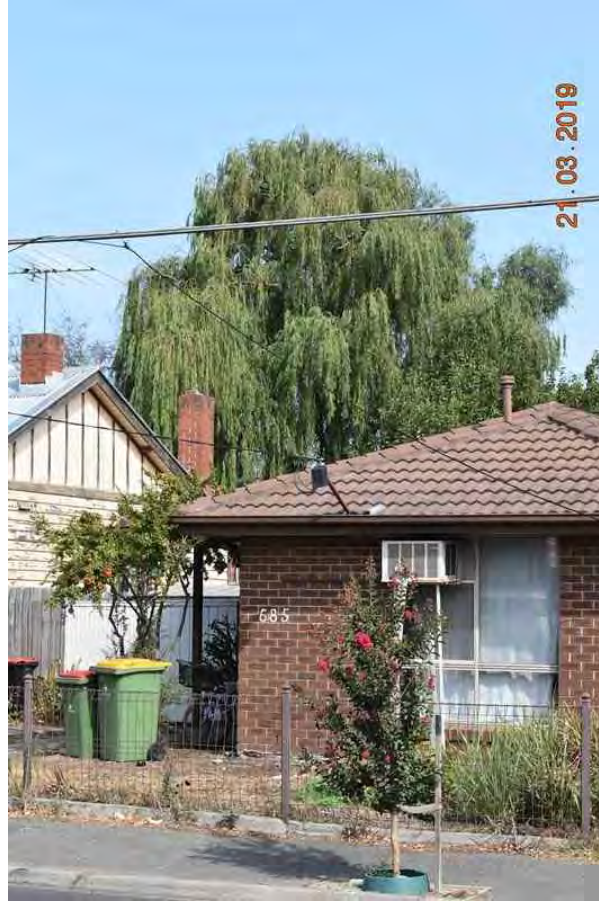
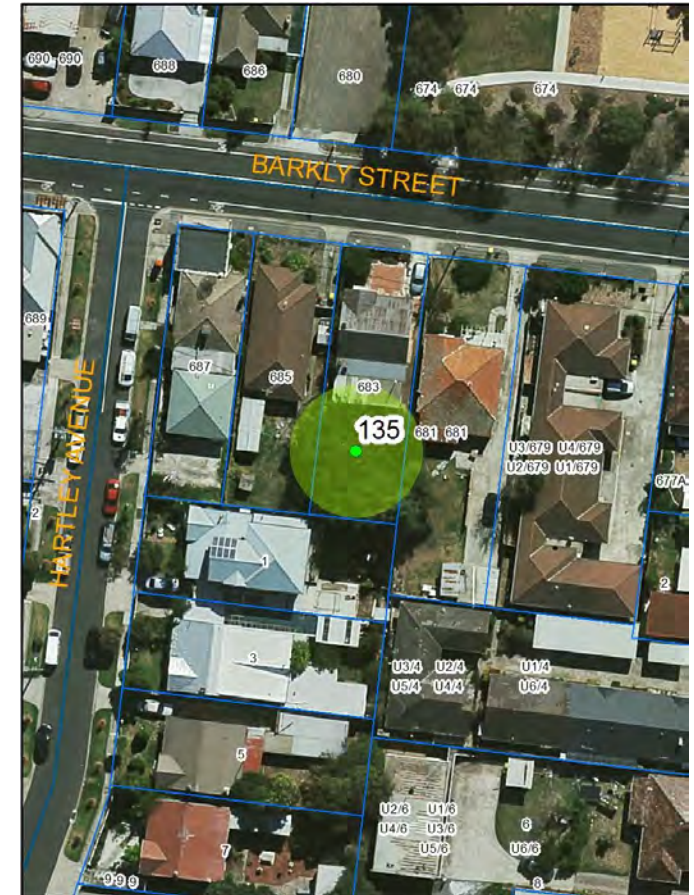
**Asset ID:** 143

**Defects:** Codominant trunks

**Recommended Works:** No works

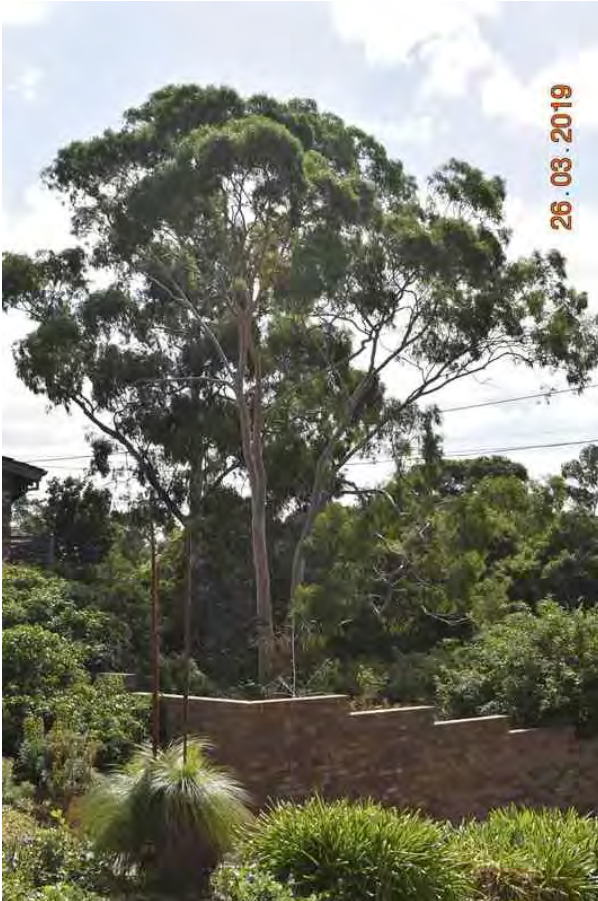
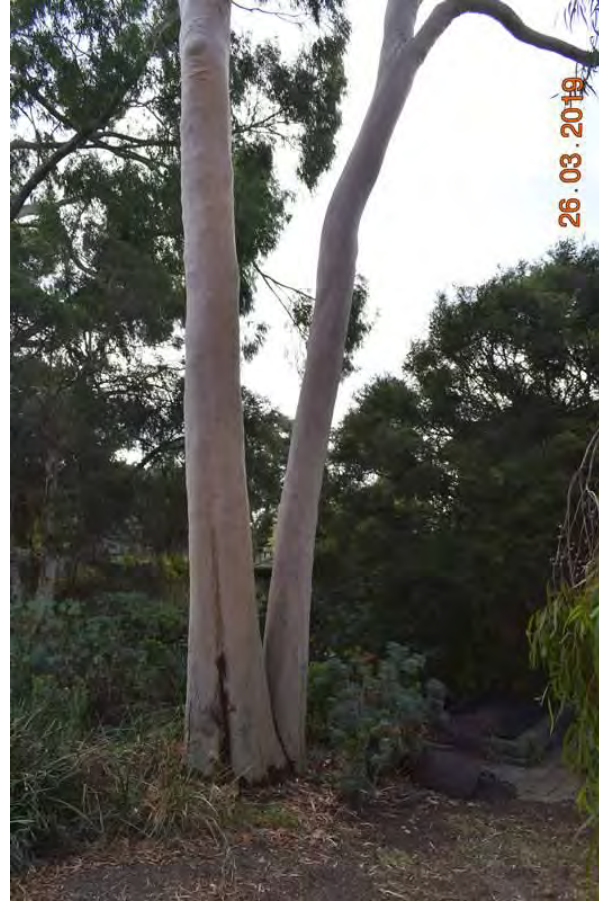
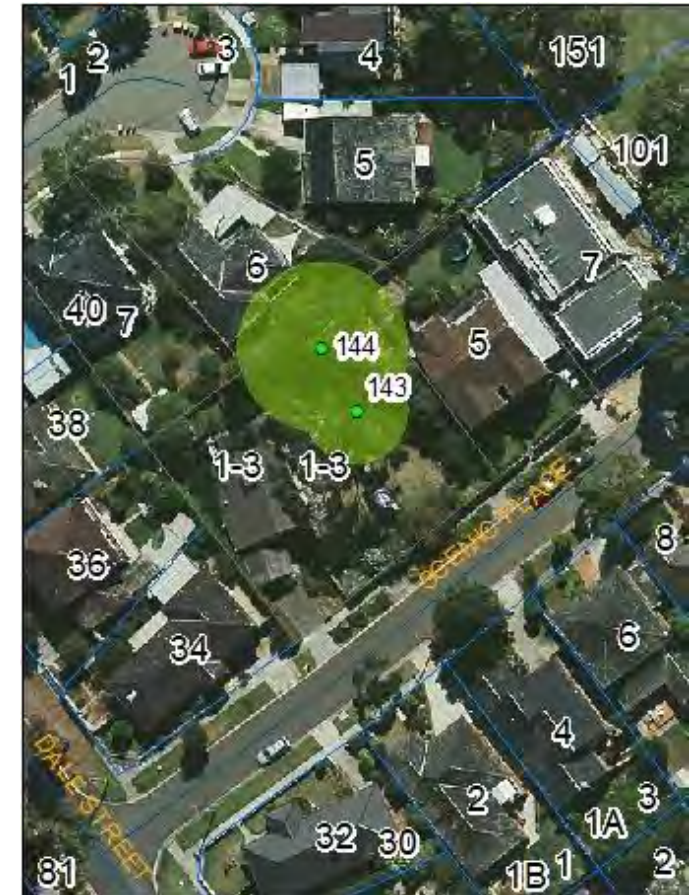
**Asset ID:** 144

**Significance Statement:** This is a large indigenous specimen in good condition. It stands tall and is dominating within the landscape

**Defects:** None

**Recommended Works:** No works

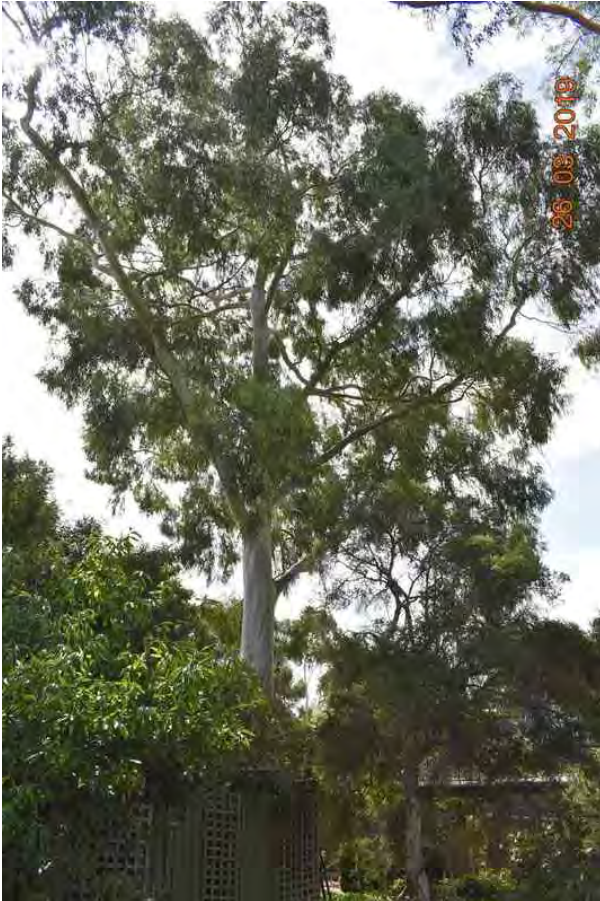
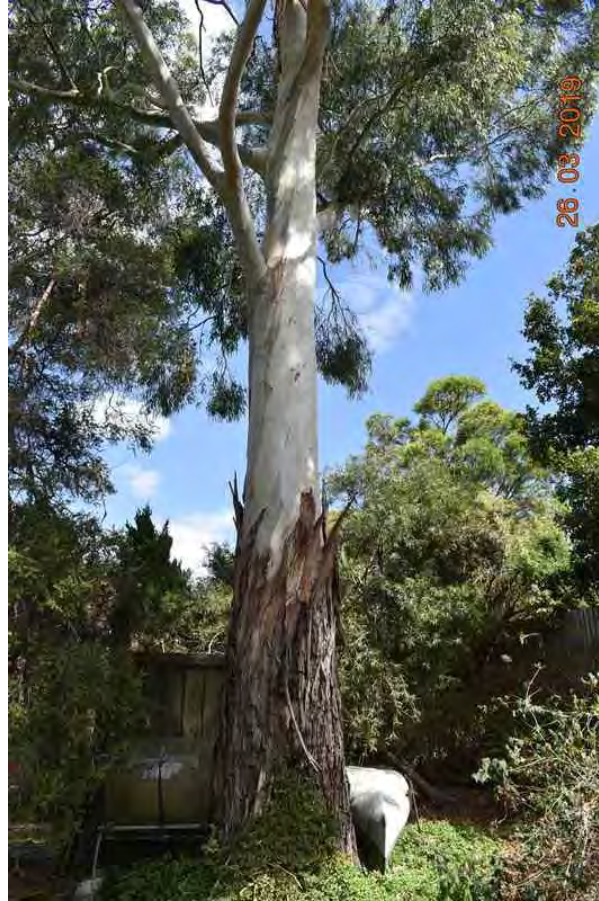
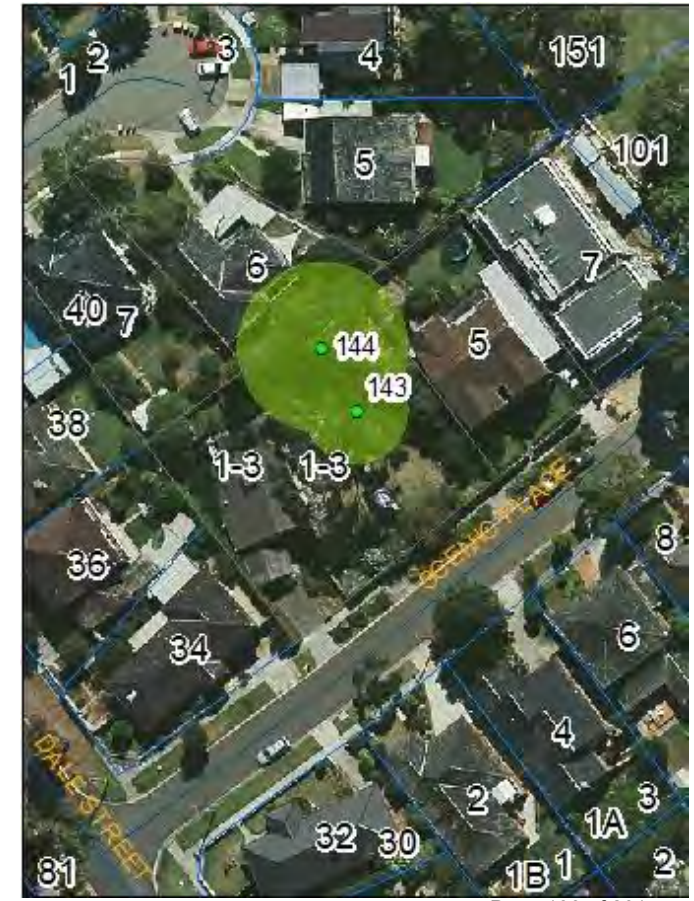
**Asset ID:** 145

**Significance Statement:** An aesthetically attractive tree in good condition considering its built up surrounds. It is located in a prominent position and can be seen from afar.

**Defects:** None

**Recommended Works:** No works

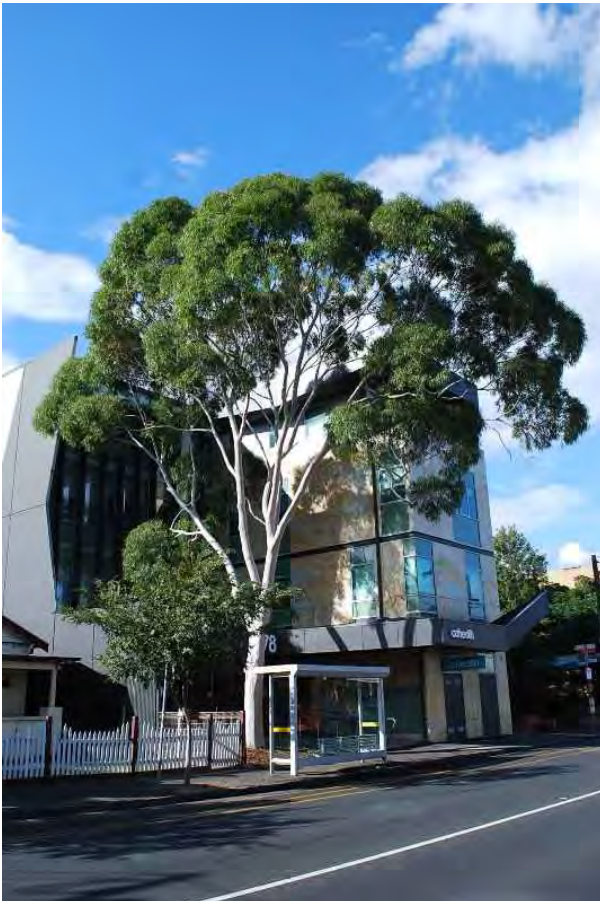
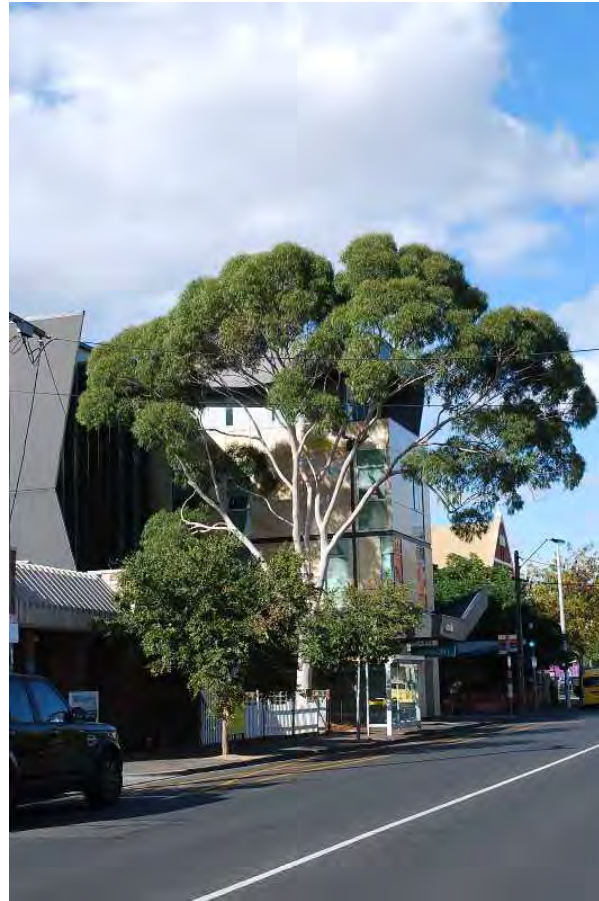
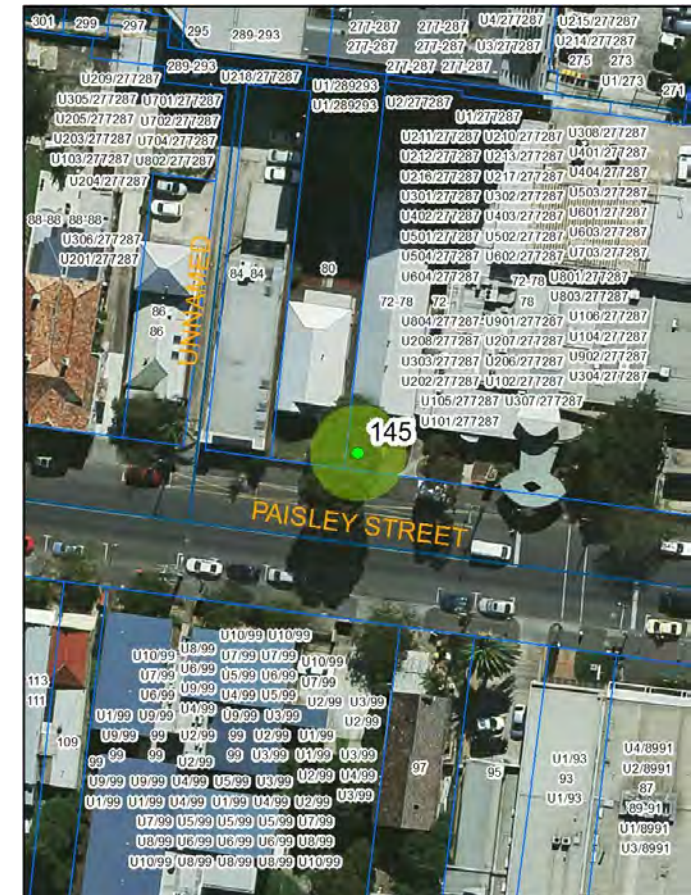
**Asset ID:** 146

**Defects:** None

**Recommended Works:** No works

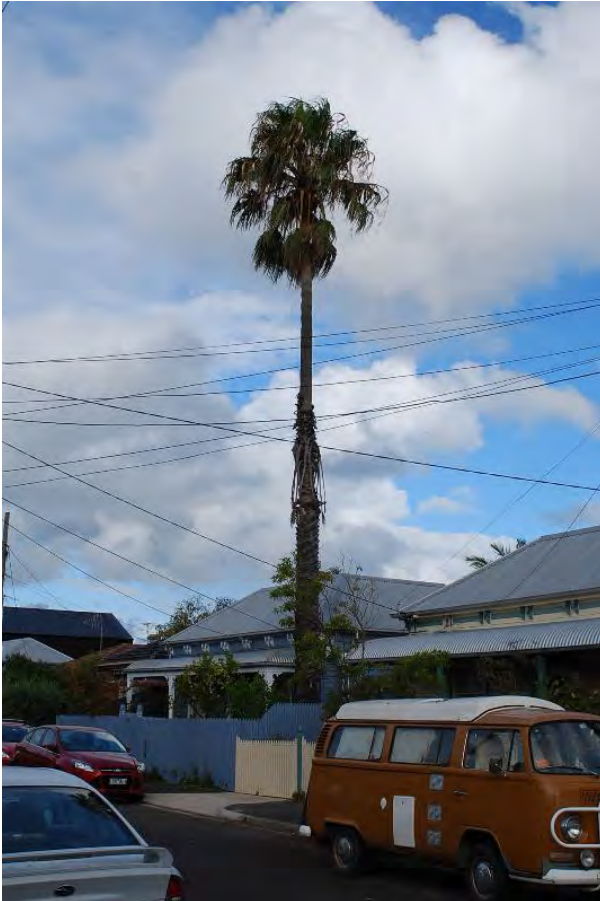
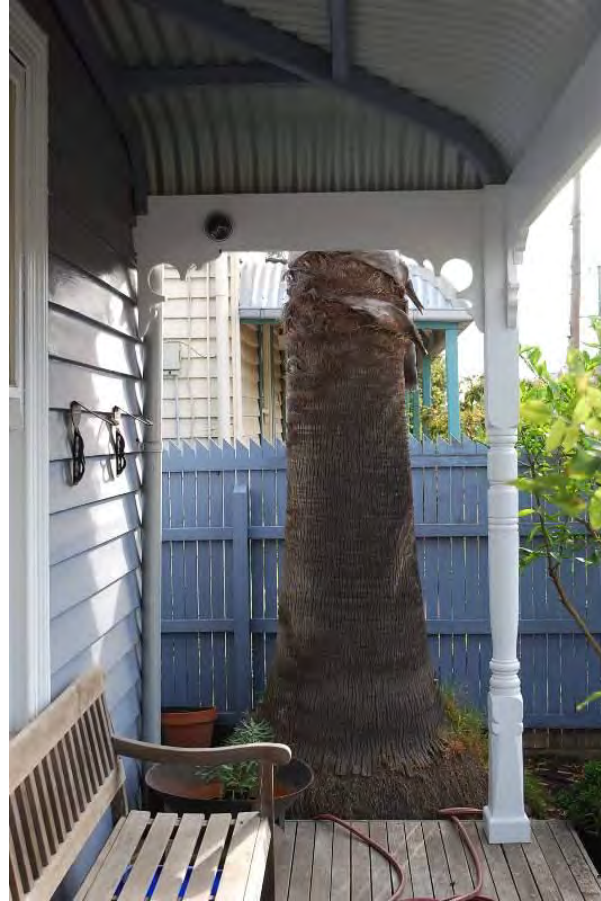
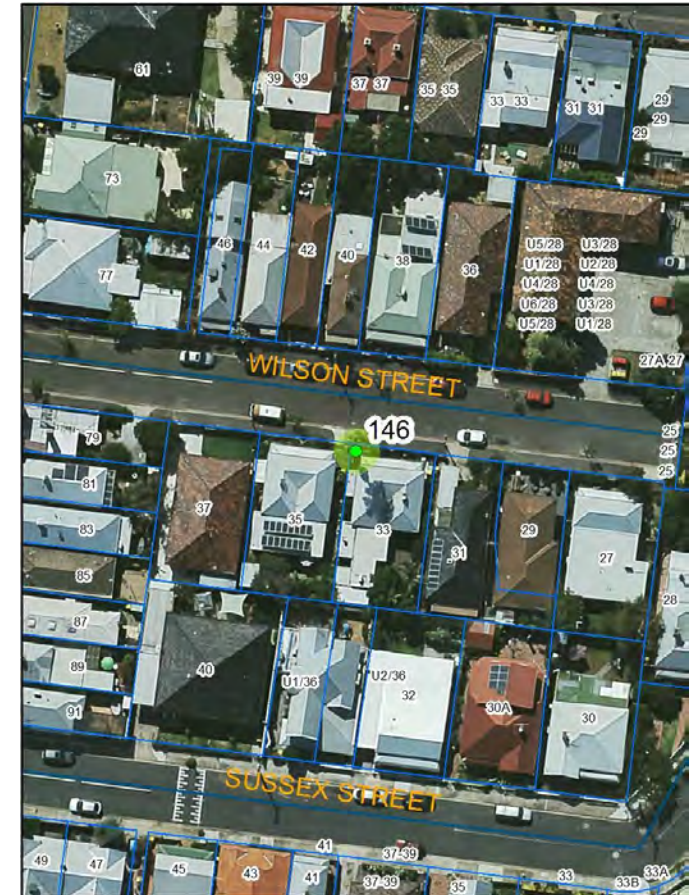
**Asset ID:** 149

**Significance Statement:** This is a large tree seemingly in good condition from afar. It adds character to the neighbourhood.

**Defects:** None

**Recommended Works:** No works

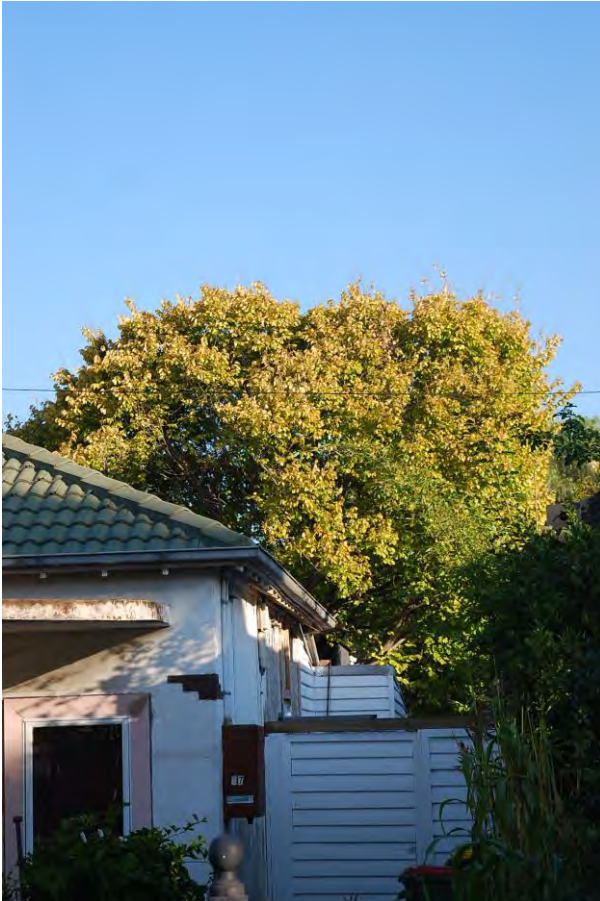
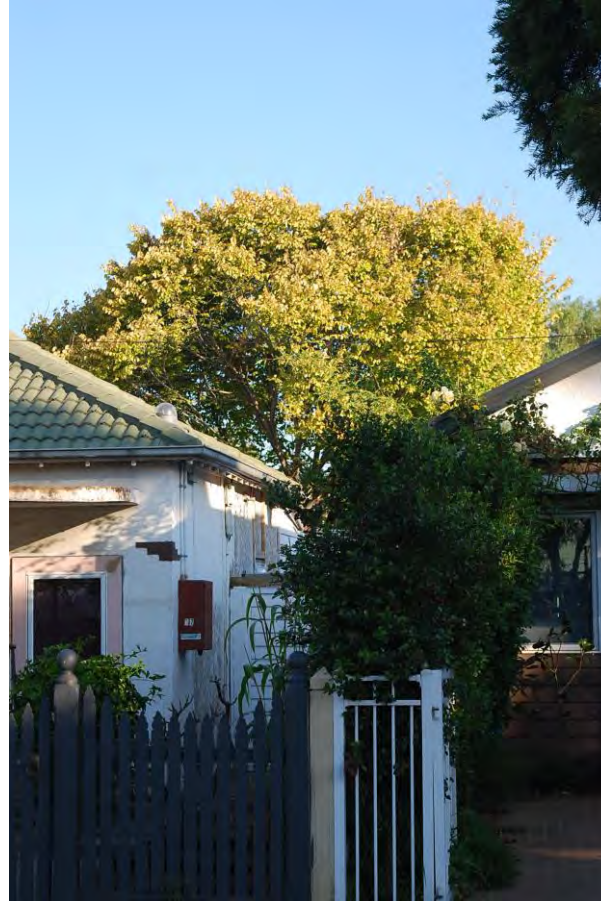
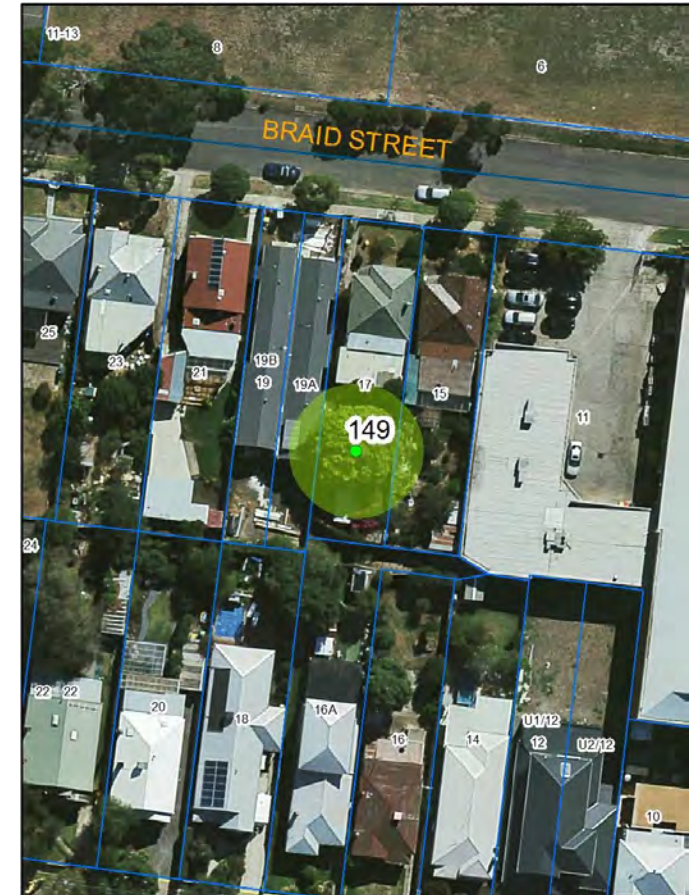
**Asset ID:** 150

**This is an exotic species with a wide canopy and in good condition. It is in a prominent location and contributes greatly to the aesthetic value of the landscape, especially in summer when it is in full bloom.**

**Defects:** Codominant trunks

**Recommended Works:** No works

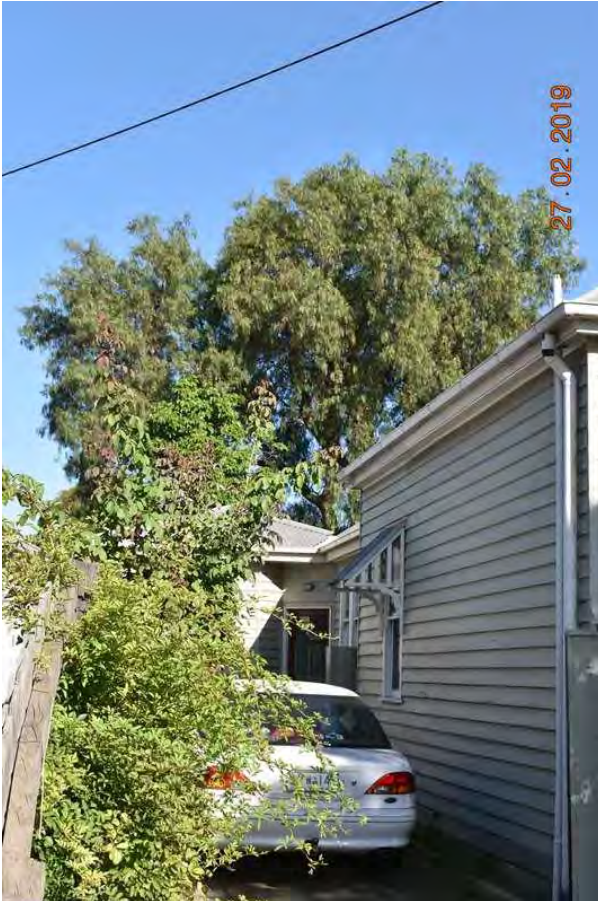
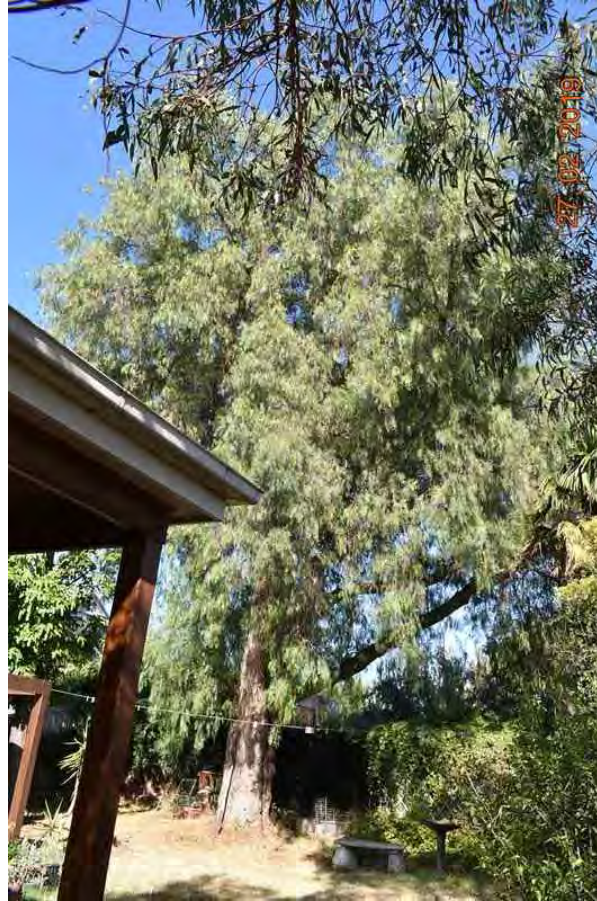
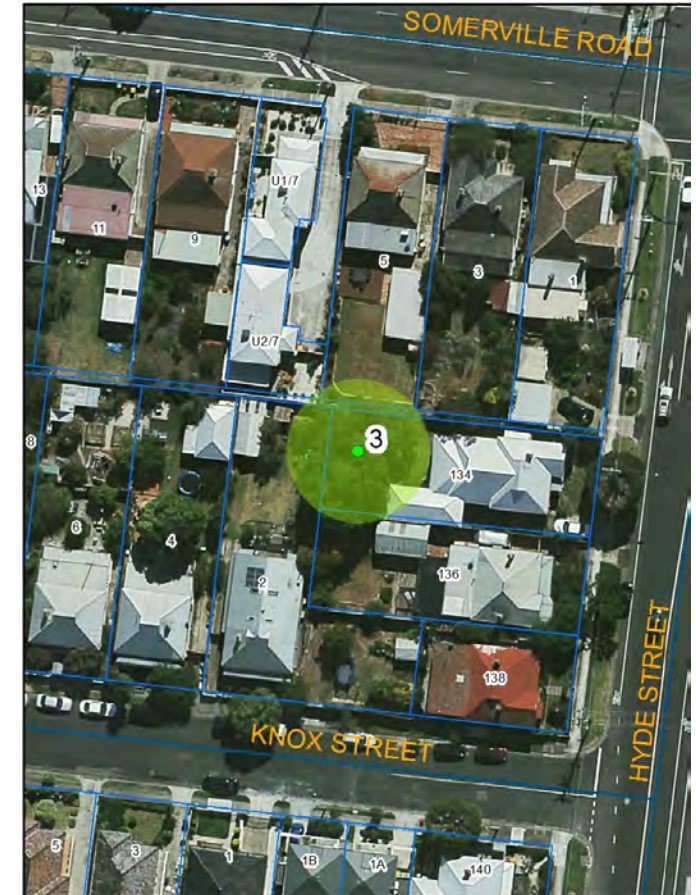
**Asset ID:** 4

**Defects:** Codominant trunks

**Recommended Works:** No works

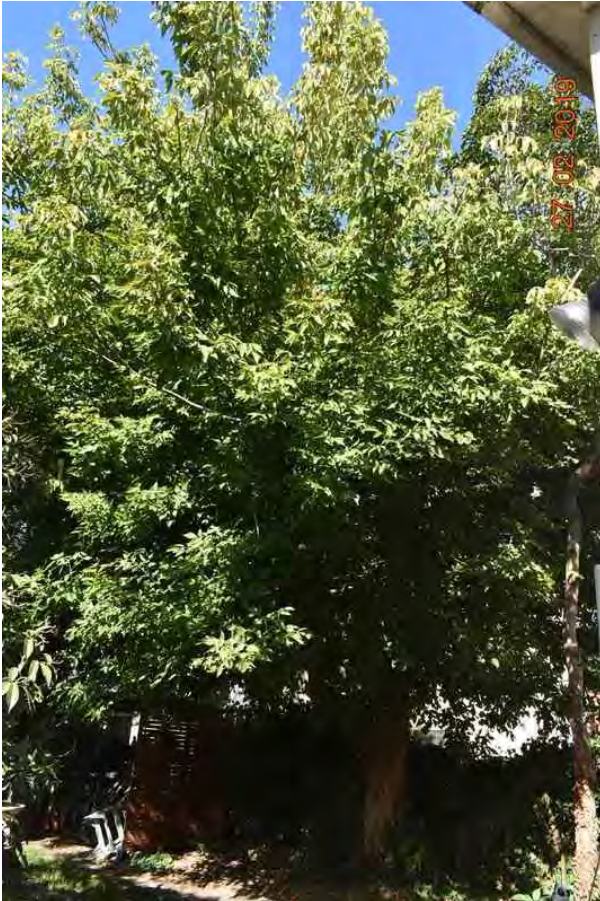
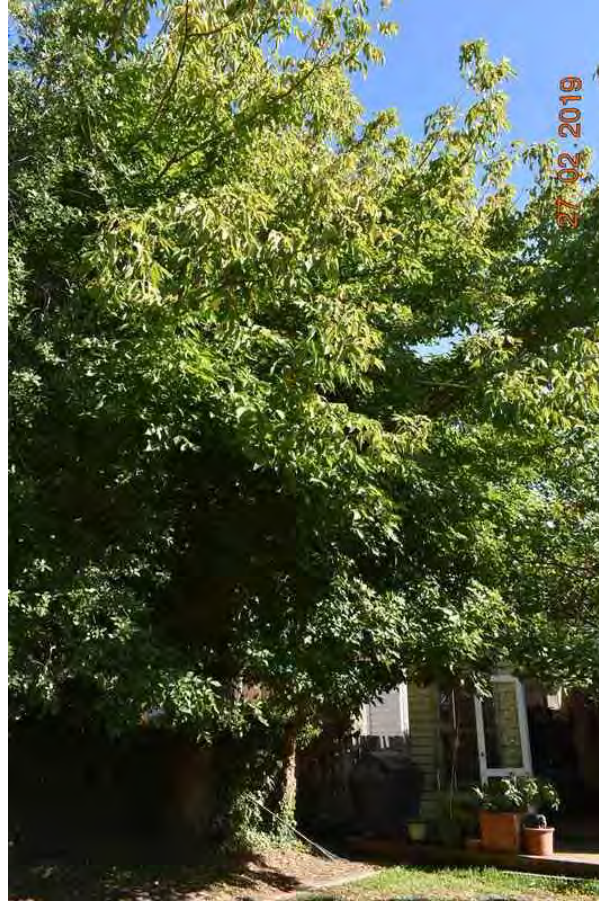
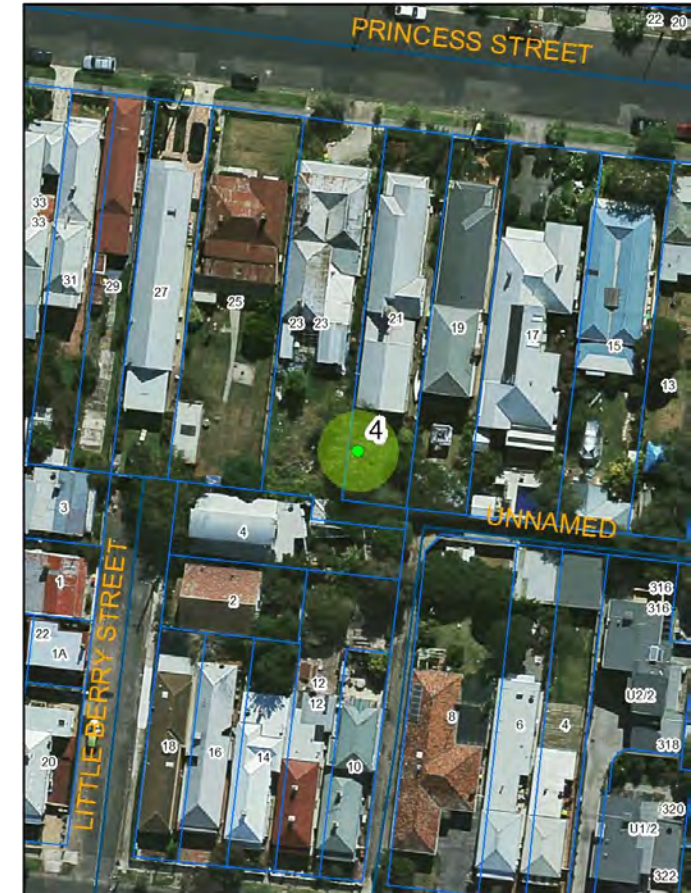
**Asset ID:** 5

**Defects:** None

**Recommended Works:** No works
