# Maribyrnong City Council Significant Tree Register 2019 Draft for Consultation

**Homewood Consulting Pty Ltd**

**Maribyrnong City Council**

December 2019

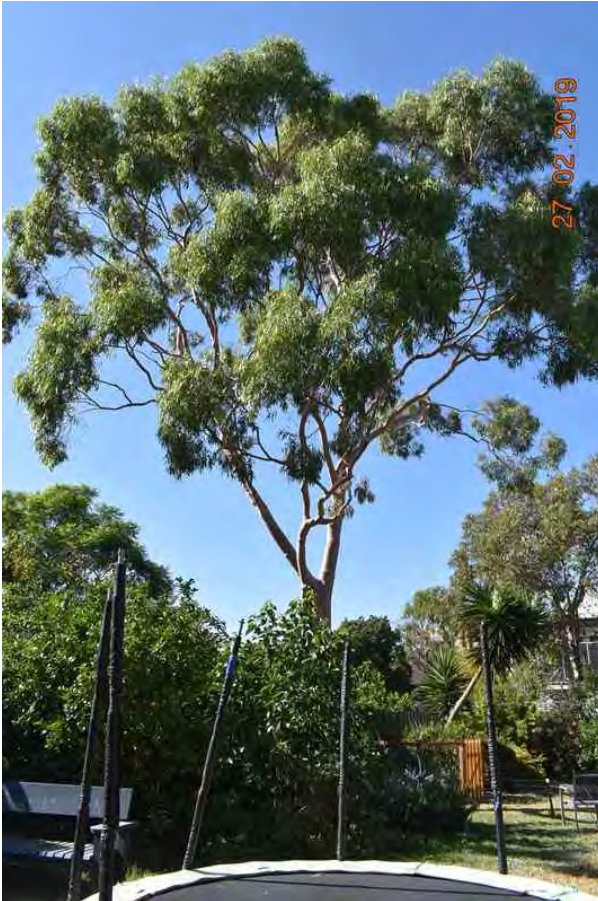
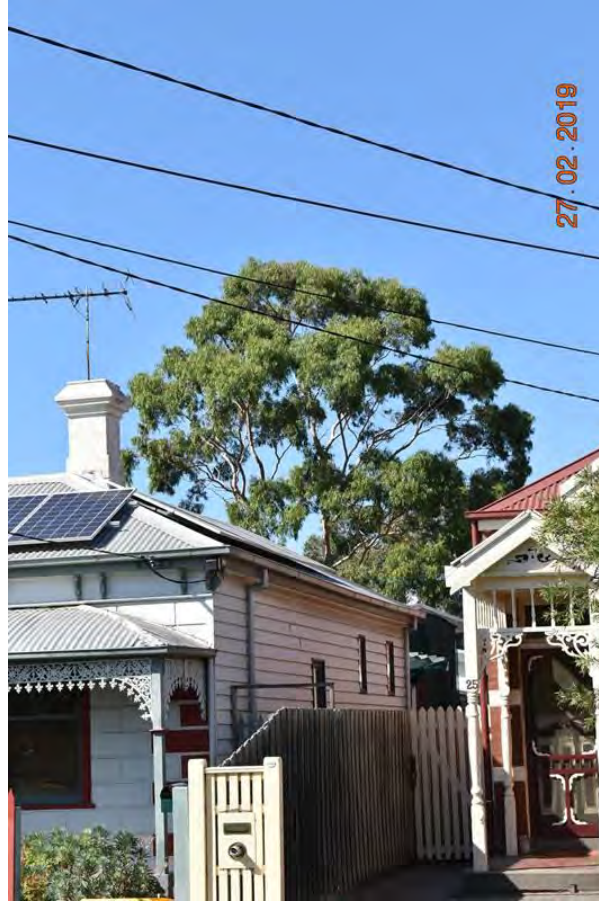
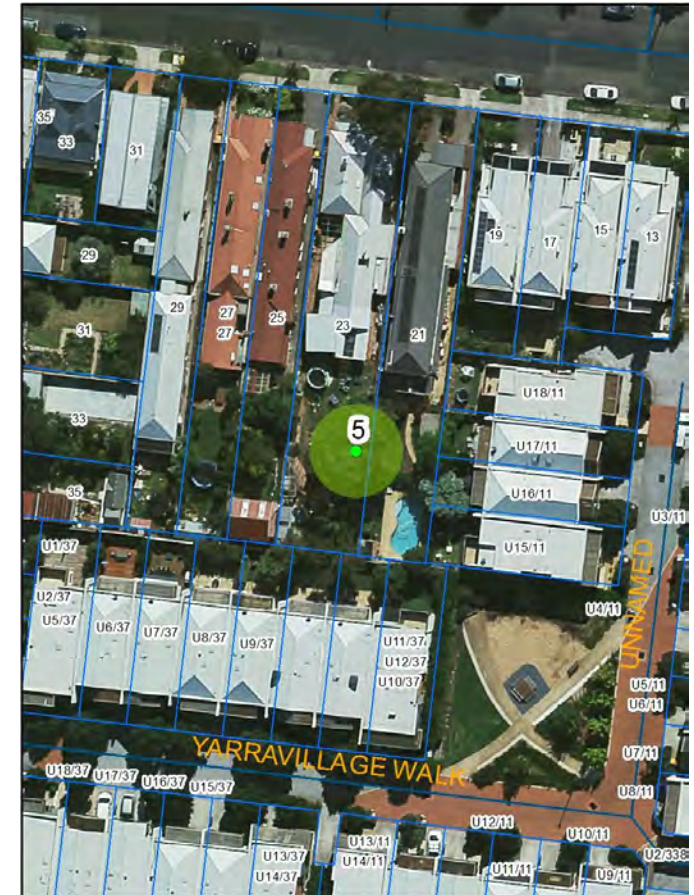
**Asset ID:** 7

**Defects:** Deadwood, Codominant trunks

**Recommended Works:** No works

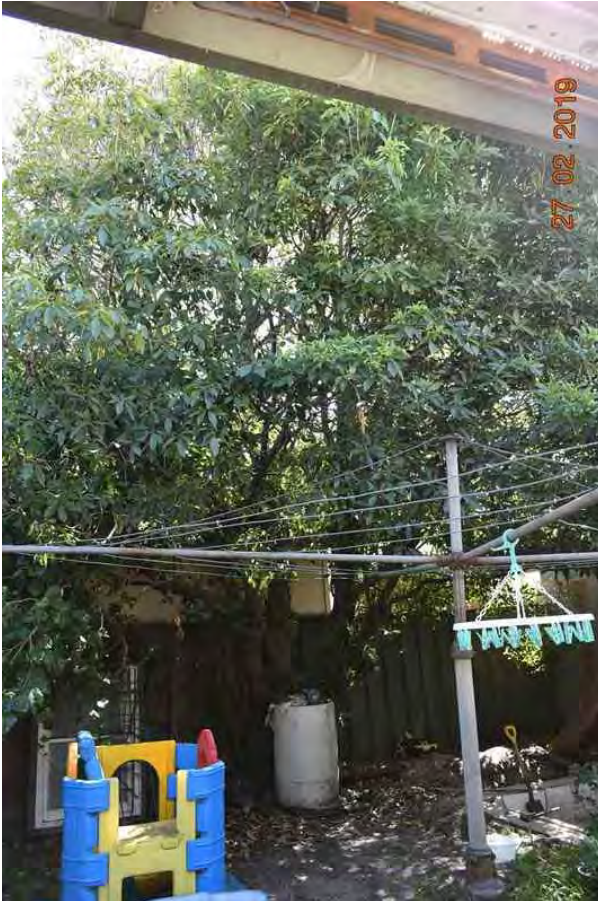
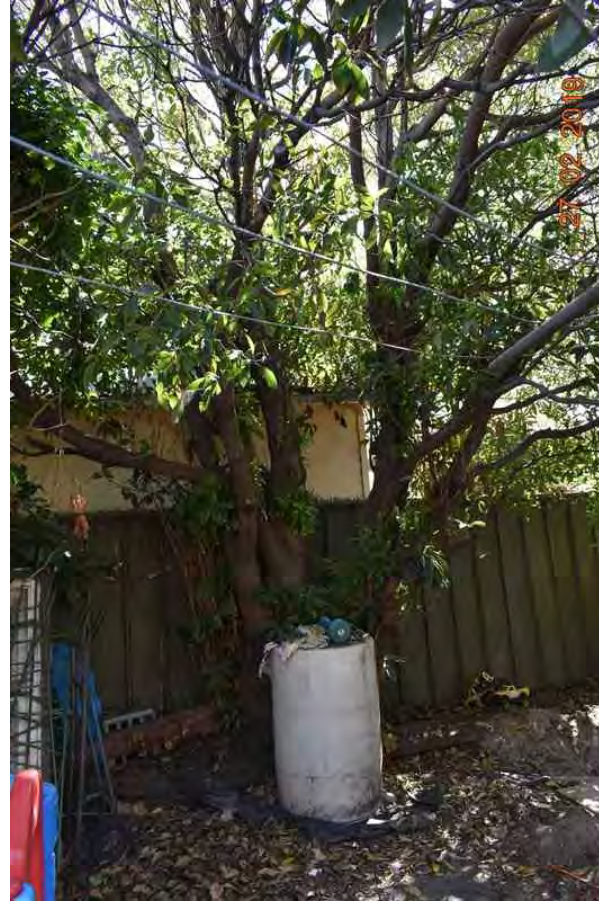
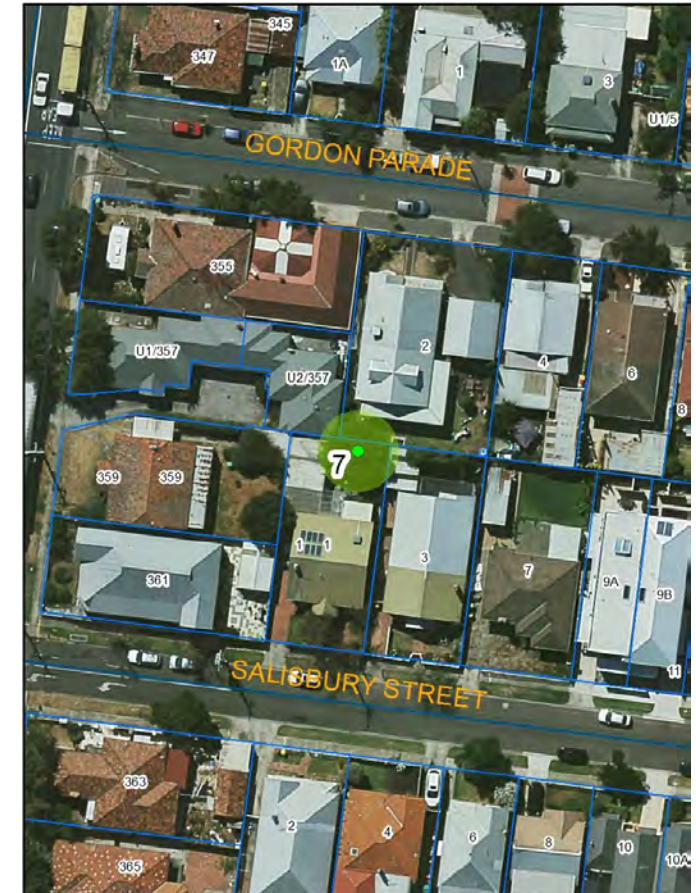
**Asset ID:** 8

**Defects:** None

**Recommended Works:** No works

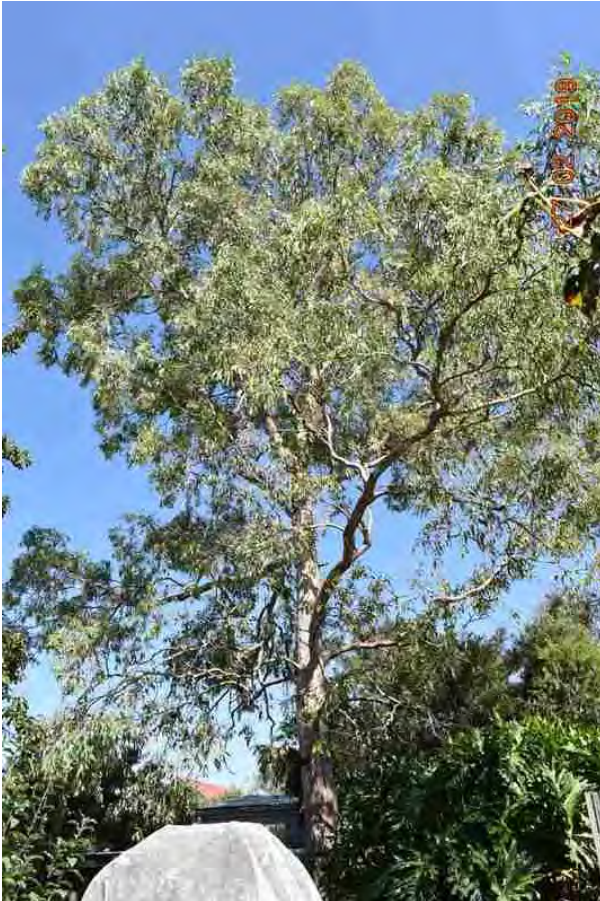
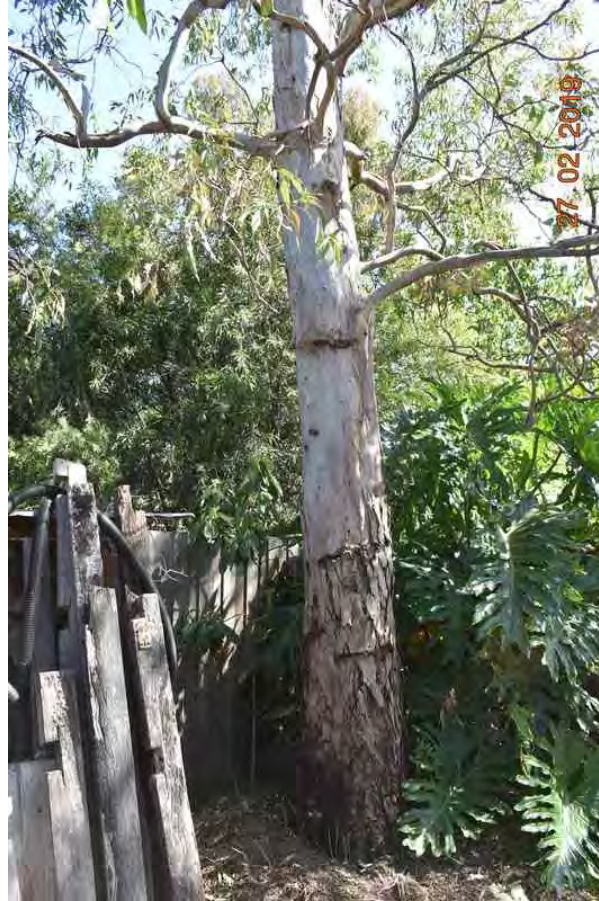
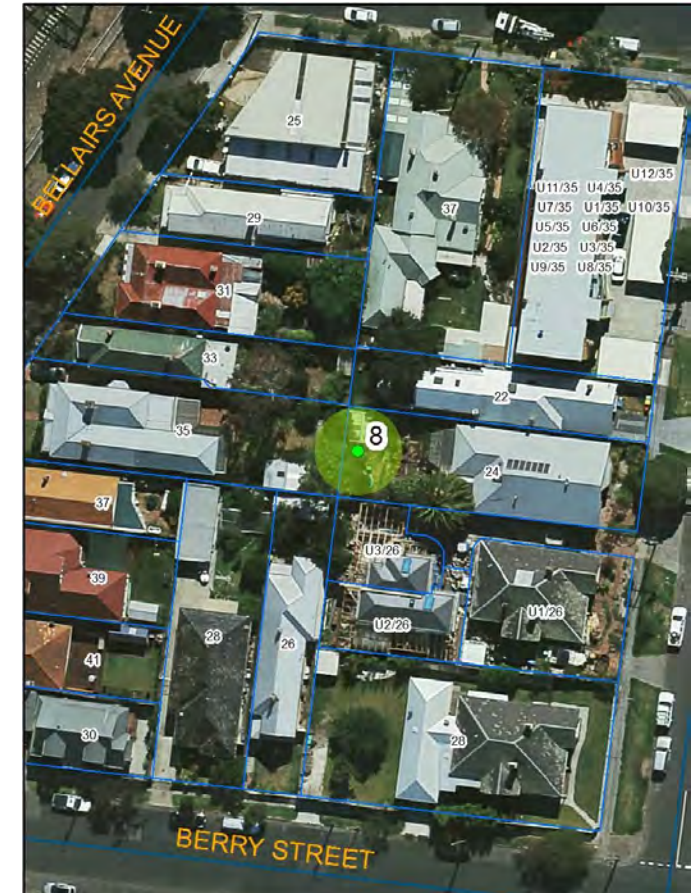
**Asset ID:** 11

**Approximate Age:** 41-60 years  
**ULE:** 21-40 years  
**Health:** Good  
**Structure:** Fair  
**Failure Probability:** 3. Moderate  
**Failure Size:** 3. 101-250mm  
**Target:** 4. Pedestrians, 3/day to 1/hr  
**Risk Score:** 1 in 5000000  
**Risk Category:** Low  
**Significance Statement:** This tree does not warrant inclusion on the significant tree register.

**Defects:** Codominant trunks  
**Recommended Works:** No works  
**Works Priority:** None  
**Comments:** Does not meet criteria  
**Record Type:** Single Tree  
**No. of Trees:** 1

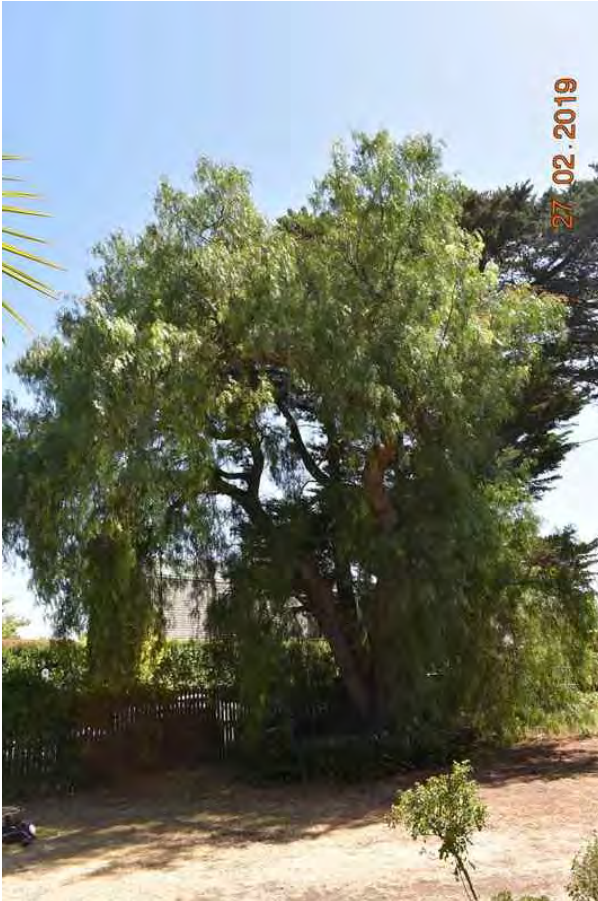
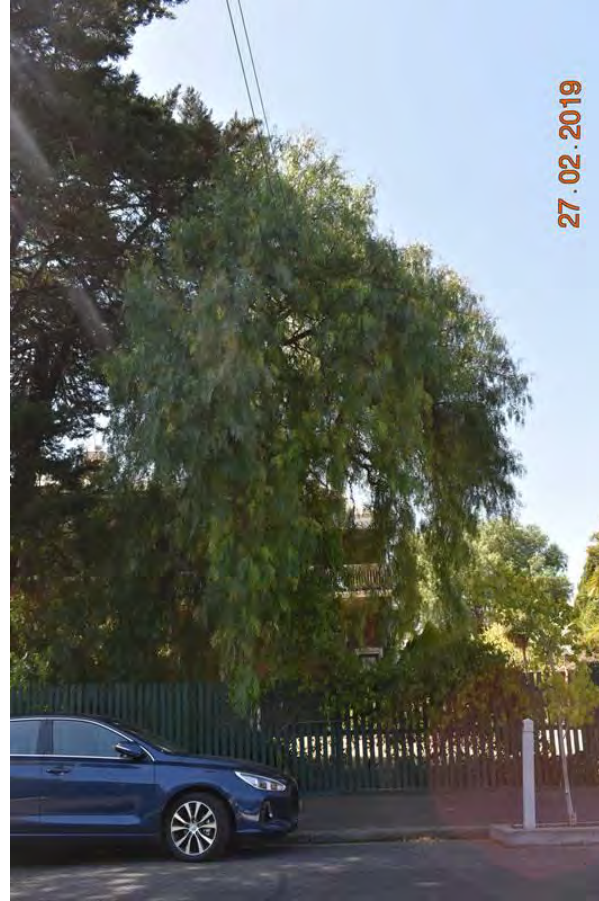
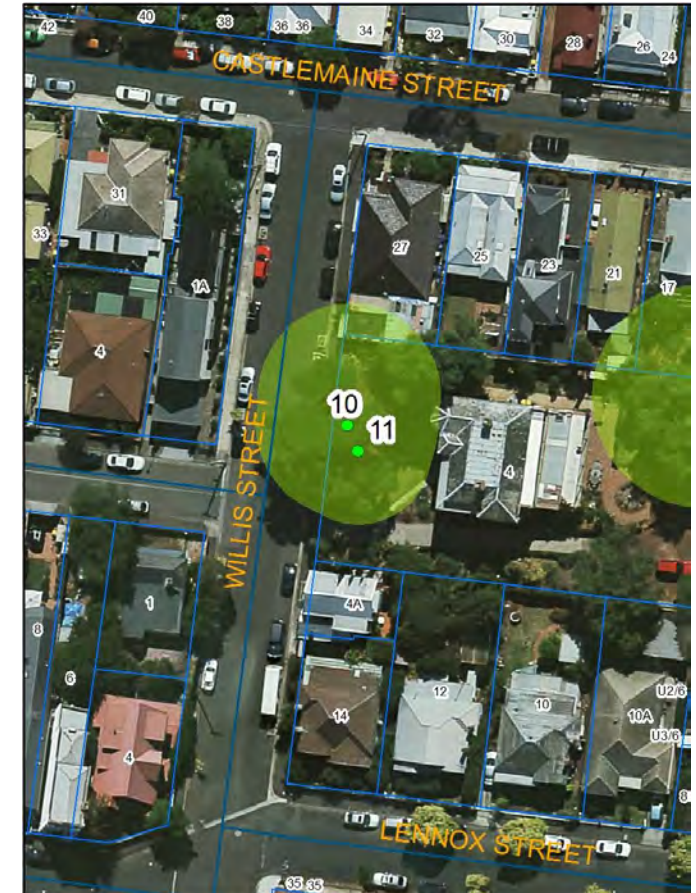
**Asset ID:** 13

**Defects:** Decay in canopy, Canopy lopped

**Recommended Works:** No works

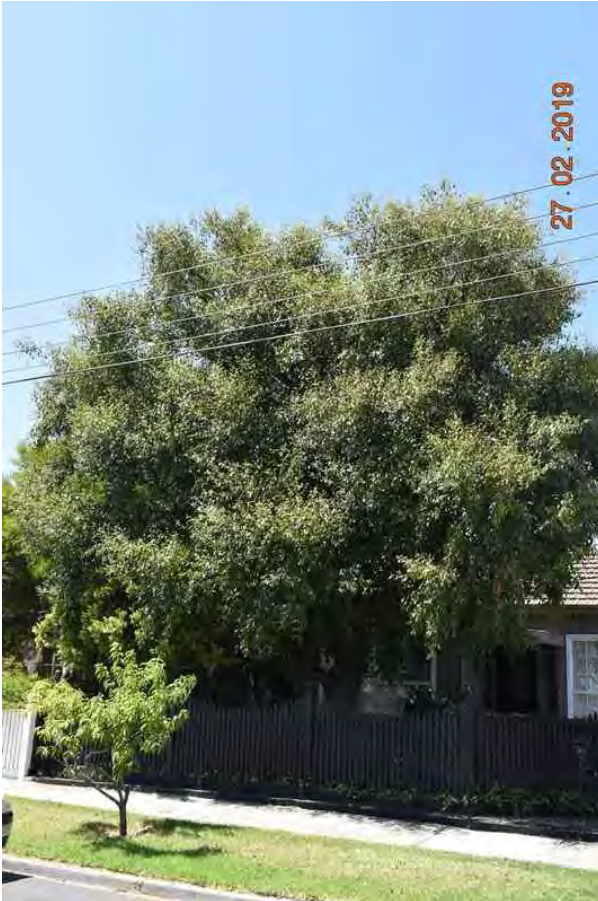
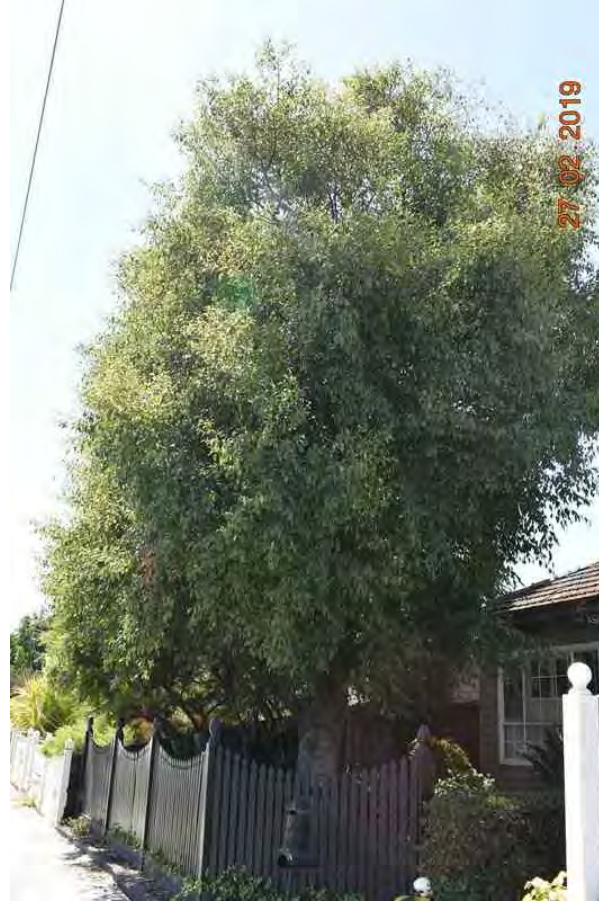
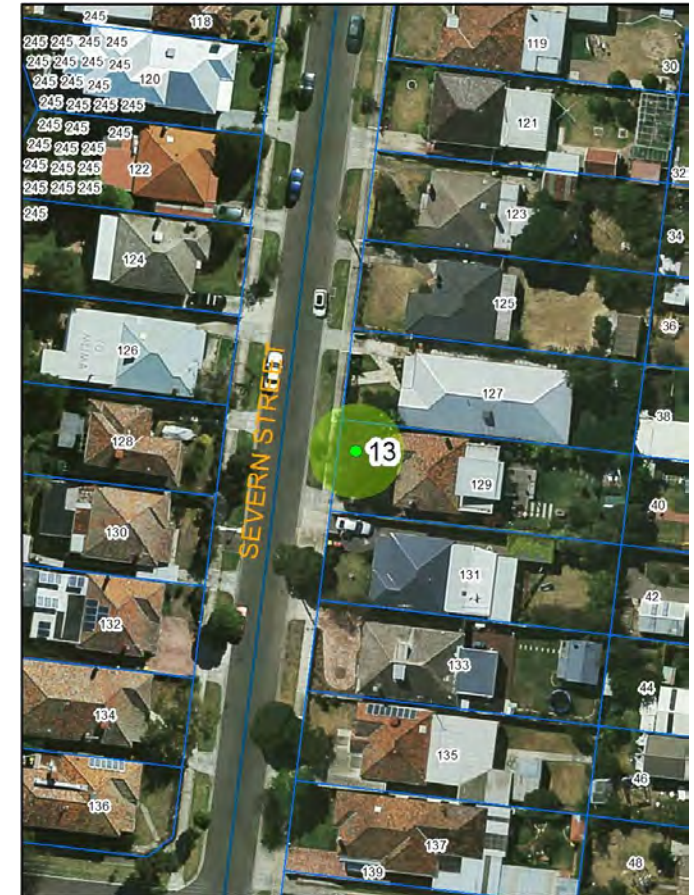
**Asset ID:** 14

**Failure Probability:** 4. Low

**Failure Size:** 3. 101-250mm

**Defects:** Canopy lopped, Codominant trunks

**Recommended Works:** Risk reduction pruning

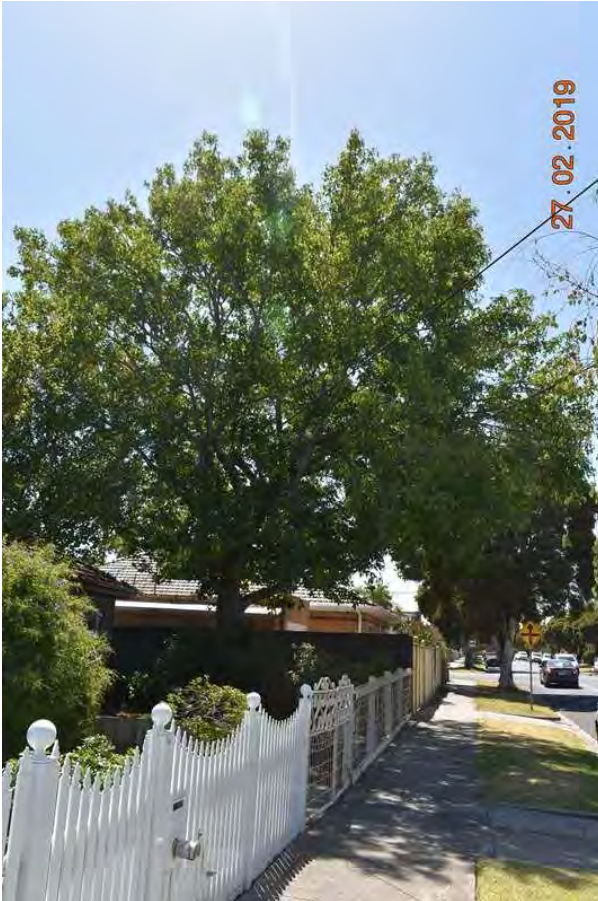
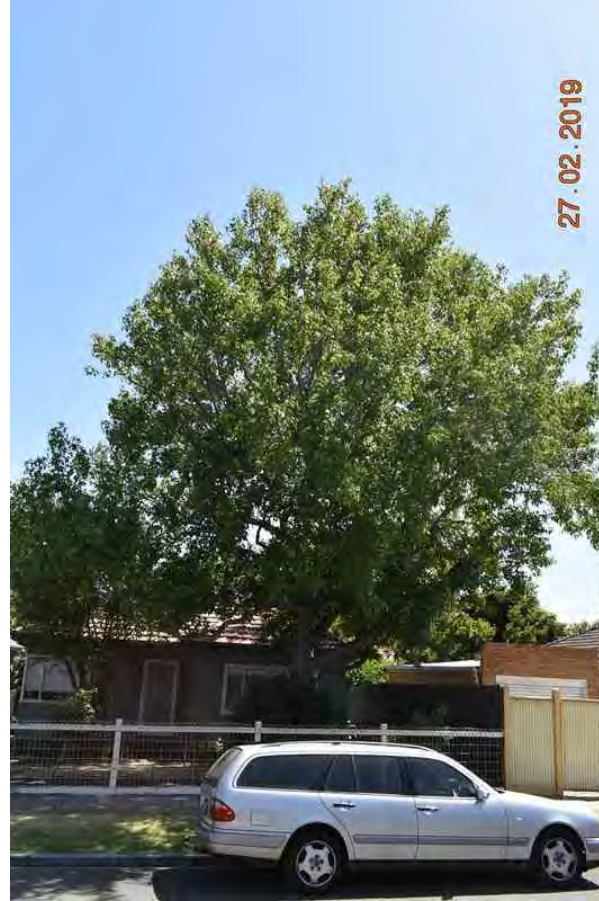
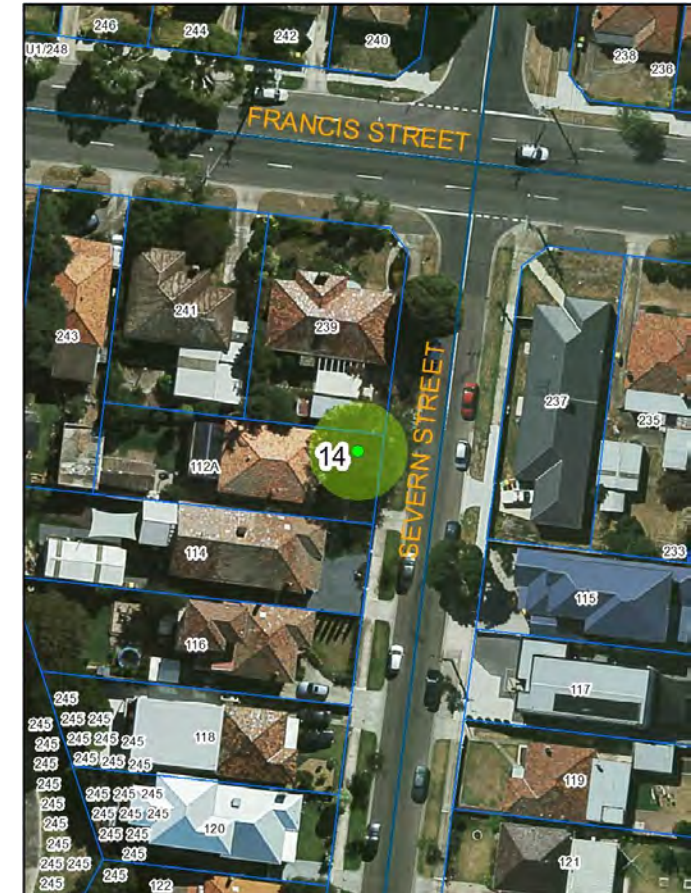
**Asset ID:** 16

**Failure Probability:** 3. Moderate

**Failure Size:** 3. 101-250mm

**Defects:** Included bark in trunk, Codominant trunks

**Recommended Works:** No works

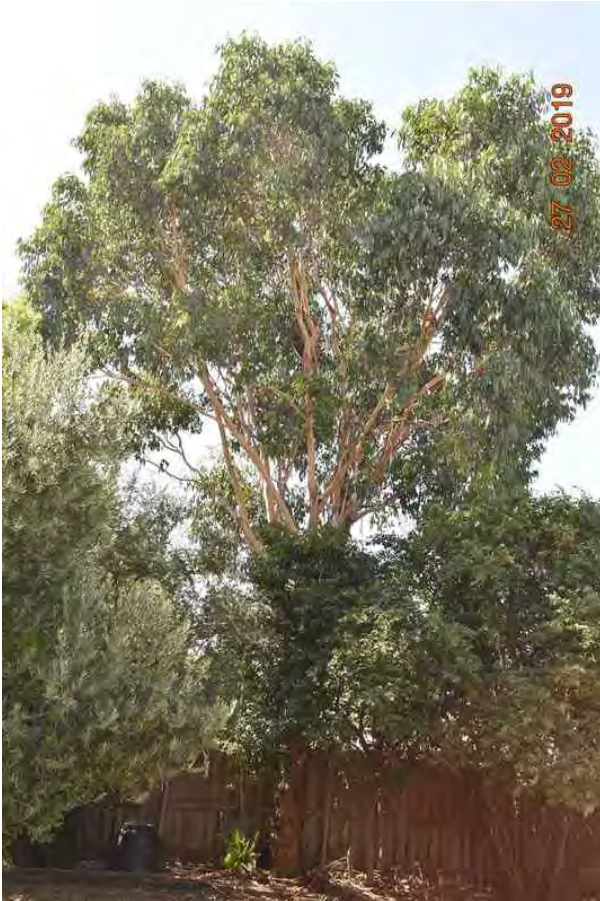
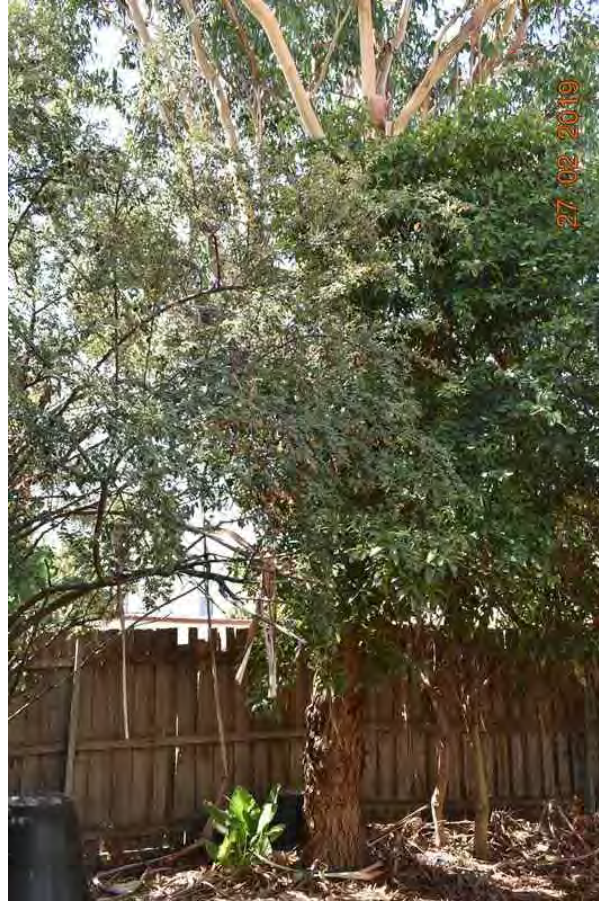
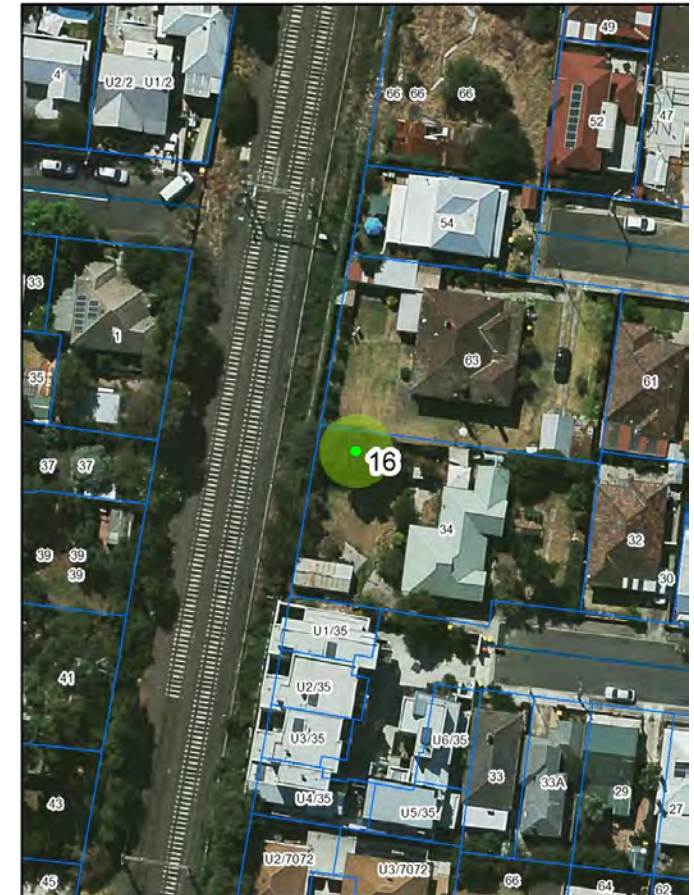
**Asset ID:** 19

**Failure Probability:** 4. Low

**Failure Size:** 3. 101-250mm

**Defects:** None

**Recommended Works:** No works

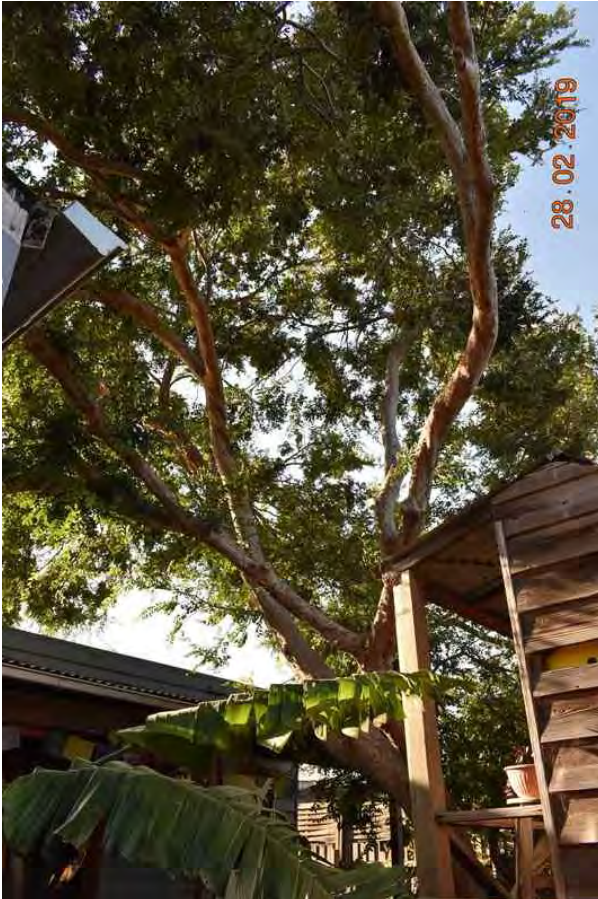
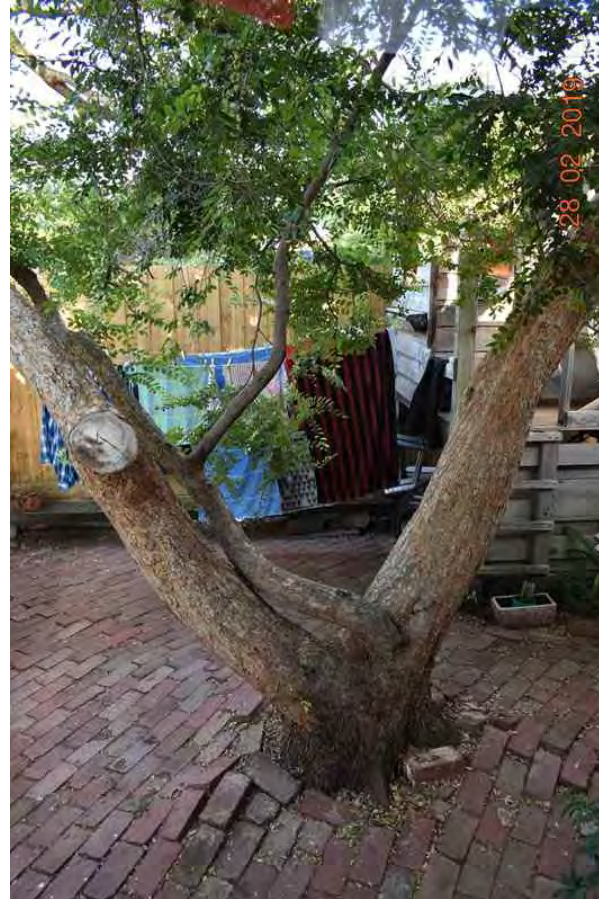
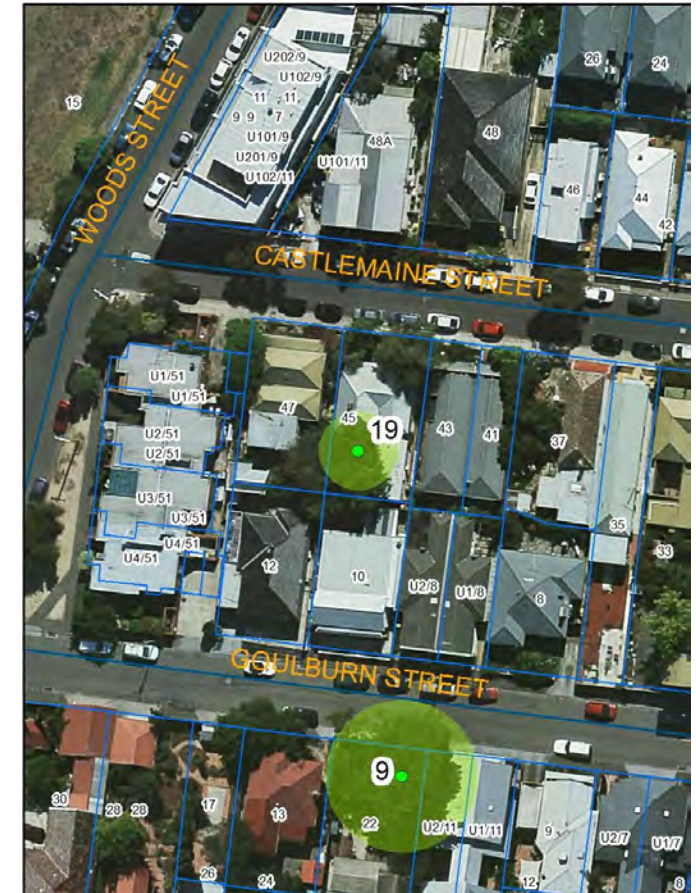
**Asset ID:** 21

**Failure Probability:** 3. Moderate

**Failure Size:** 3. 101-250mm

**Defects:** Canopy lopped, Codominant trunks

**Comments:** Lopping and failure history. Does not meet criteria

**Recommended Works:** No works

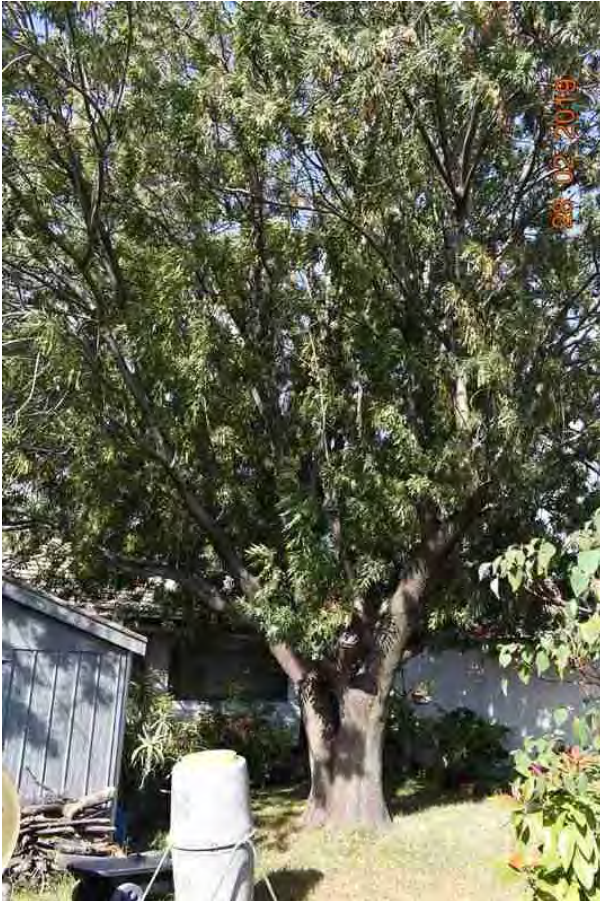
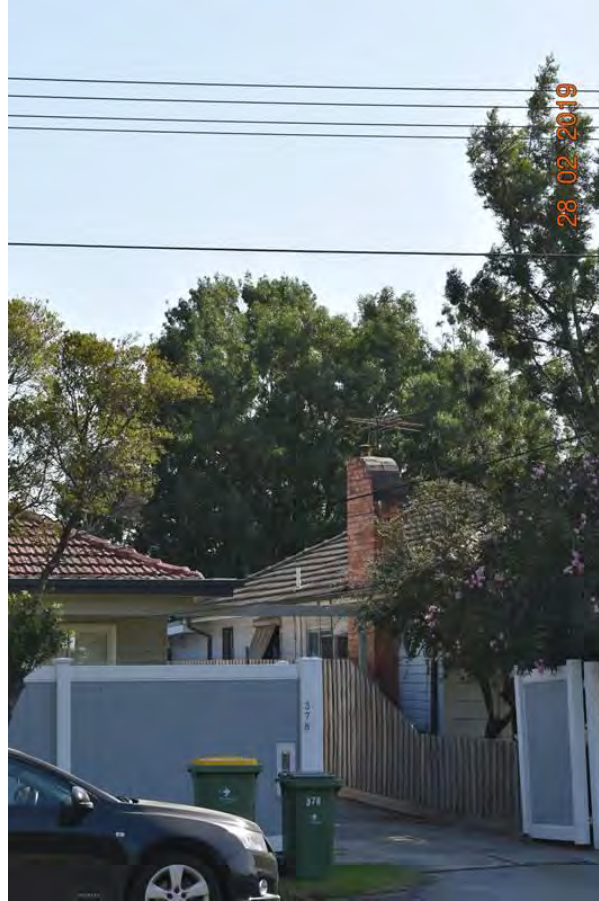
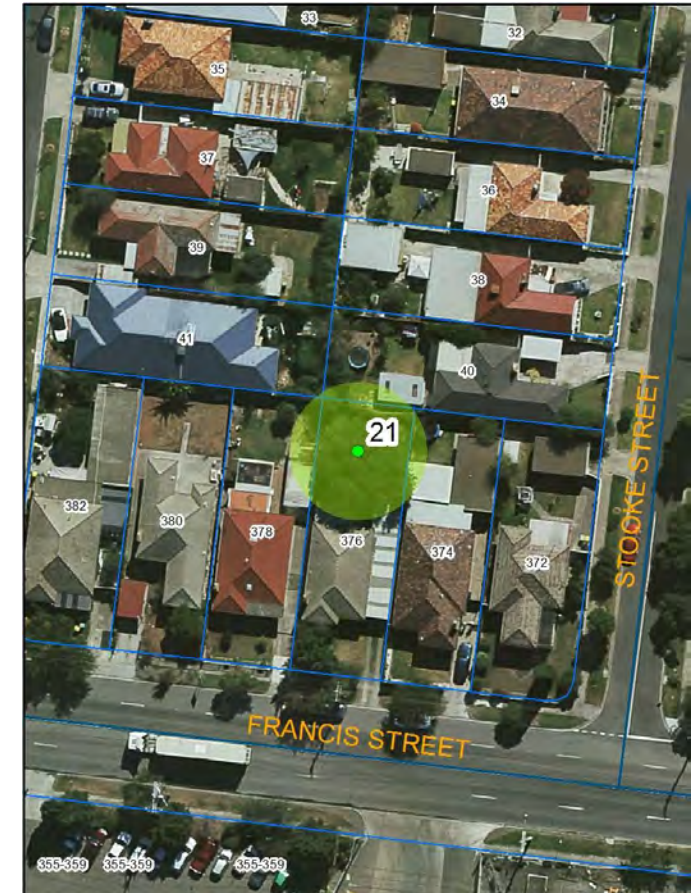
**Asset ID:** 23

**Failure Probability:** 4. Low

**Failure Size:** 3. 101-250mm

**Defects:** Codominant trunks

**Recommended Works:** No works

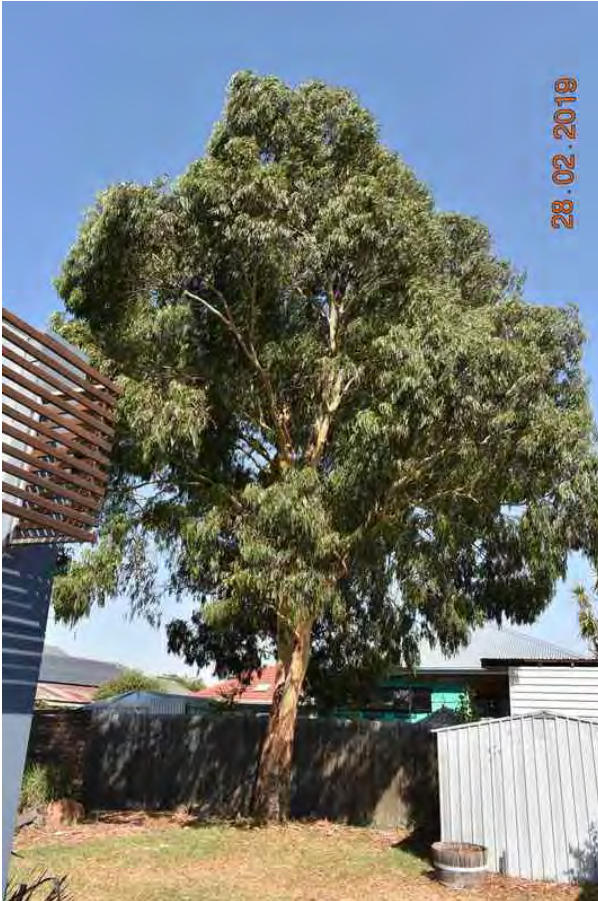
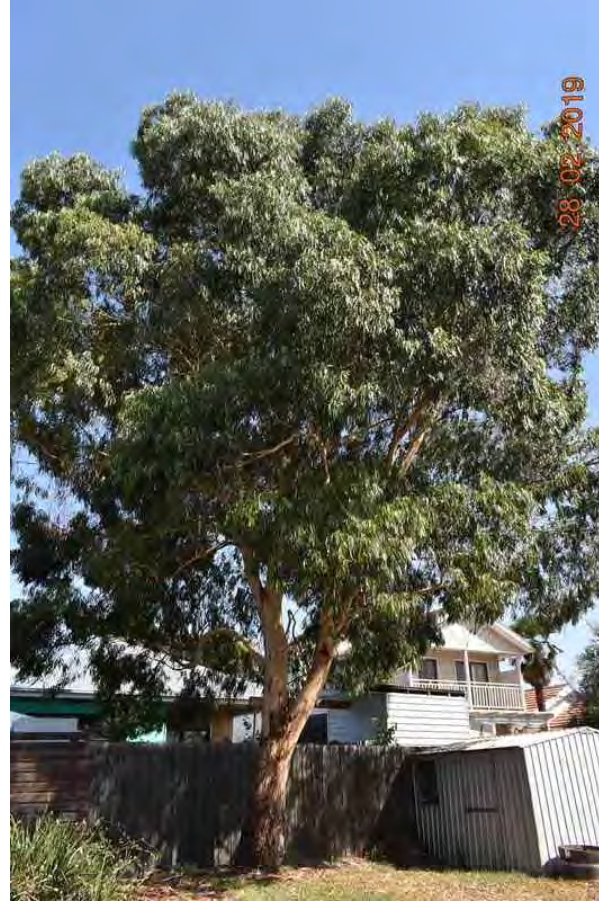
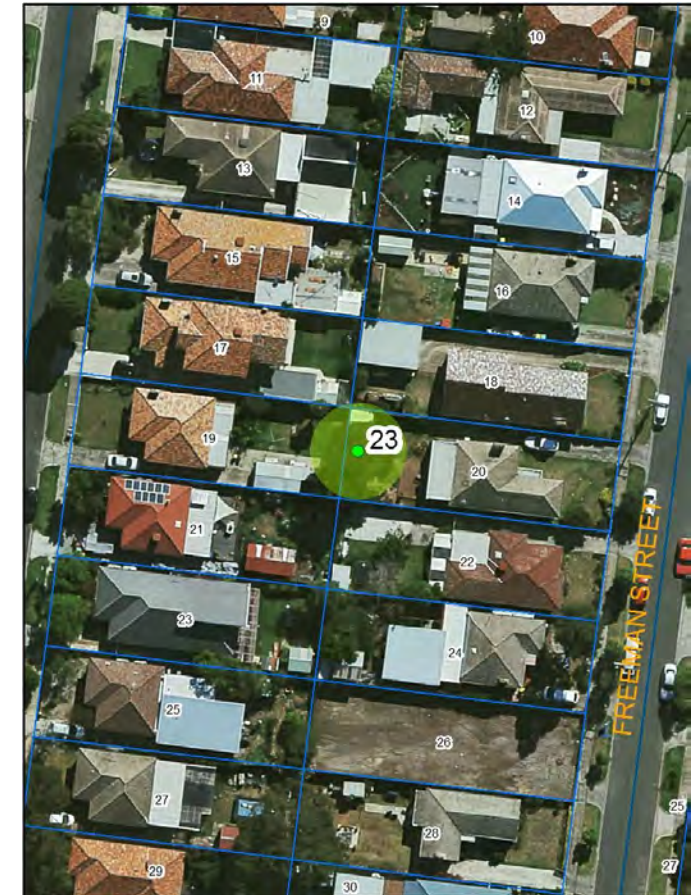
**Asset ID:** 24

**Failure Probability:** 4. Low

**Failure Size:** 3. 101-250mm

**Defects:** Deadwood, Codominant trunks

**Recommended Works:** Deadwood removal, Risk reduction pruning

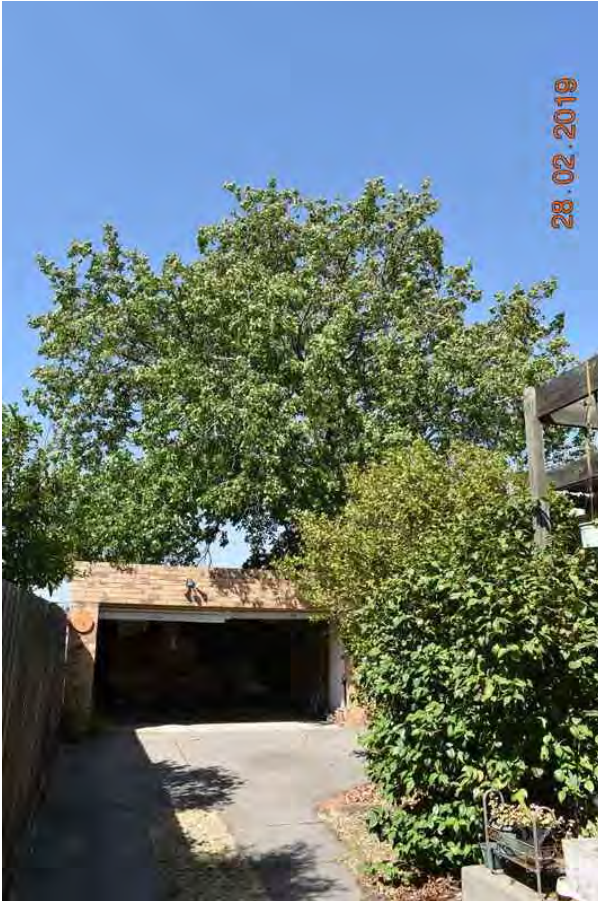
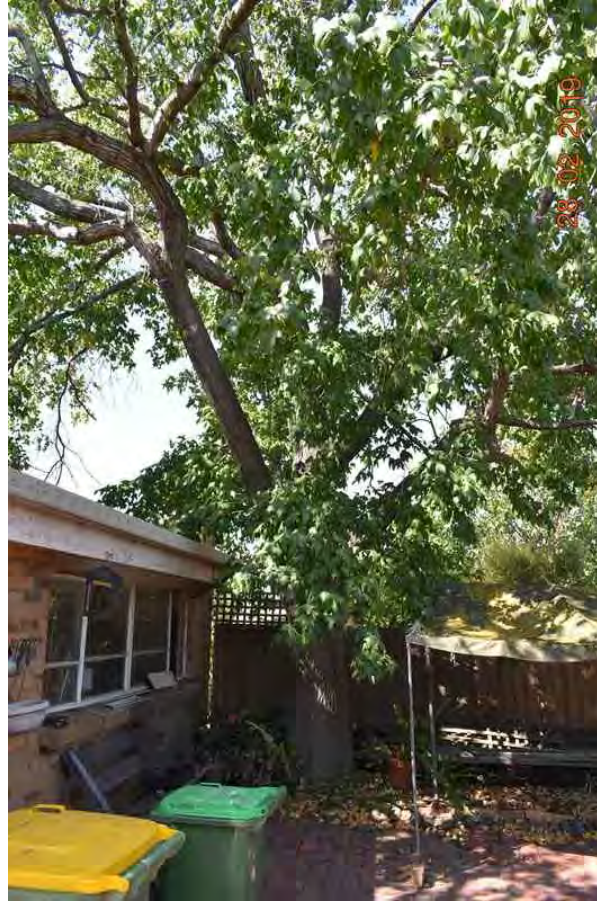
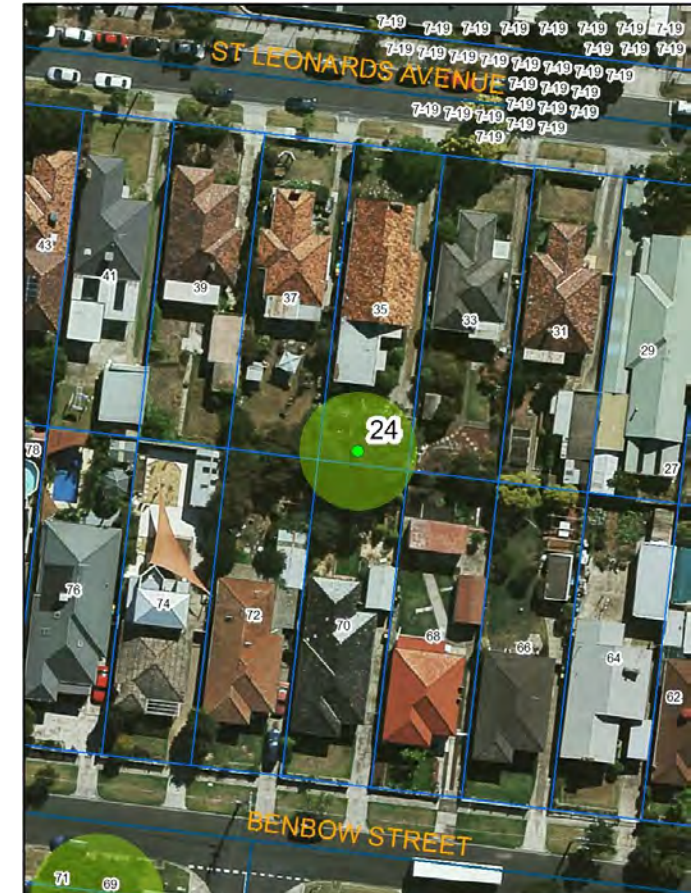
**Asset ID:** 25

**Failure Probability:** 4. Low

**Failure Size:** 3. 101-250mm

**Defects:** Canopy lopped

**Recommended Works:** No works

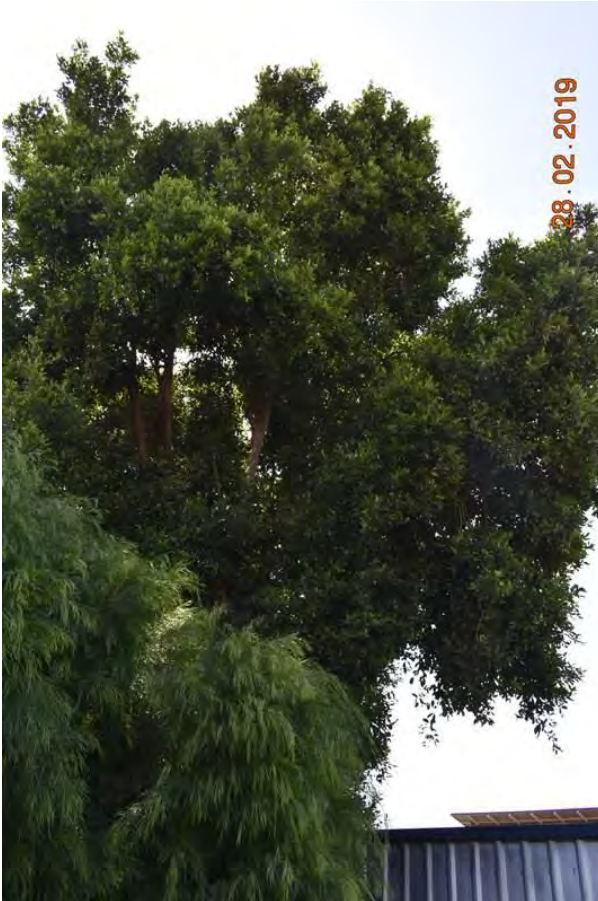
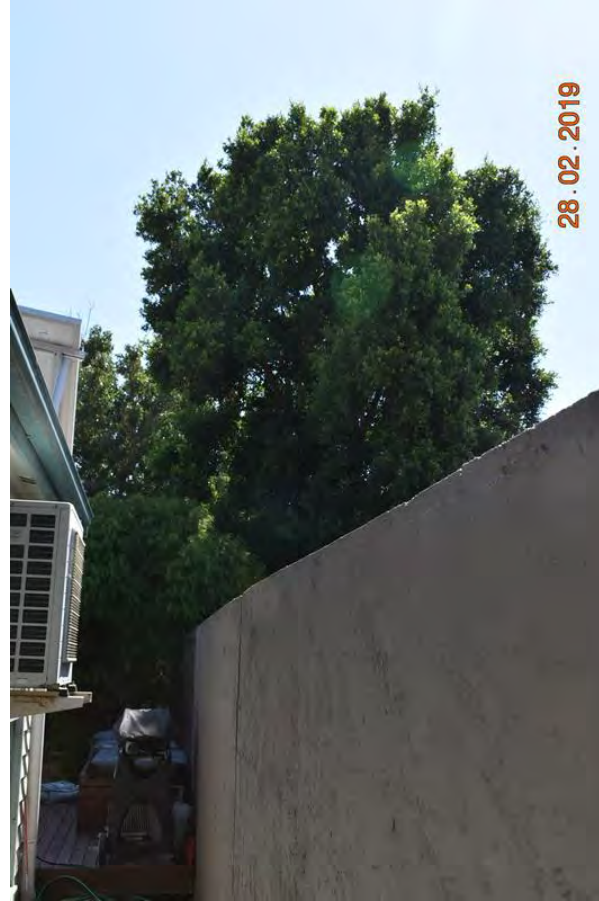
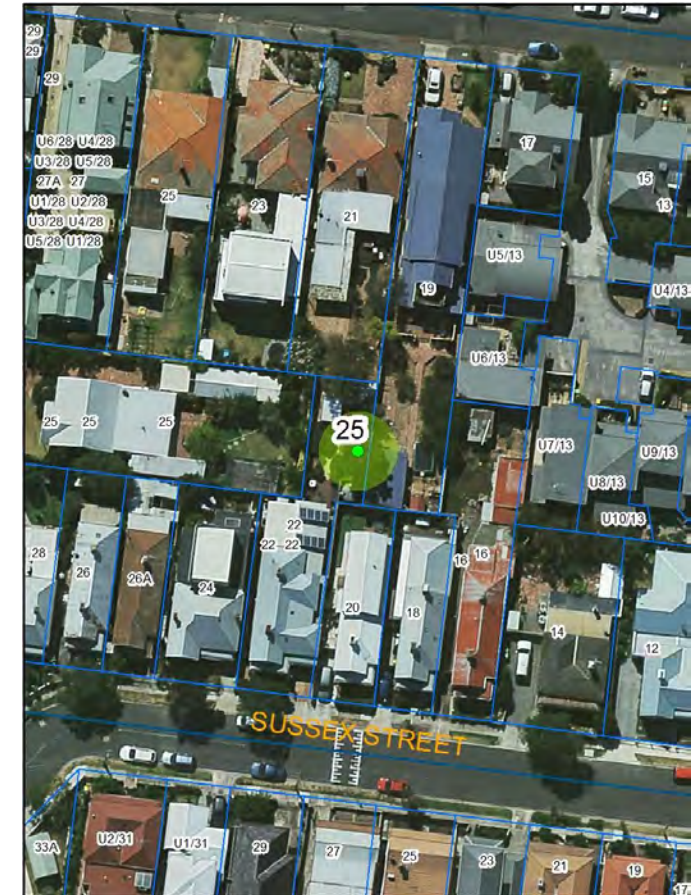
**Asset ID:** 26

**Failure Probability:** 2. High

**Failure Size:** 3. 101-250mm

**Defects:** Pest and disease, Codominant stems in canopy, Active split in canopy  
**Recommended Works:** Structural pruning

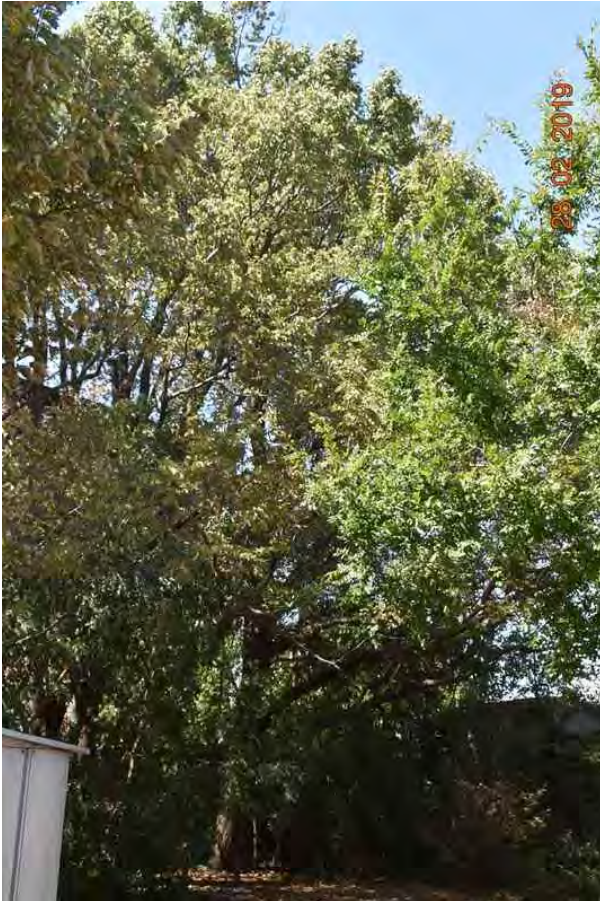
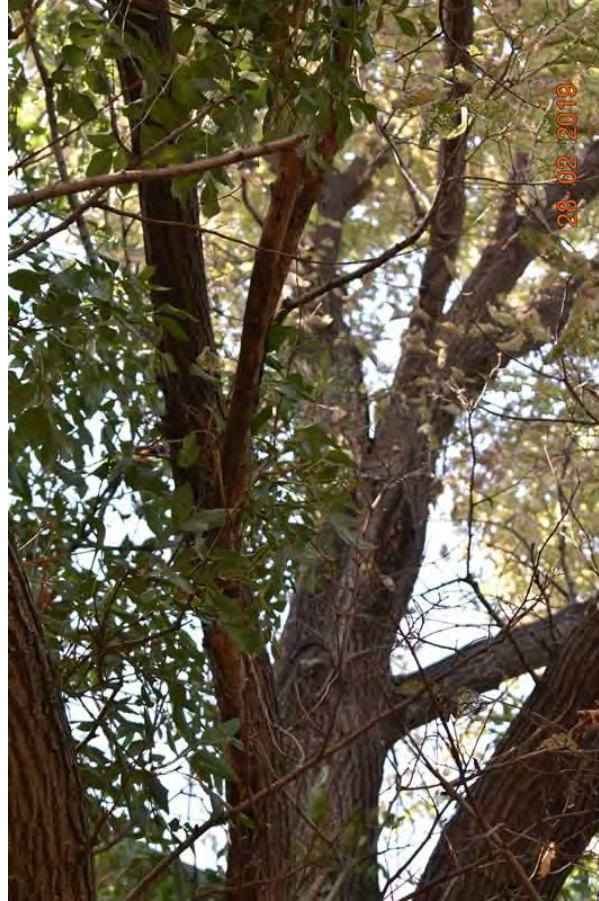
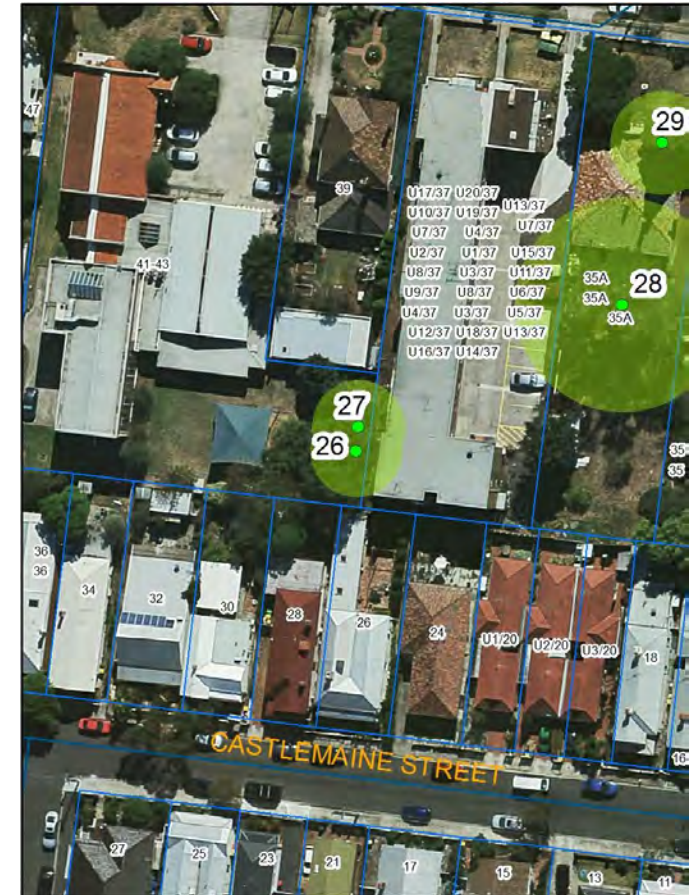
**Asset ID:** 27

**Failure Probability:** 3. Moderate

**Failure Size:** 3. 101-250mm

**Defects:** Pest and disease, Canopy lopped,

**Recommended Works:** Risk reduction pruning
