# Maribyrnong City Council Significant Tree Register 2019 Draft for Consultation

**Homewood Consulting Pty Ltd**

**Maribyrnong City Council**

December 2019

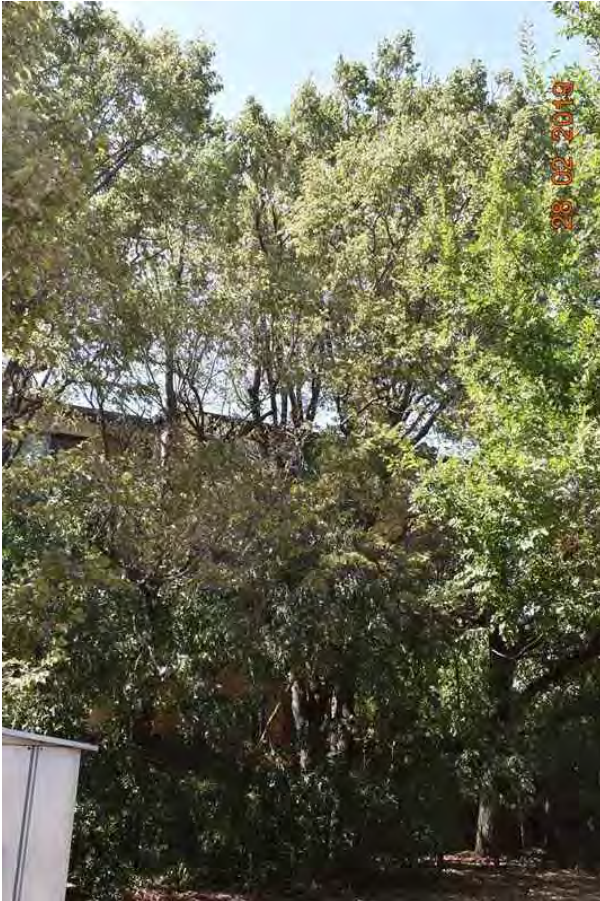
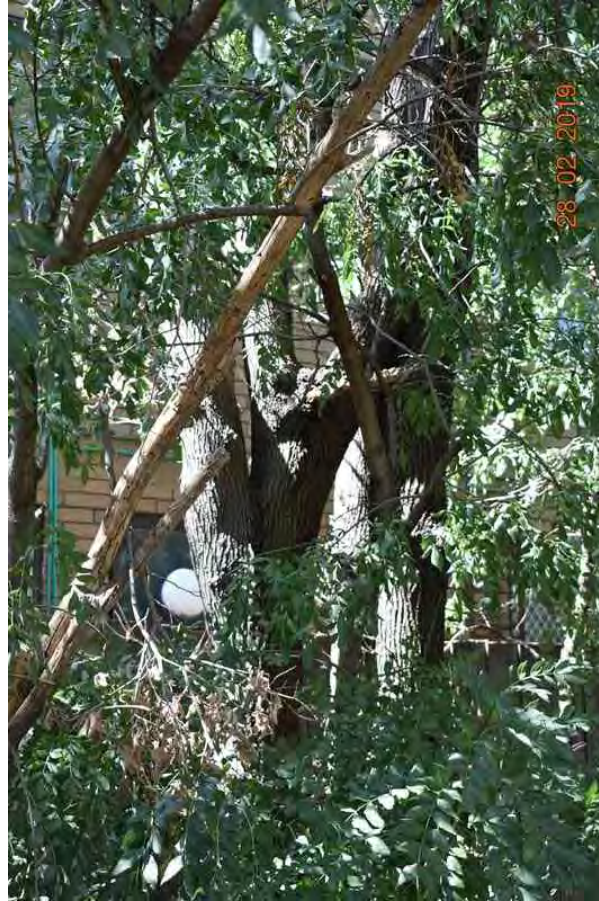
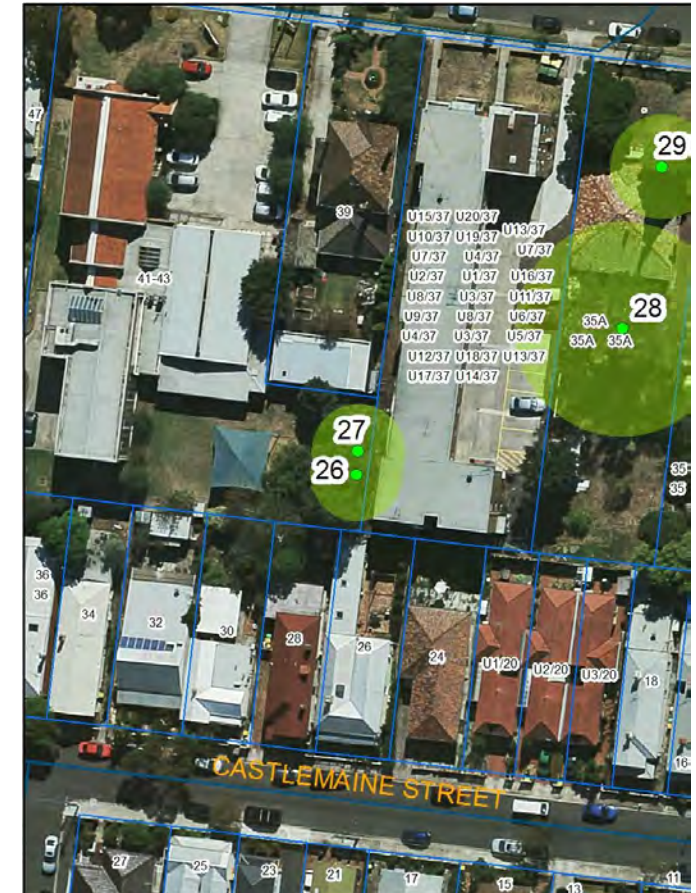
**Asset ID:** 31

**Failure Probability:** 3. Moderate

**Failure Size:** 3. 101-250mm

**Defects:** Deadwood, Decay in canopy

**Recommended Works:** No works

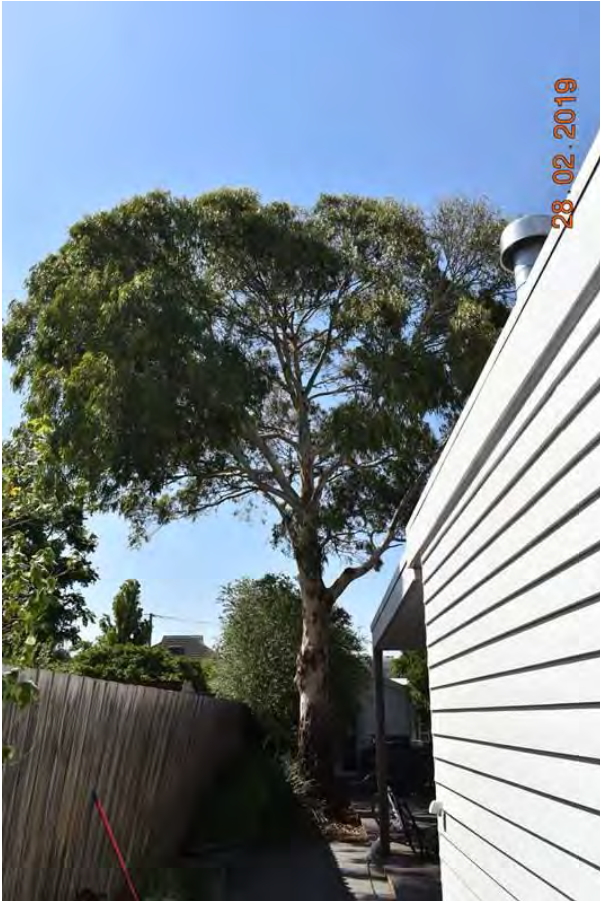
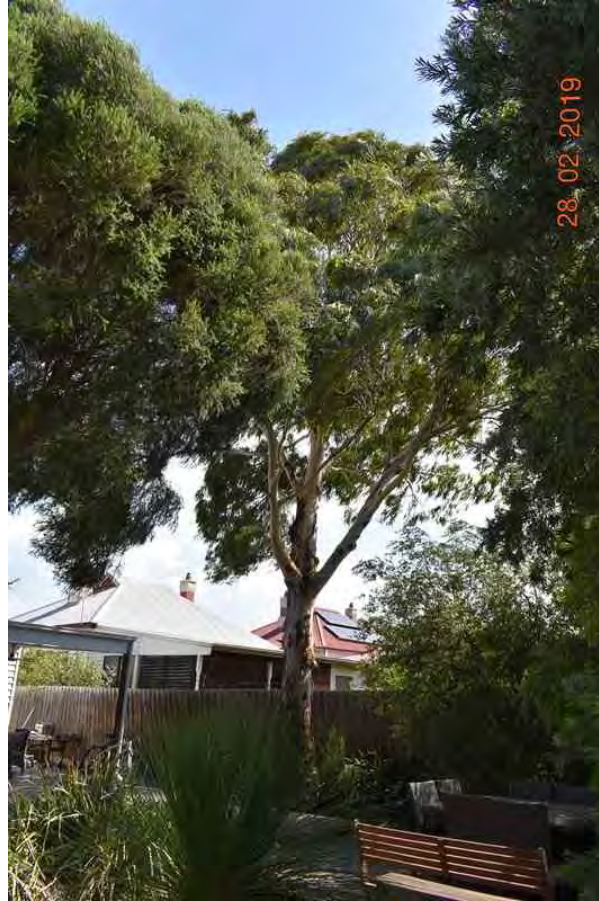
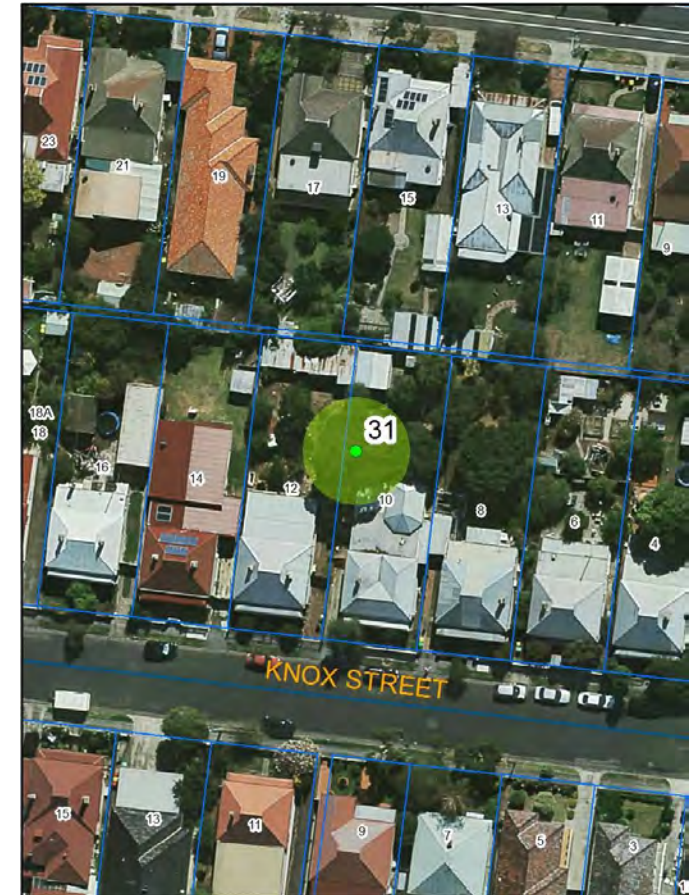
**Asset ID:** 33

**Failure Probability:** 3. Moderate

**Failure Size:** 4. 26-100mm

**Defects:** Codominant trunks

**Recommended Works:** No works

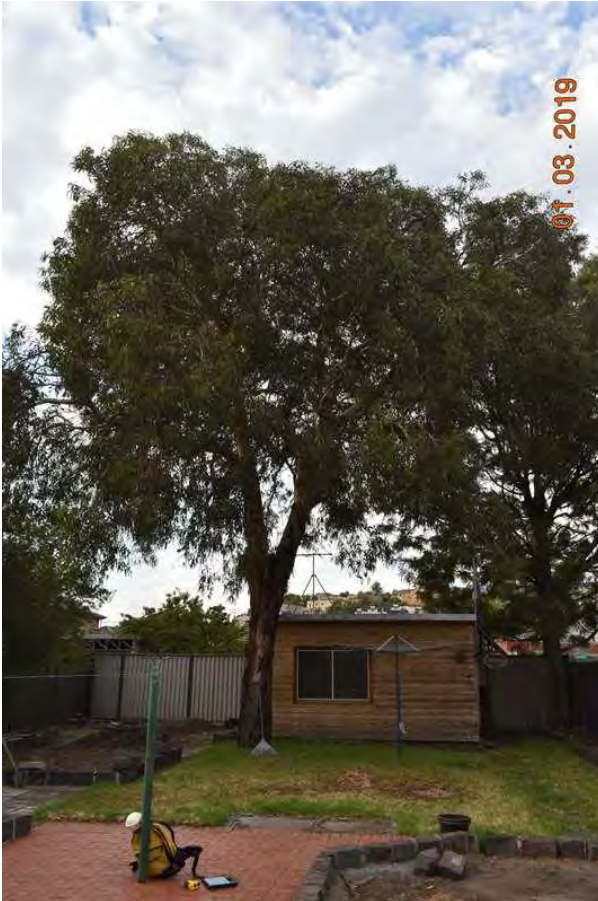
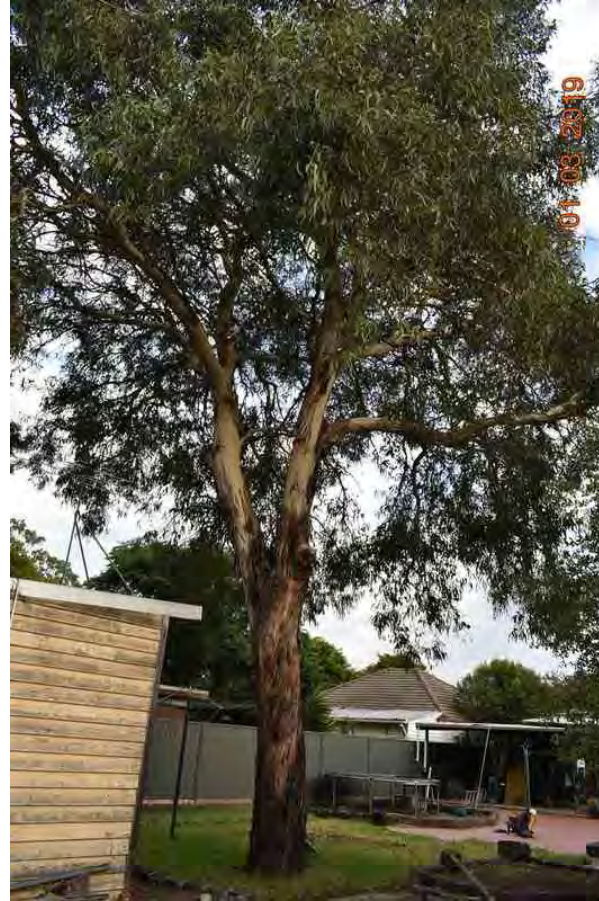
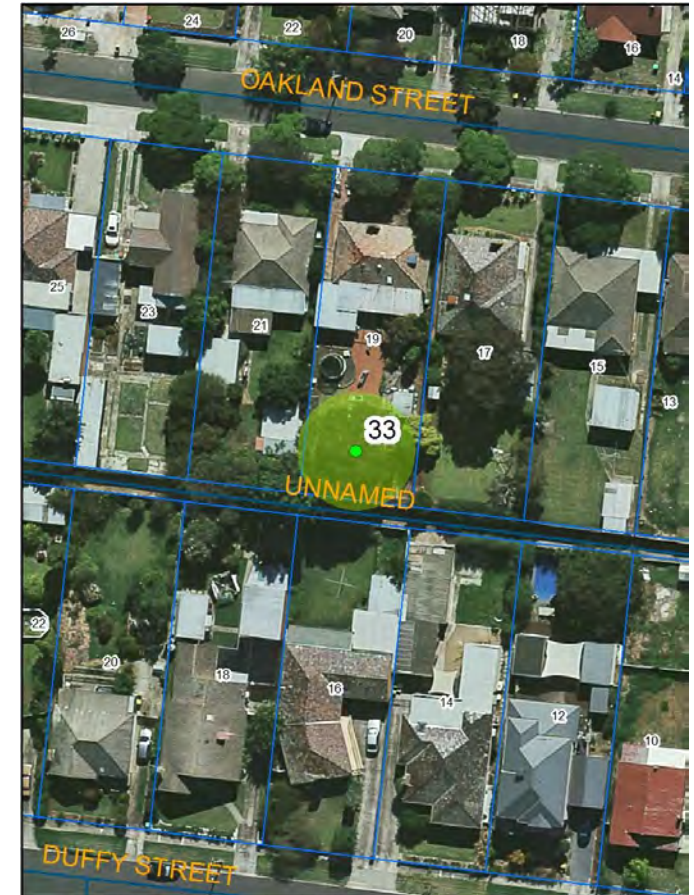
**Asset ID:** 35

**Failure Probability:** 3. Moderate

**Failure Size:** 4. 26-100mm

**Defects:** Codominant trunks

**Recommended Works:** No works

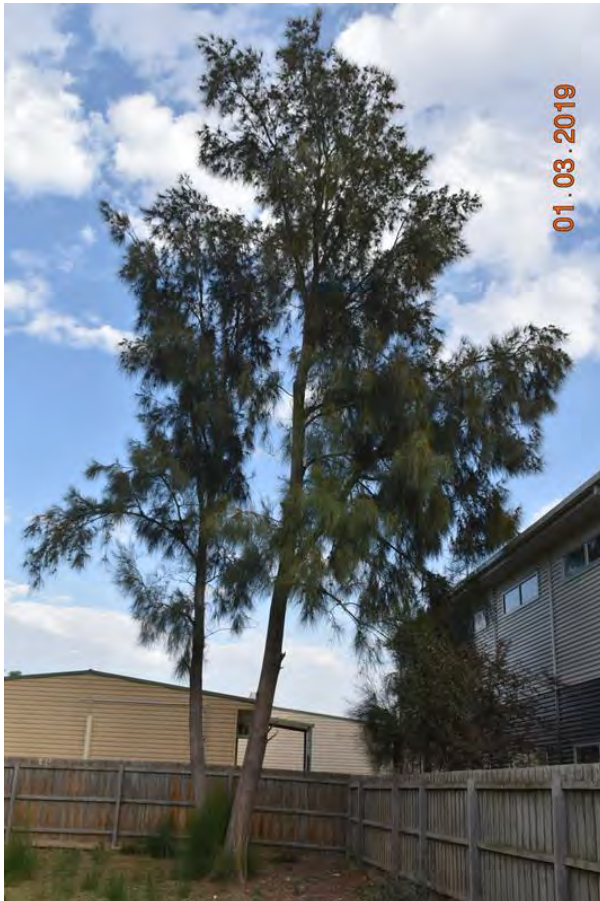
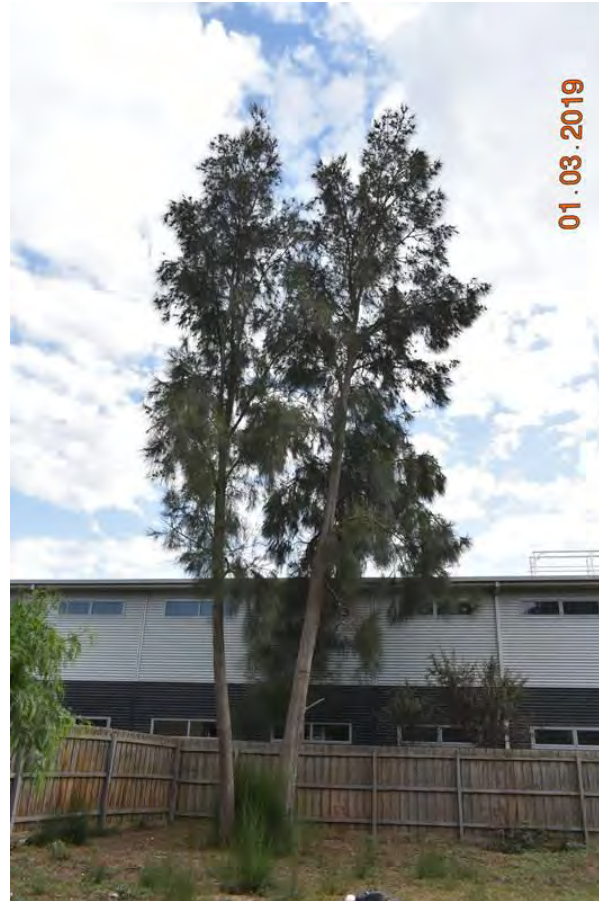
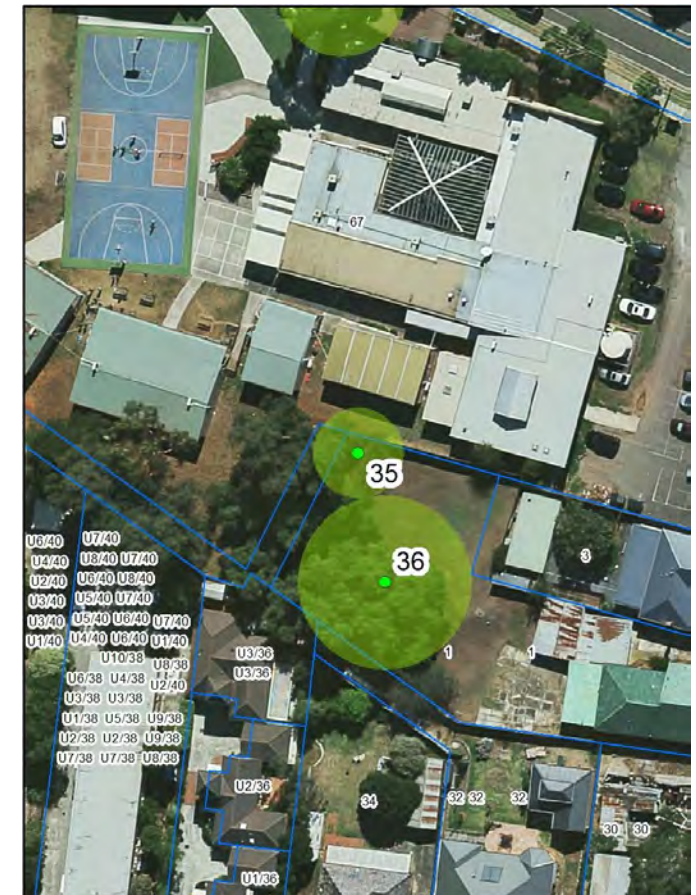
**Asset ID:** 36

**Failure Probability:** 3. Moderate

**Failure Size:** 4. 26-100mm

**Defects:** None

**Recommended Works:** No works

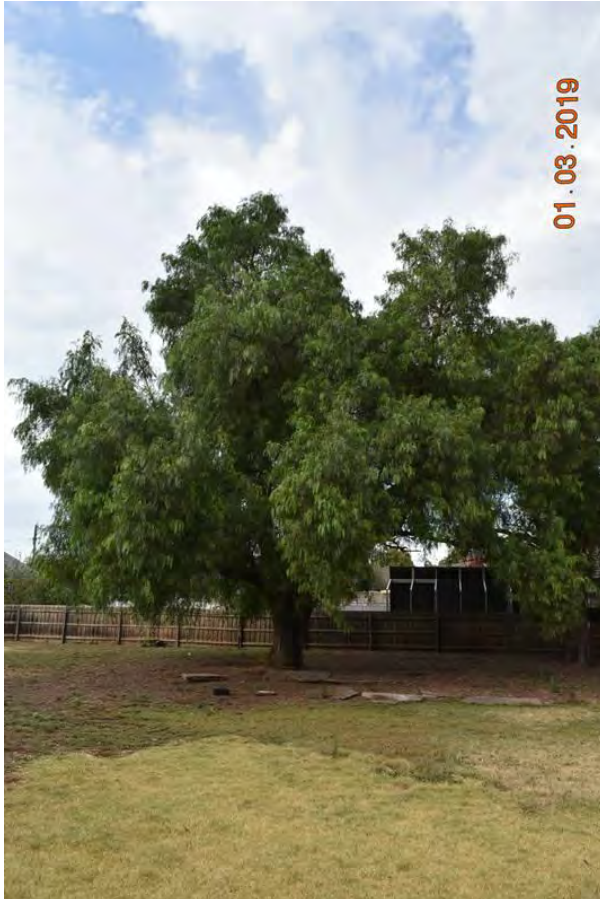
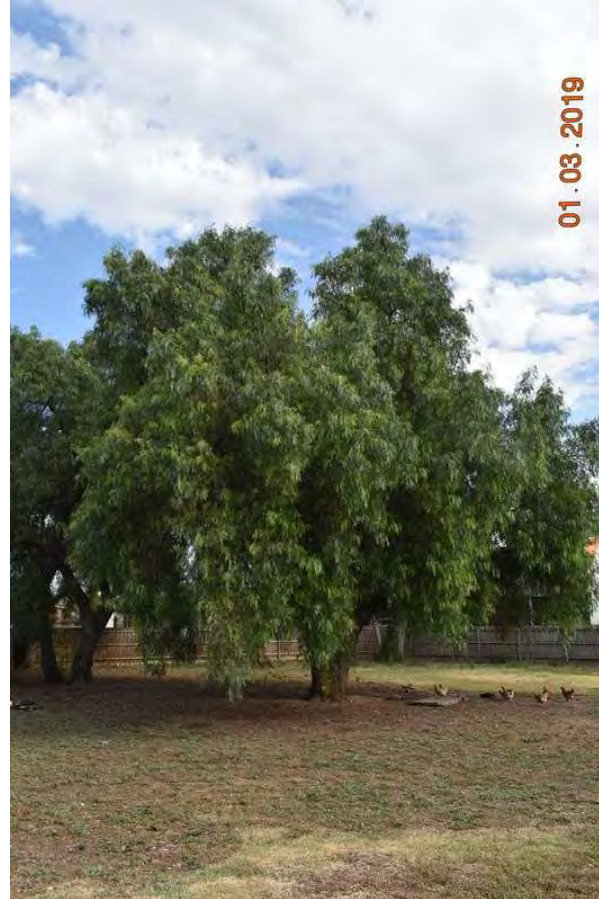
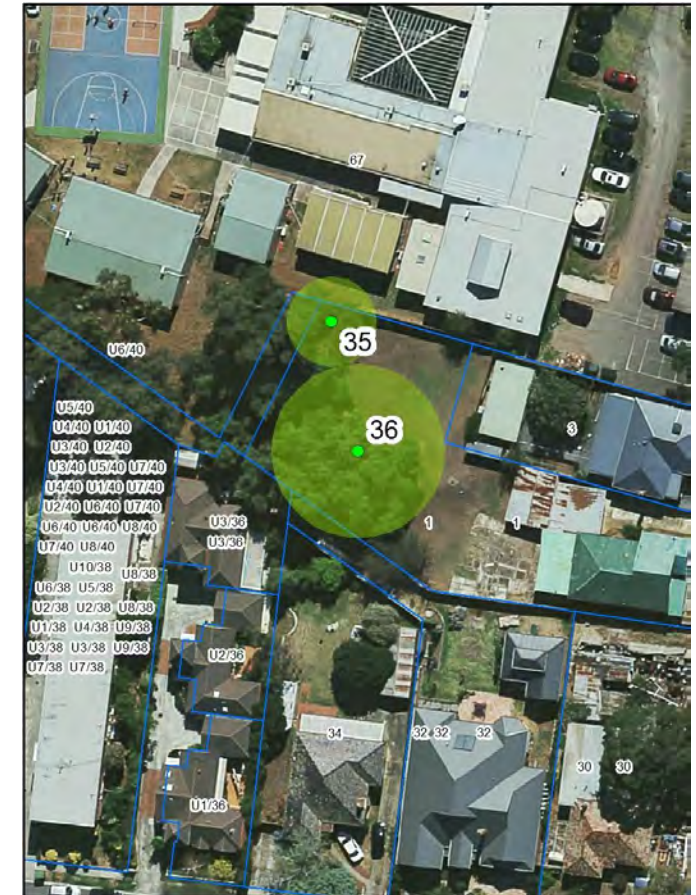
**Asset ID:** 44

**Failure Probability:** 4. Low

**Failure Size:** 3. 101-250mm

**Defects:** None

**Comments:** Does not meet criteria. Minor ELB damage

**Recommended Works:** Risk reduction pruning

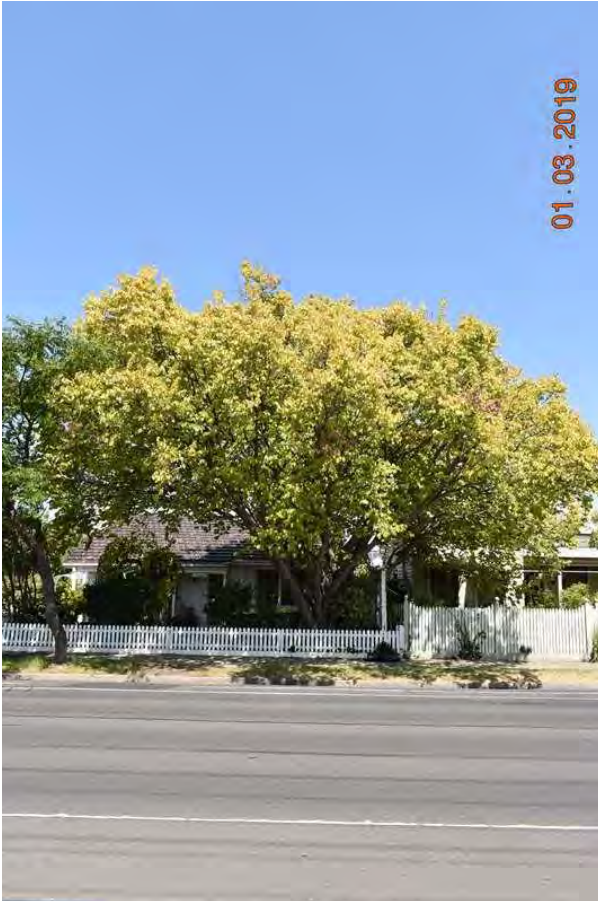
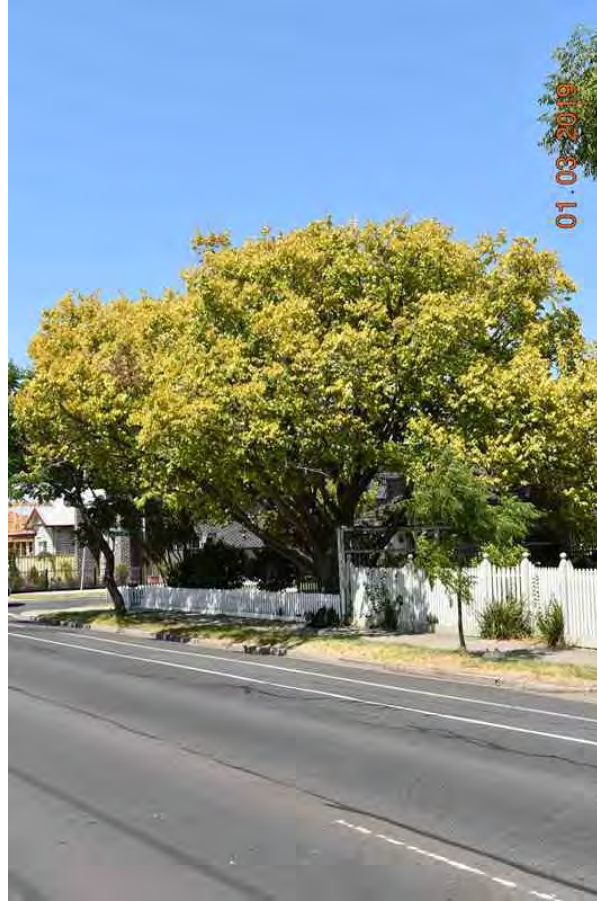
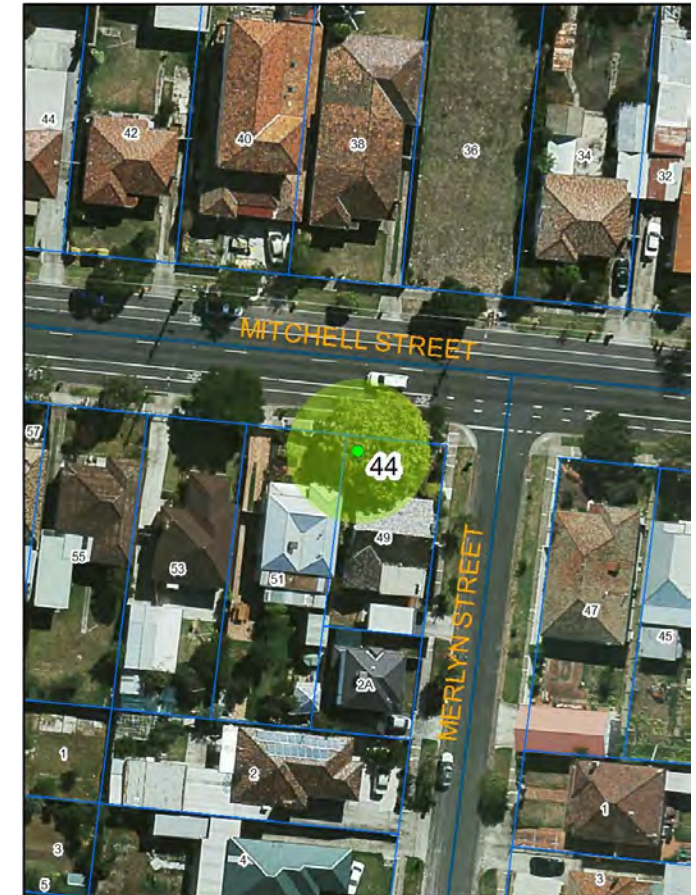
**Asset ID:** 51

**Failure Probability:** 4. Low

**Failure Size:** 4. 26-100mm

**Defects:** None

**Recommended Works:** No works

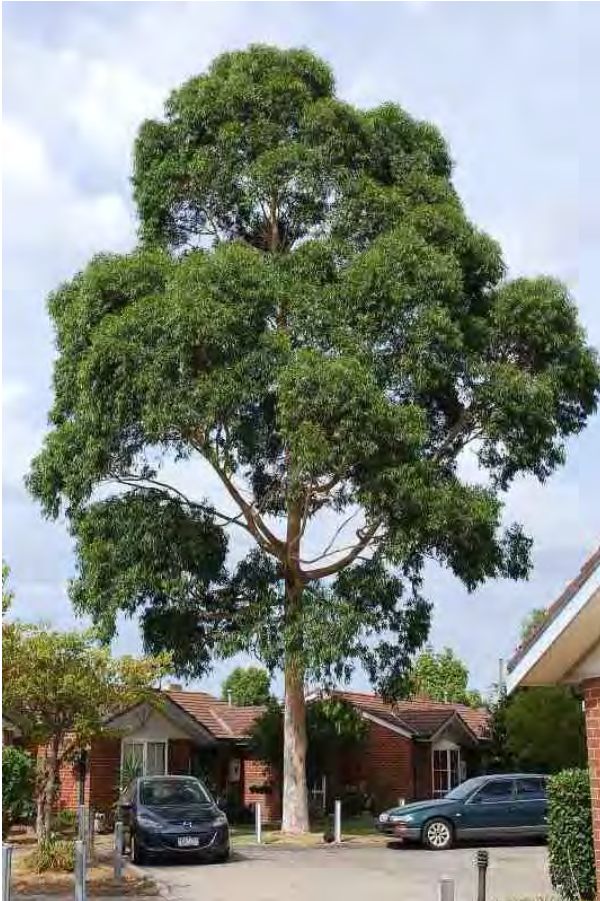
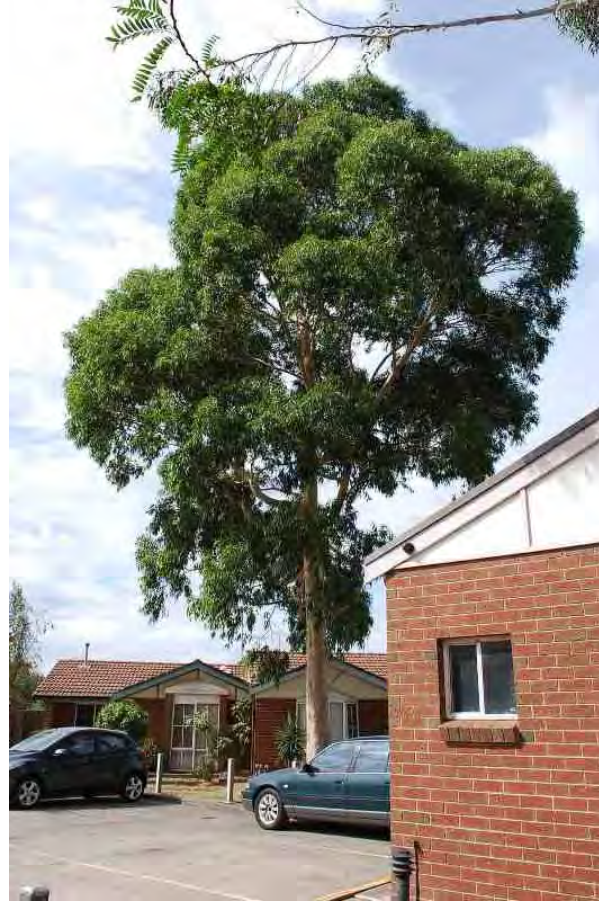
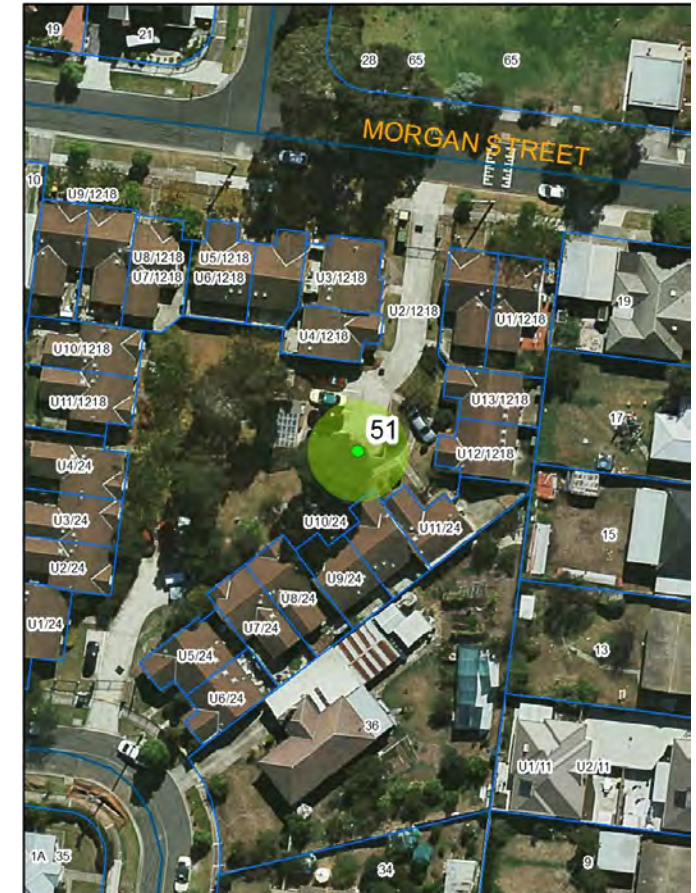
**Asset ID:** 52

**Failure Probability:** 2. High

**Failure Size:** 3. 101-250mm

**Defects:** Included bark in canopy, Decay in trunk

**Recommended Works:** No works

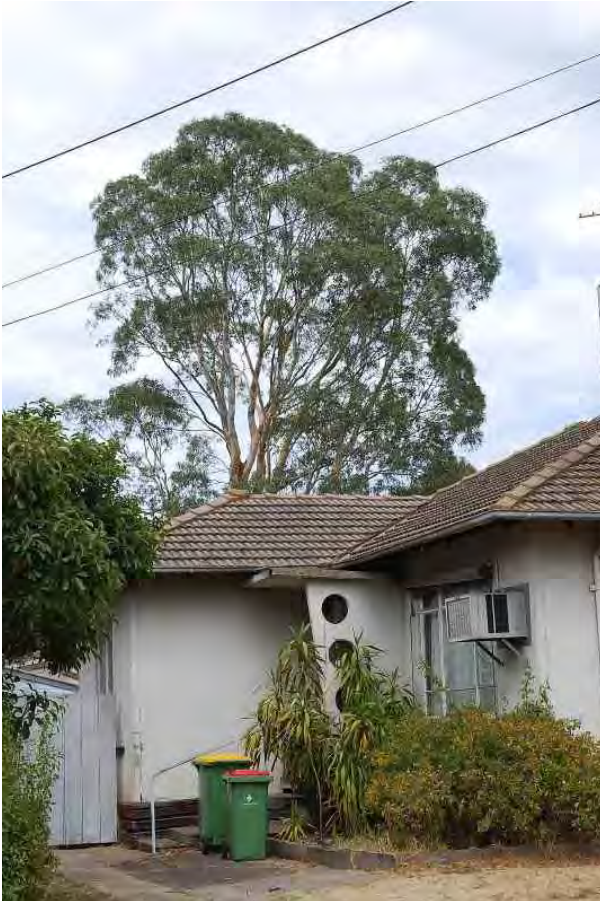
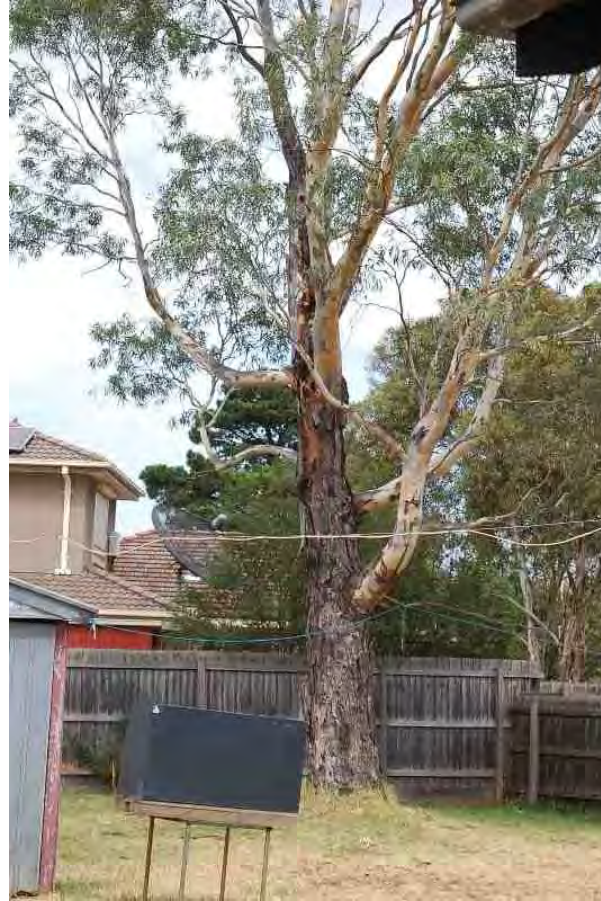
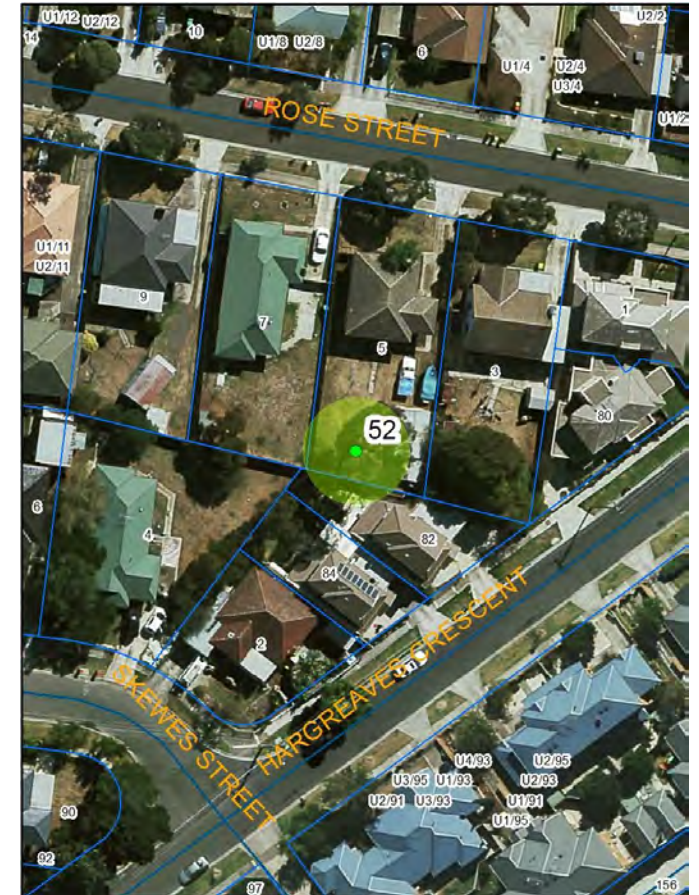
**Asset ID:** 55

**Failure Probability:** 4. Low

**Failure Size:** 4. 26-100mm

**Defects:** None

**Recommended Works:** No works

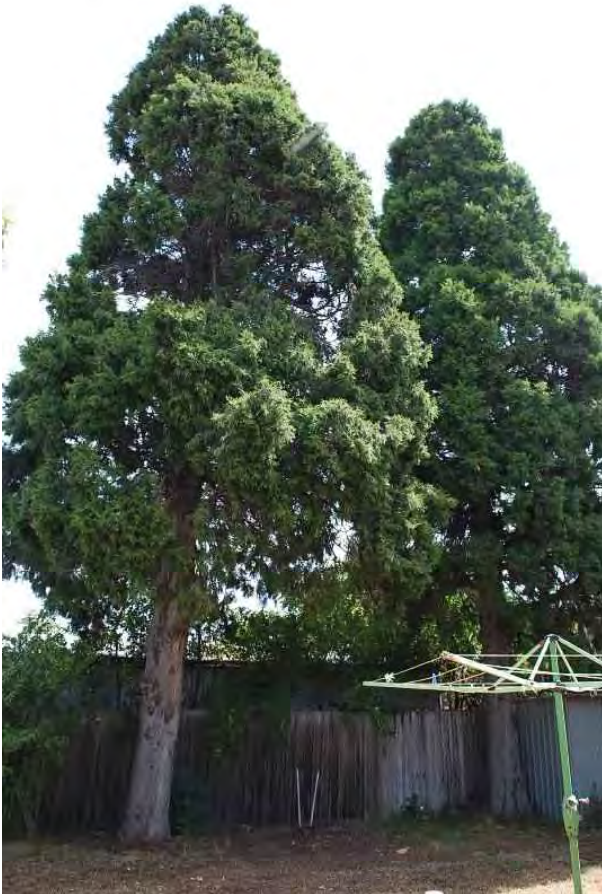
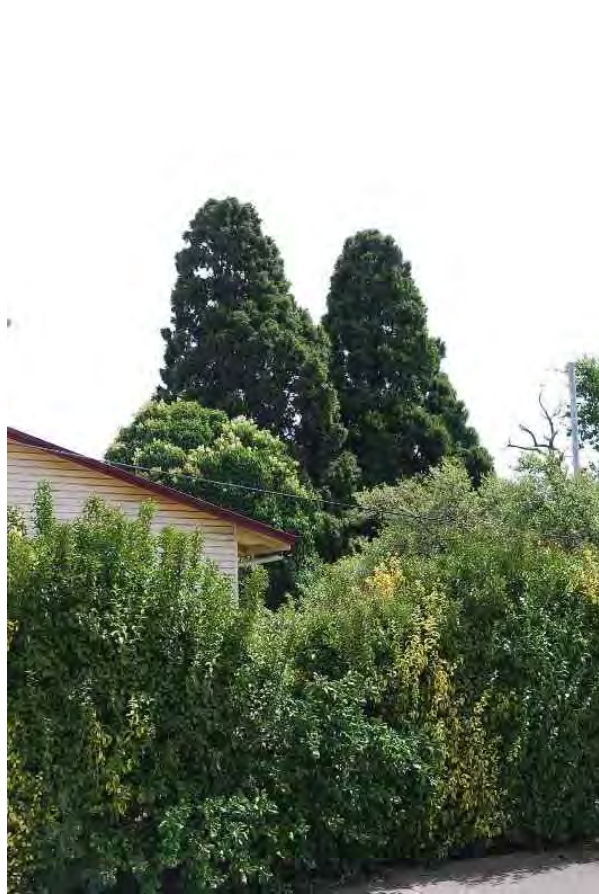
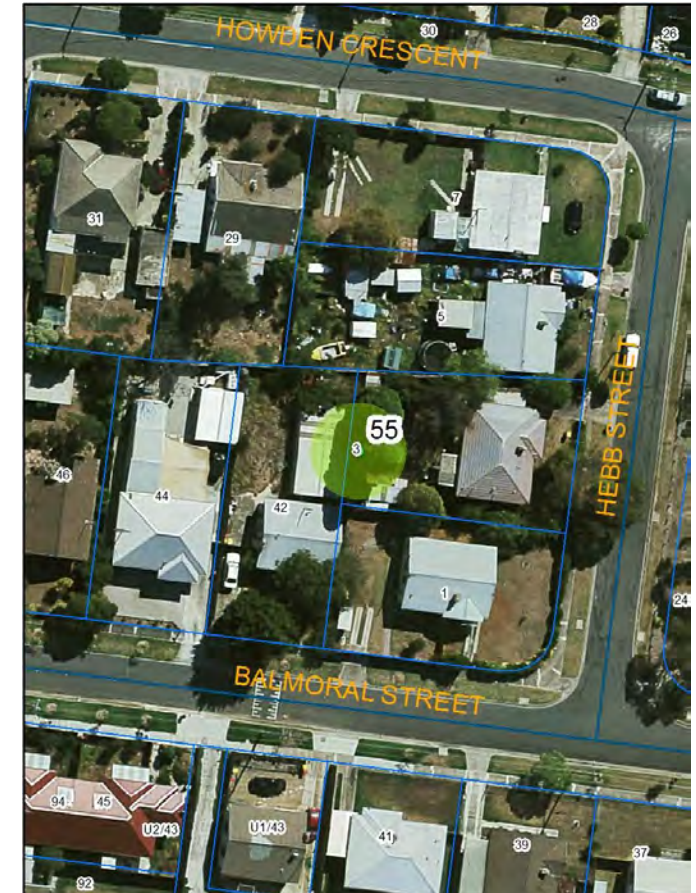
**Asset ID:** 65

**Failure Probability:** 3. Moderate

**Failure Size:** 2. 251-450mm

**Defects:** Bracket fungi on trunk, Included bark in trunk, Codominant trunks

**Recommended Works:** No works

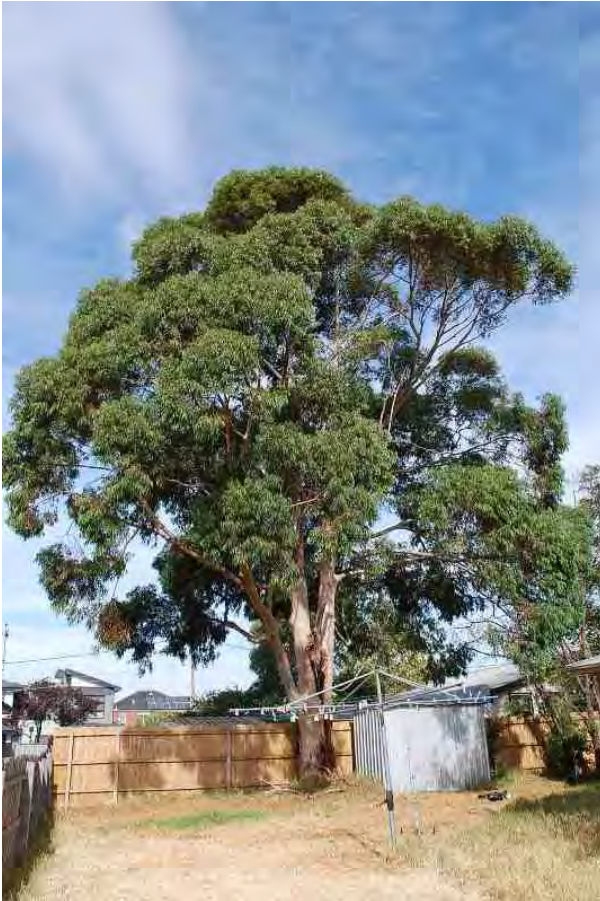
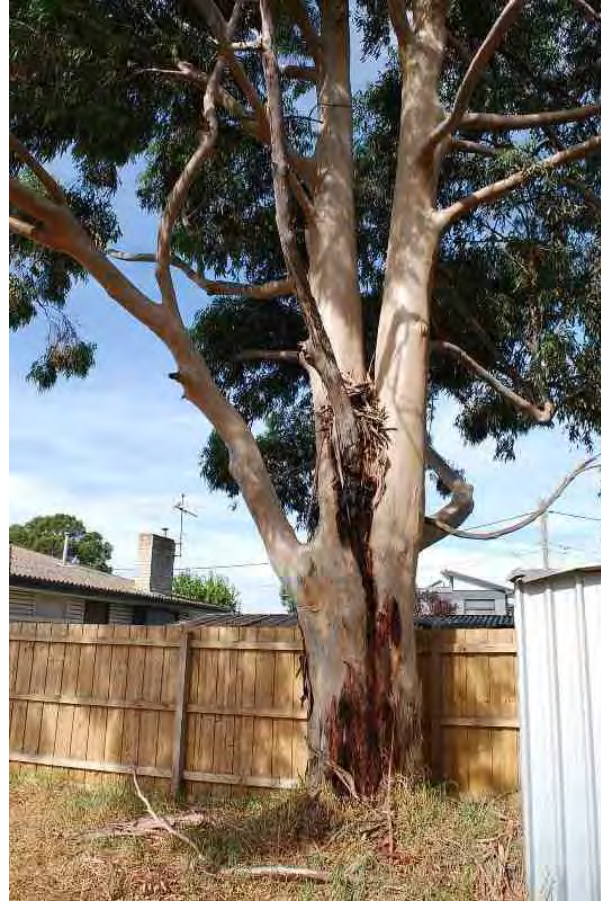
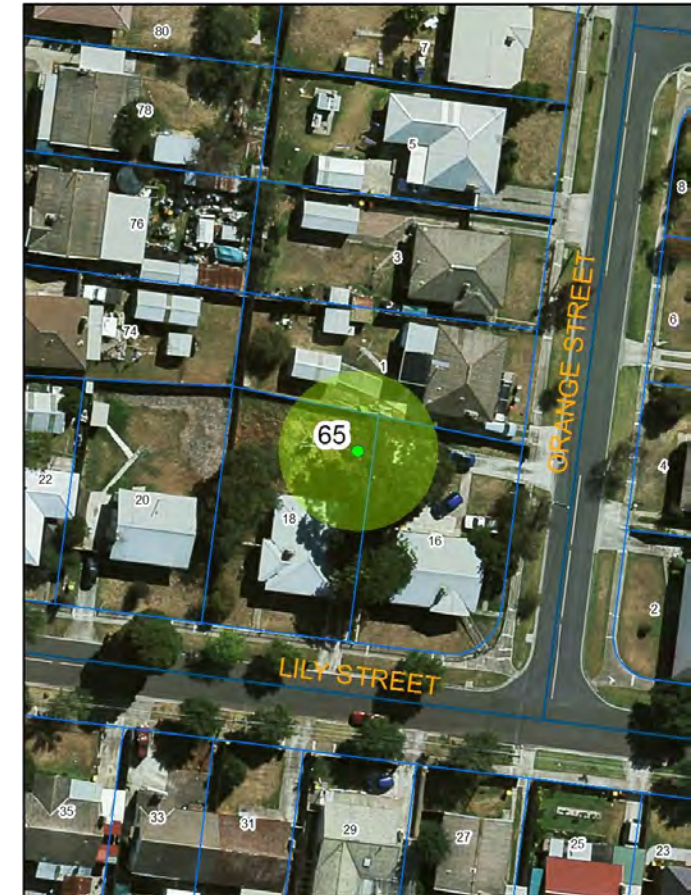
**Asset ID:** 68

**Failure Probability:** 3. Moderate

**Failure Size:** 3. 101-250mm

**Defects:** Codominant stems in canopy, Trunk lopped, Trunk lean  
**Recommended Works:** No works

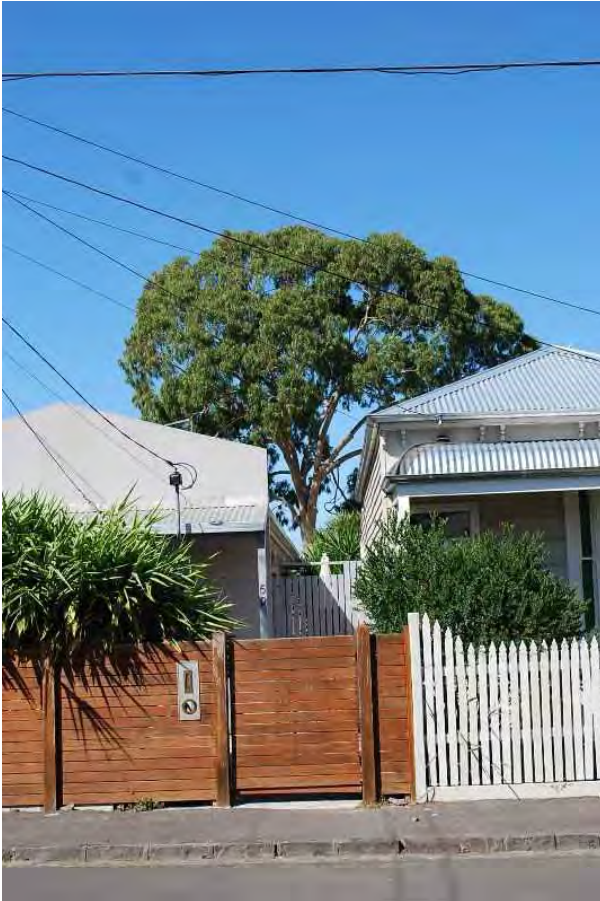
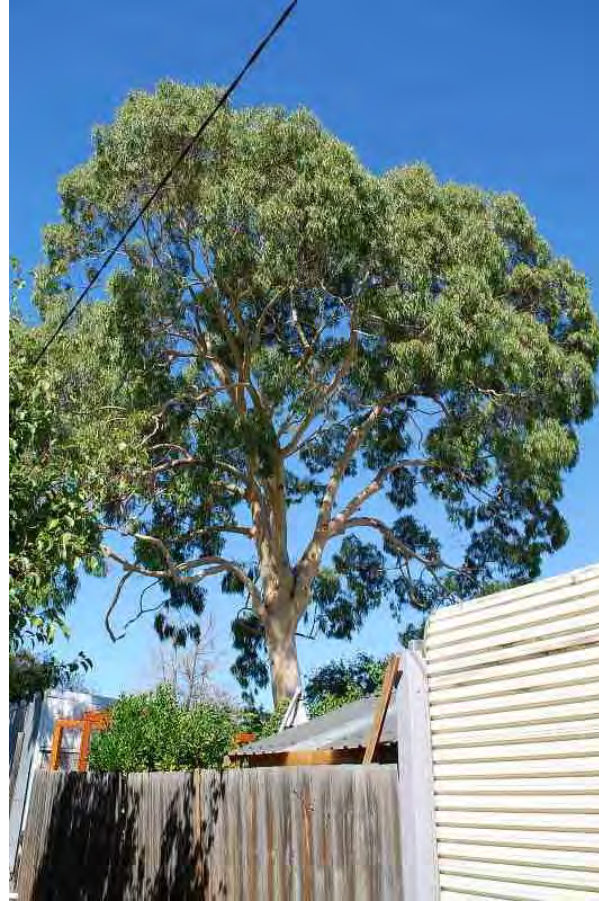
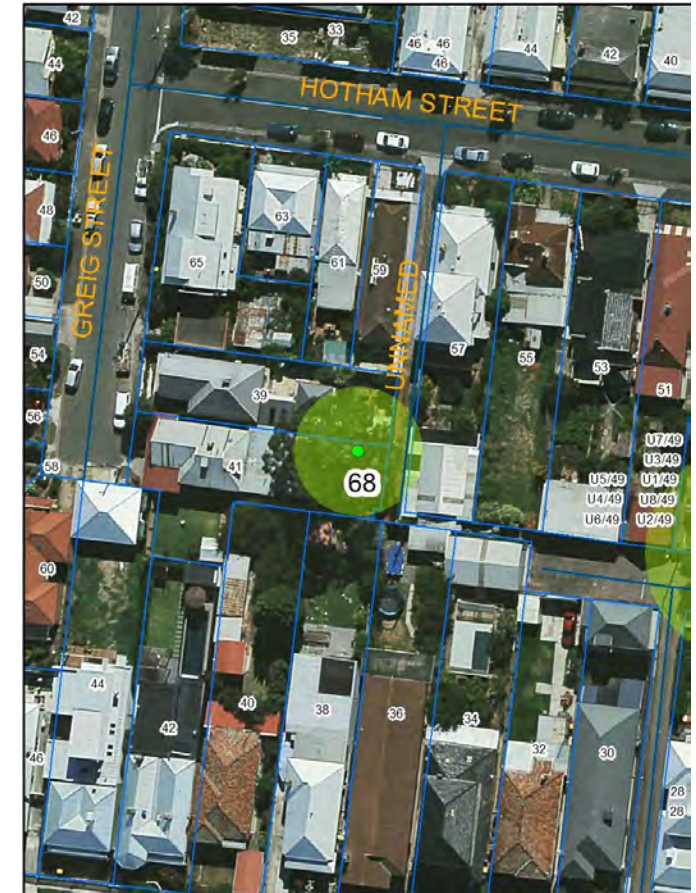
**Asset ID:** 69

**Failure Probability:** 3. Moderate

**Failure Size:** 4. 26-100mm

**Defects:** Included bark in trunk, Codominant trunks

**Recommended Works:** No works

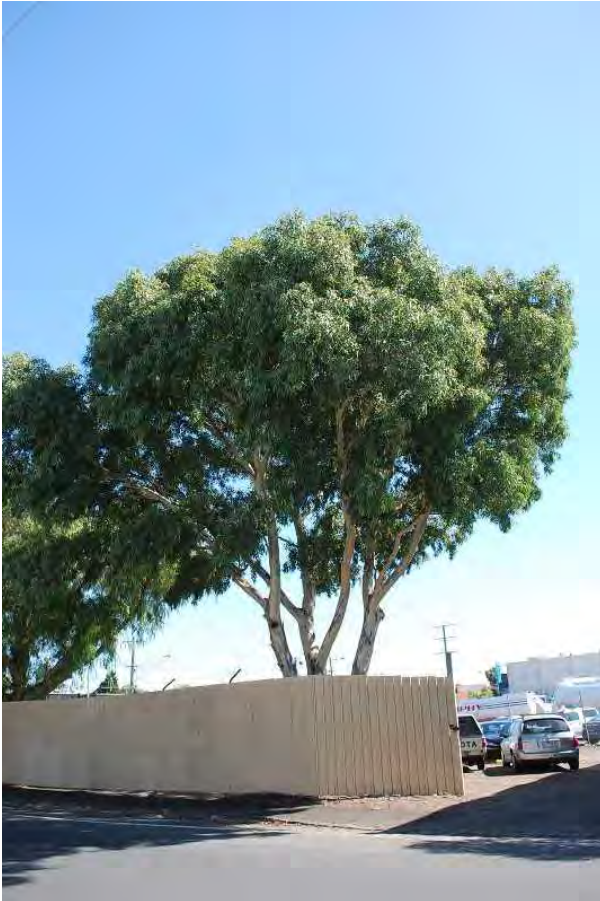
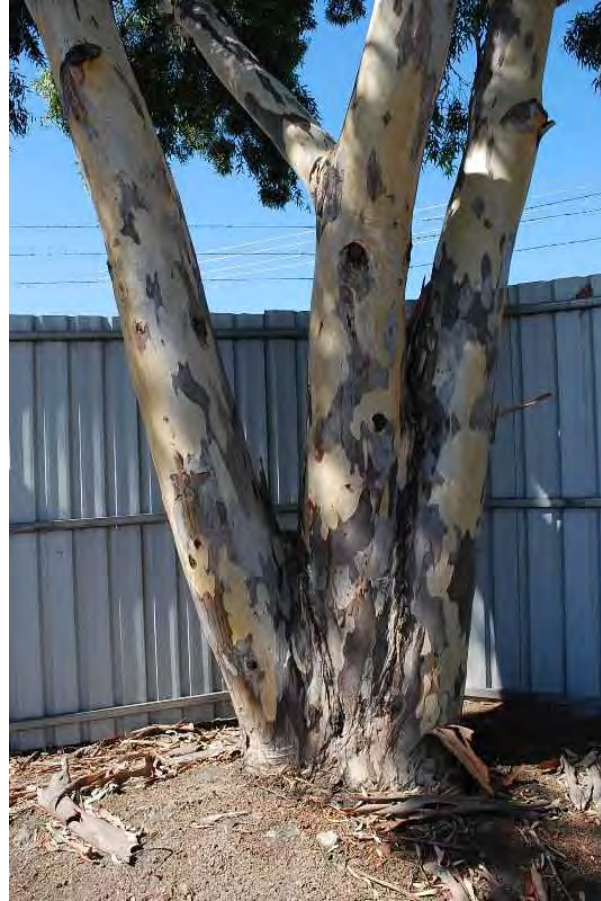
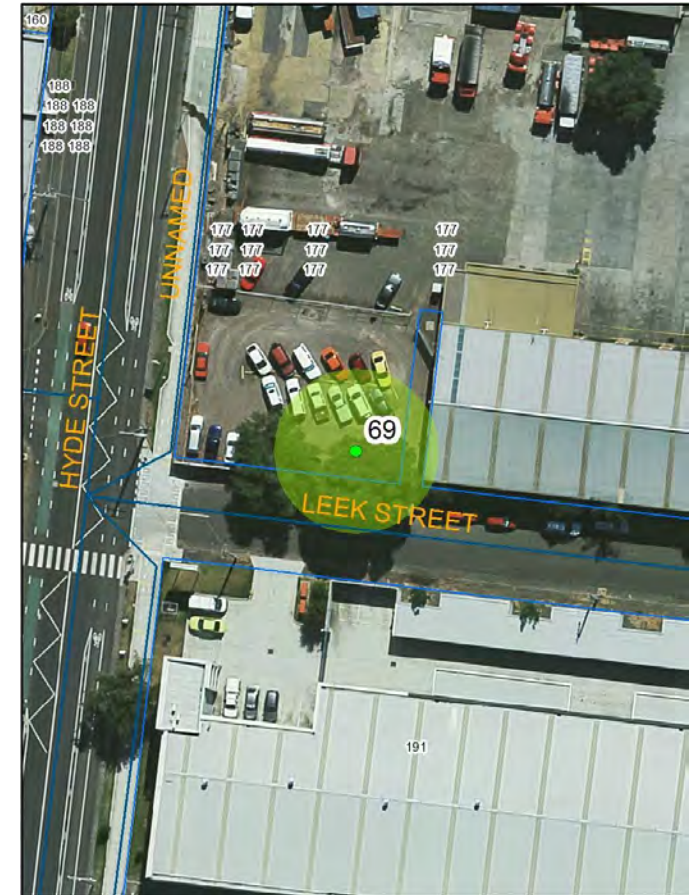
**Asset ID:** 70

**Approximate Age:** 100+ years  
**ULE:** 11-20 years  
**Health:** Good  
**Structure:** Fair  
**Failure Probability:** 3. Moderate  
**Failure Size:** 4. 26-100mm  
**Target:** 3. Vehicles, stationary  
**Risk Score:** 1 in 5000000  
**Risk Category:** Low  
**Significance Statement:**

**Defects:** Decay in canopy, Decay in trunk  
**Recommended Works:** No works  
**Works Priority:** None  
**Comments:** 3m from house. Causing structural damage to house  
**Record Type:** Single Tree  
**No. of Trees:** 1

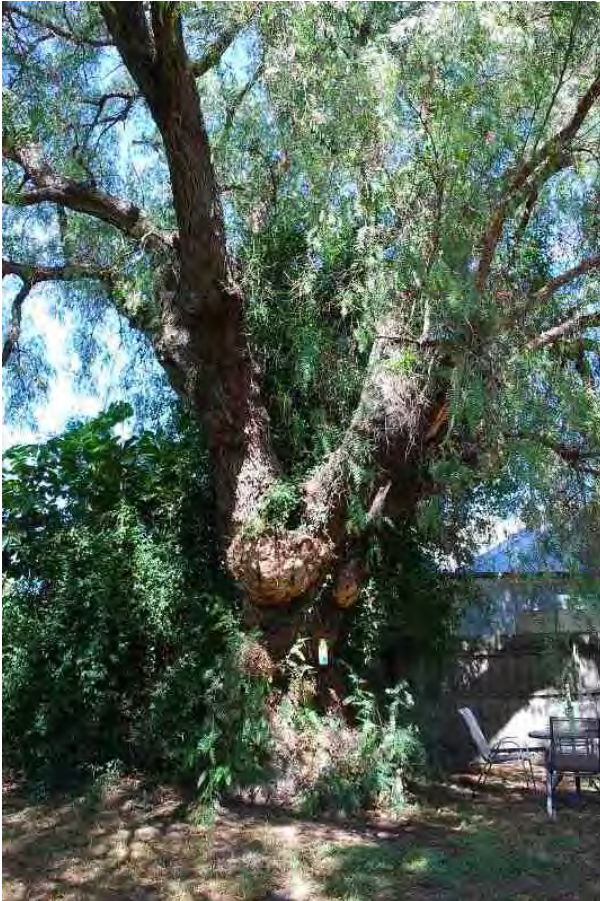
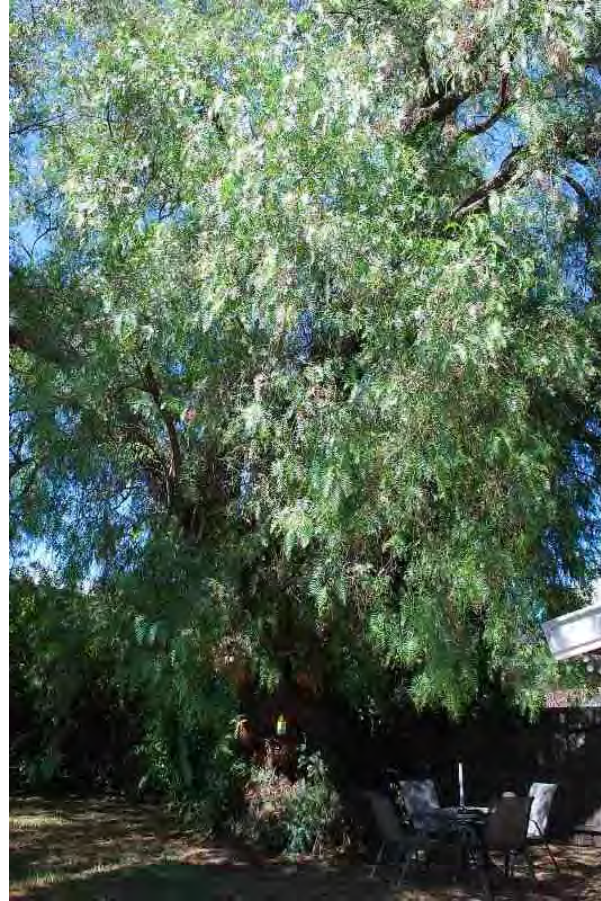
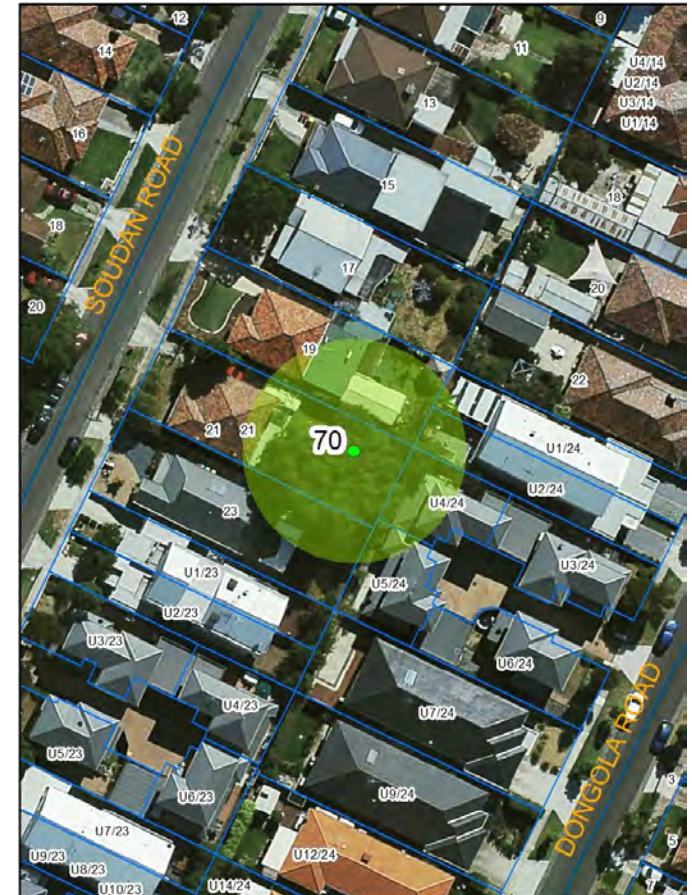
**Asset ID:** 71

**Approximate Age:** 61-80 years  
**ULE:** 40+ years  
**Health:** Good  
**Structure:** Good  
**Failure Probability:** 3. Moderate  
**Failure Size:** 4. 26-100mm  
**Target:** 4. Pedestrians, 3/day to 1/hr  
**Risk Score:** 1 in 50000000  
**Risk Category:** Very low  
**Significance Statement:** This tree does not warrant inclusion on the significant tree register

**Defects:** None  
**Recommended Works:** No works  
**Works Priority:** None  
**Comments:** Too small for a Peppercorn  
**Record Type:** Single Tree  
**No. of Trees:** 1
