# Maribyrnong City Council Significant Tree Register 2019 Draft for Consultation

**Homewood Consulting Pty Ltd**

**Maribyrnong City Council**

December 2019

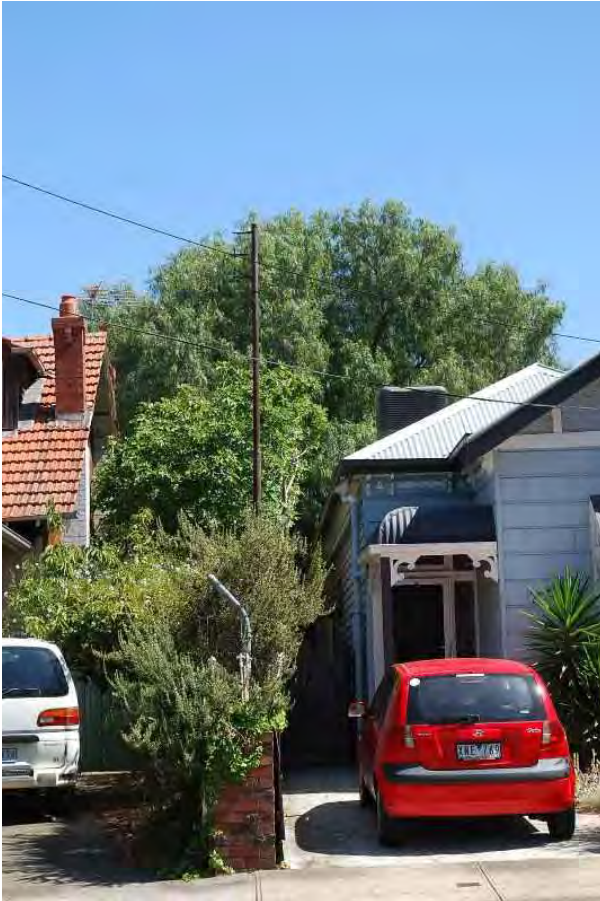
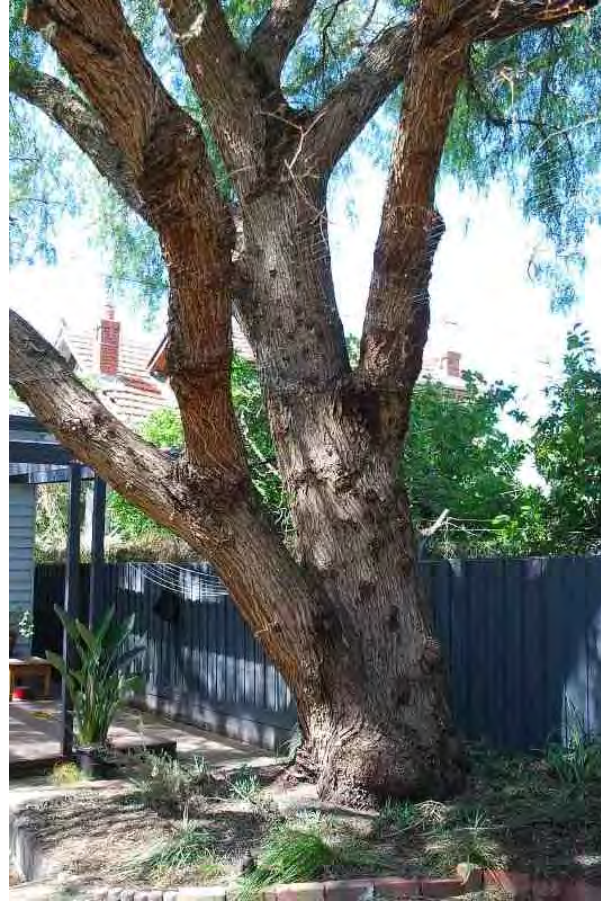
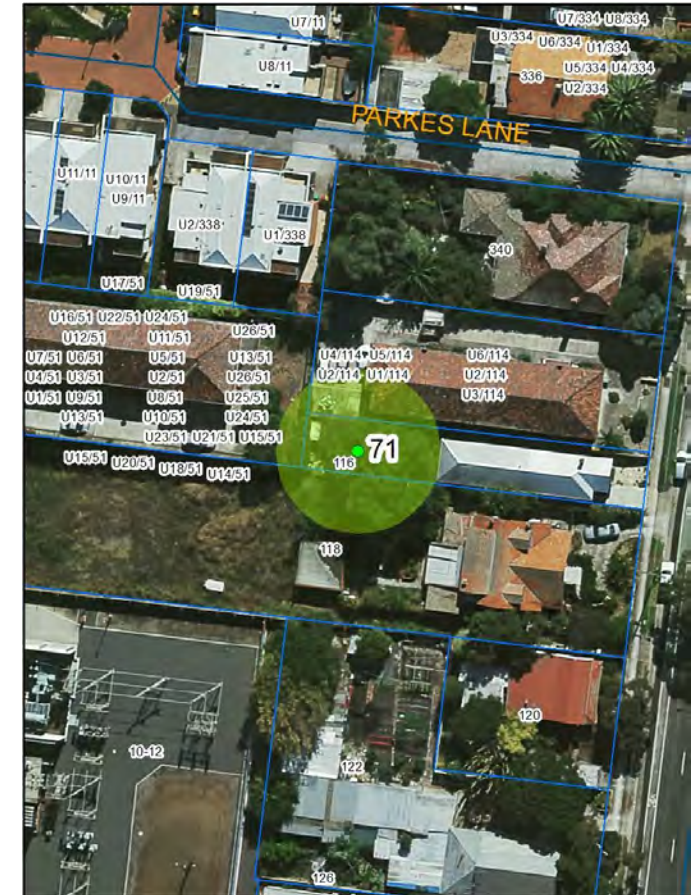
**Asset ID:** 75

**Failure Probability:** 3. Moderate

**Failure Size:** 3. 101-250mm

**Defects:** Cavity in canopy, Codominant trunks

**Recommended Works:** Risk reduction pruning

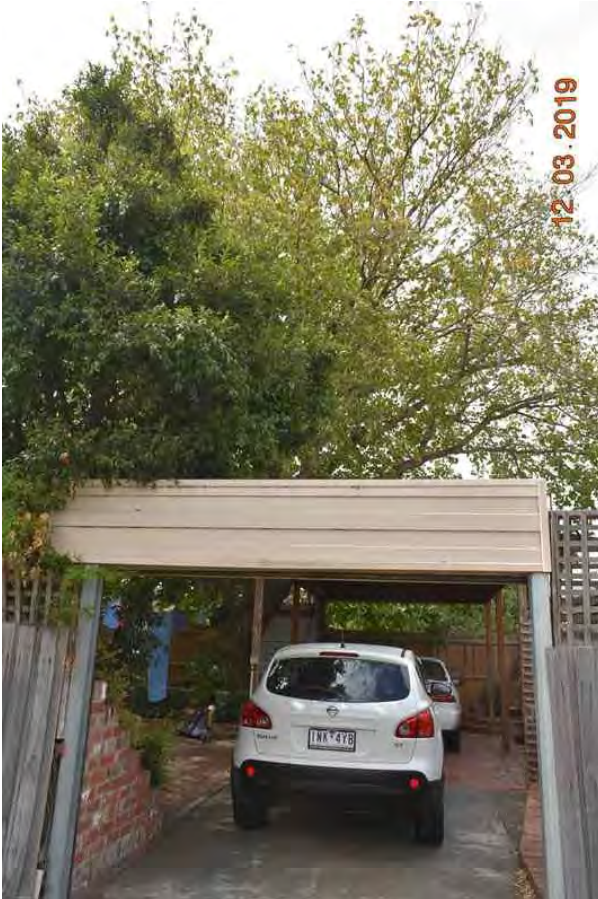
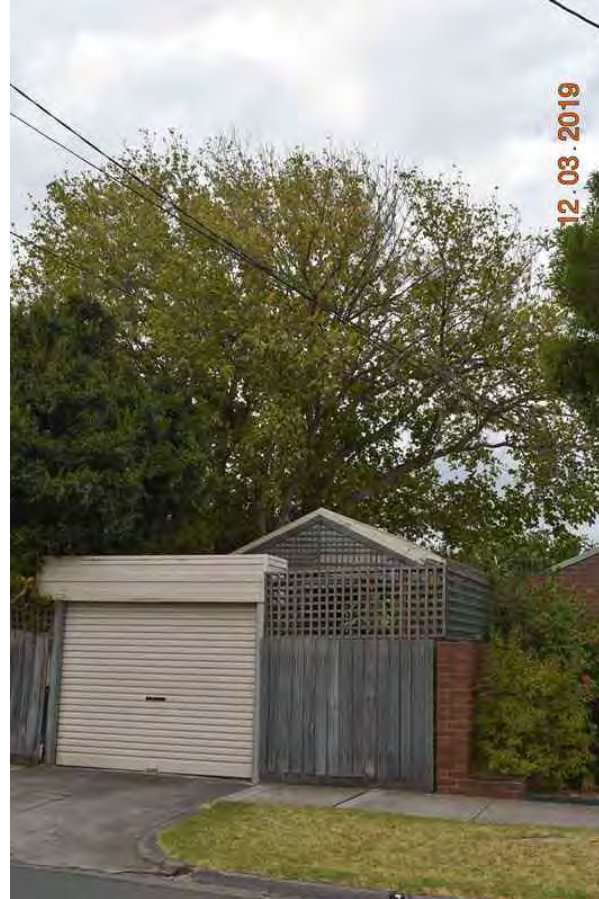
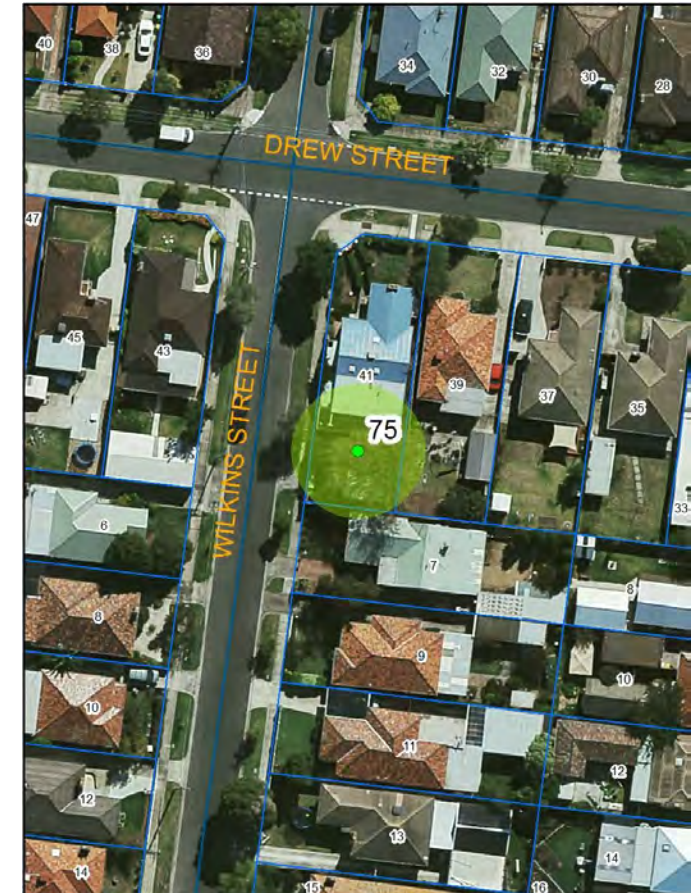
**Asset ID:** 77

**Failure Probability:** 4. Low

**Failure Size:** 4. 26-100mm

**Defects:** None

**Recommended Works:** No works

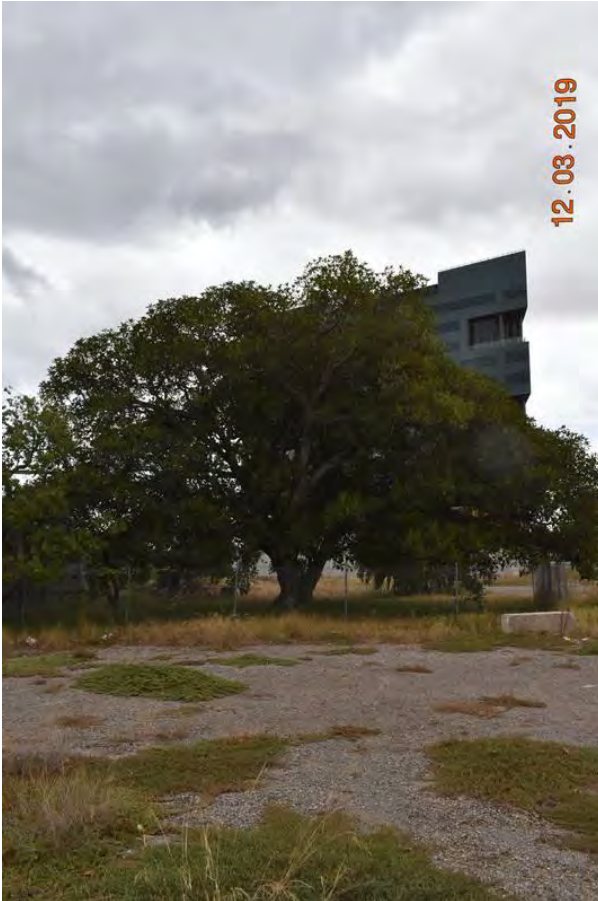
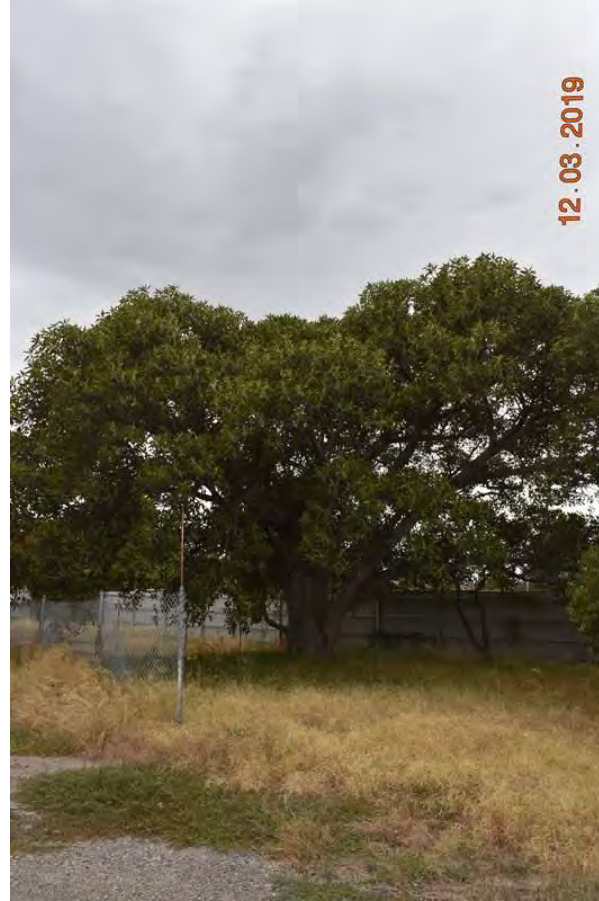
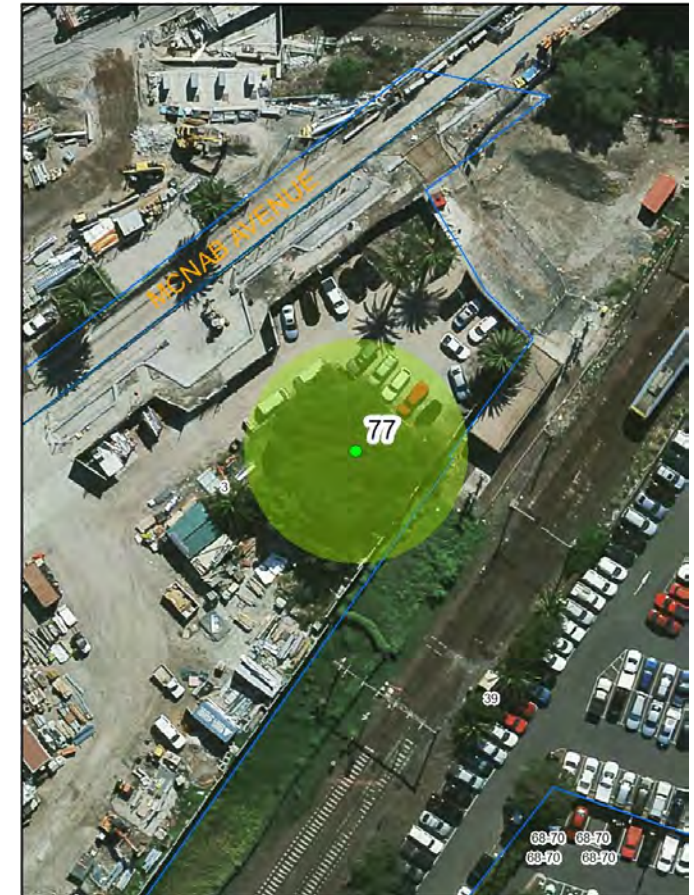
**Asset ID:** 78

**Failure Probability:** 3. Moderate

**Failure Size:** 3. 101-250mm

**Defects:** Deadwood, Codominant trunks

**Recommended Works:** No works

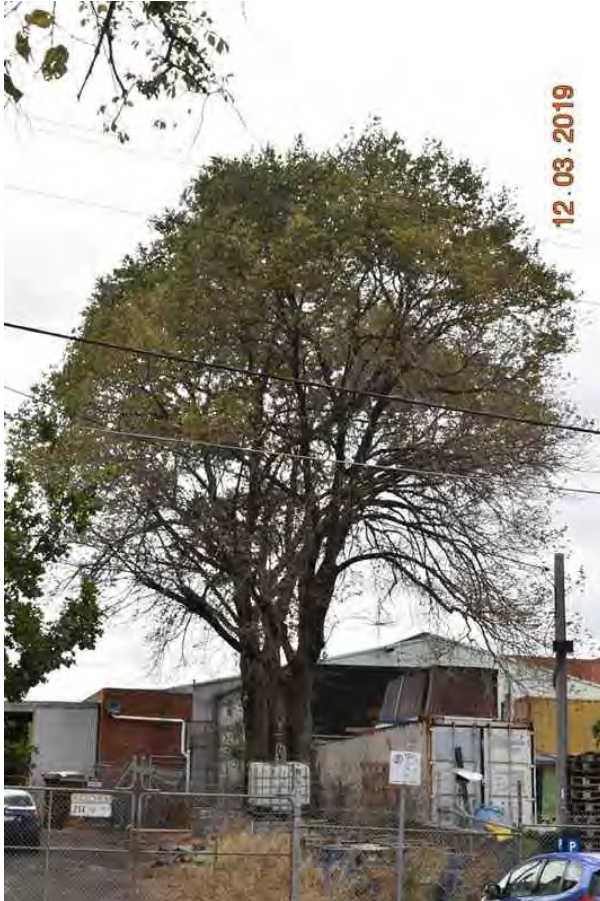
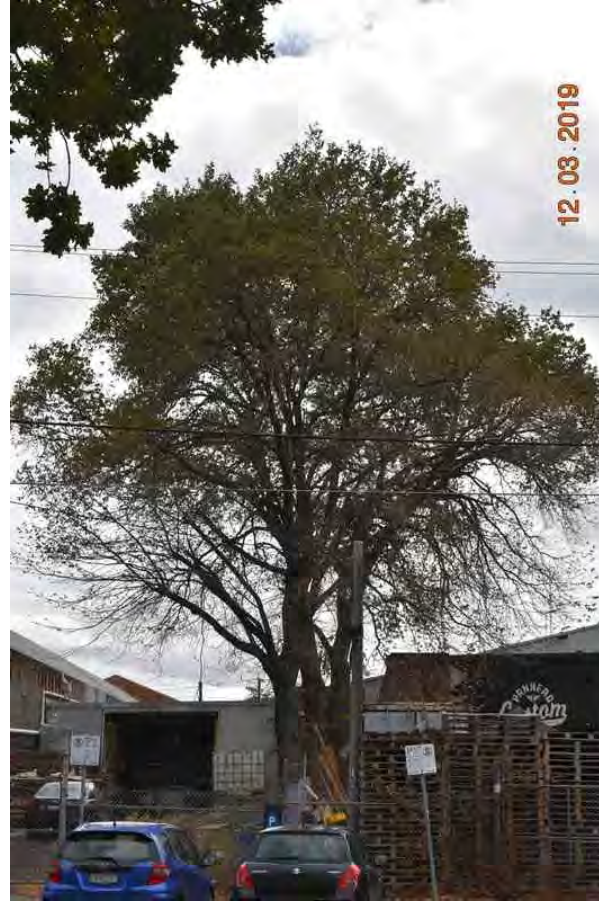
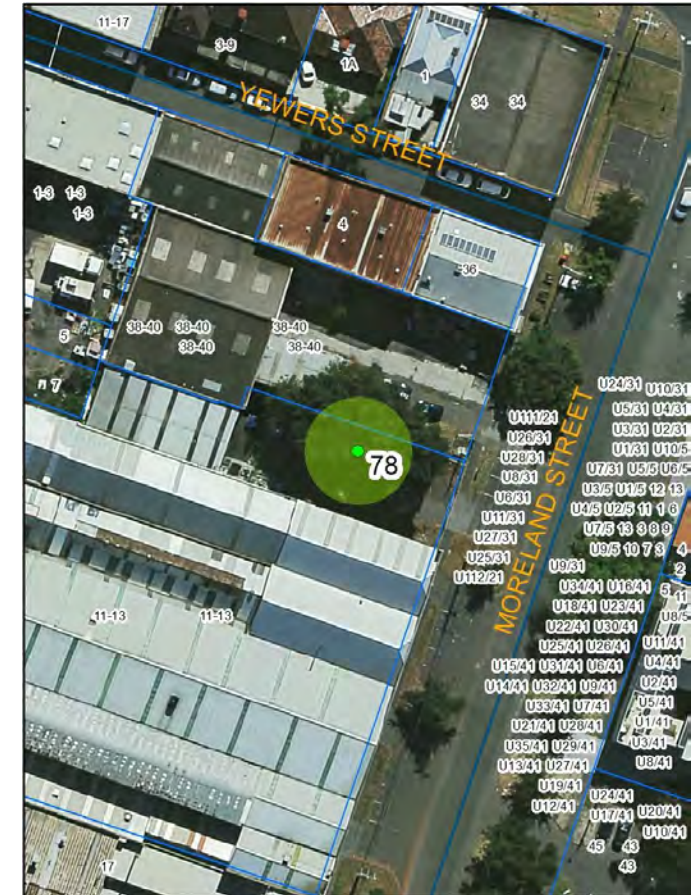
**Asset ID:** 79

**Failure Probability:** 4. Low

**Failure Size:** 3. 101-250mm

**Defects:** Cavity in canopy, Extended branches in canopy, Codominant trunks

**Recommended Works:** No works

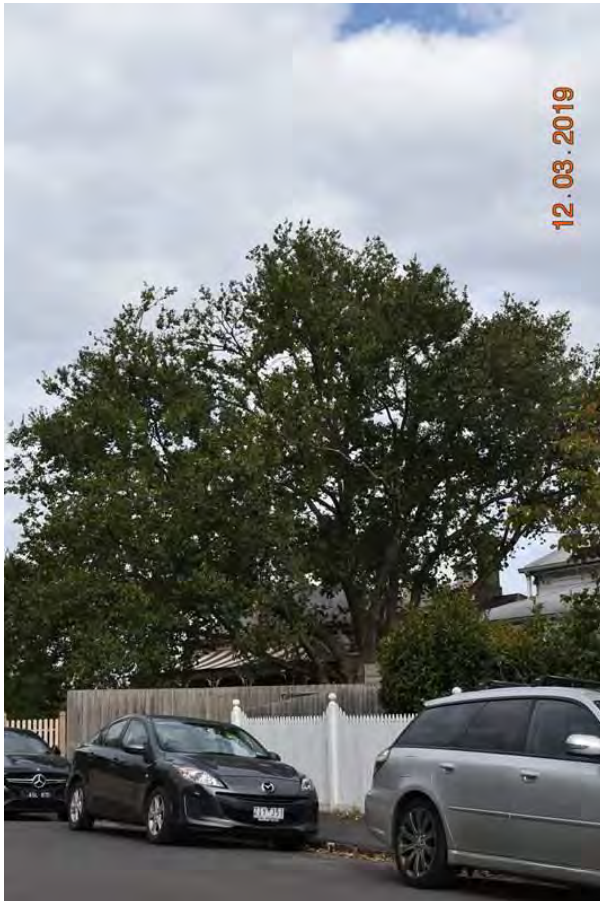
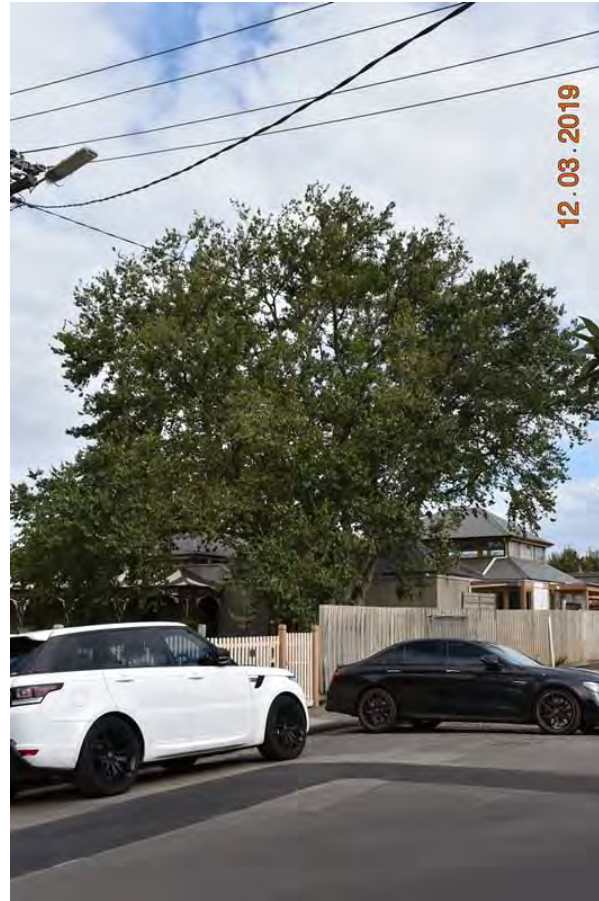
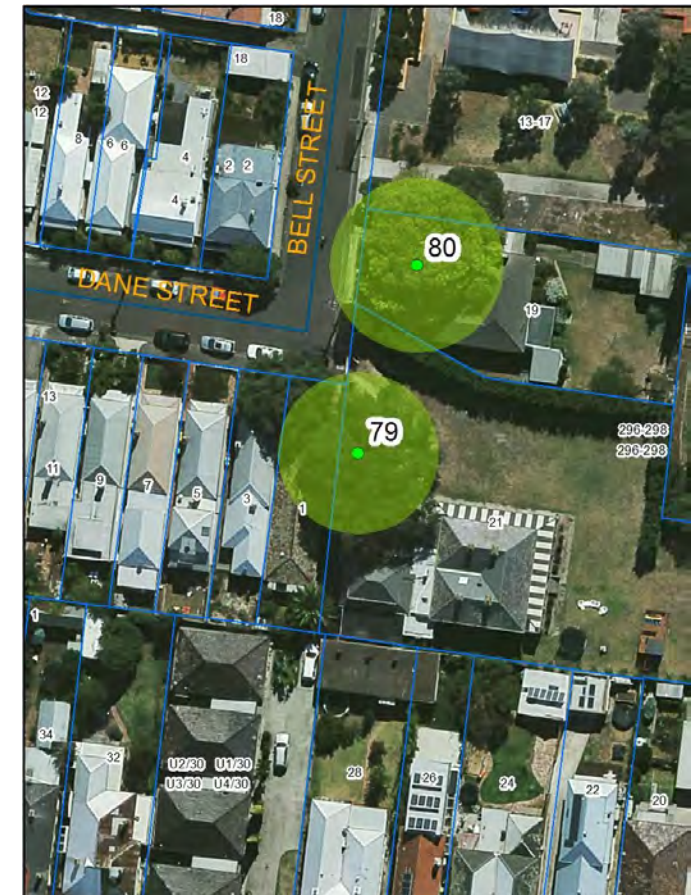
**Asset ID:** 82

**Failure Probability:** 3. Moderate

**Failure Size:** 3. 101-250mm

**Defects:** Cavity in trunk, Decay in trunk

**Comments:** Tree is very close to the house about 1.5m and causing structural damage

**Recommended Works:** No works

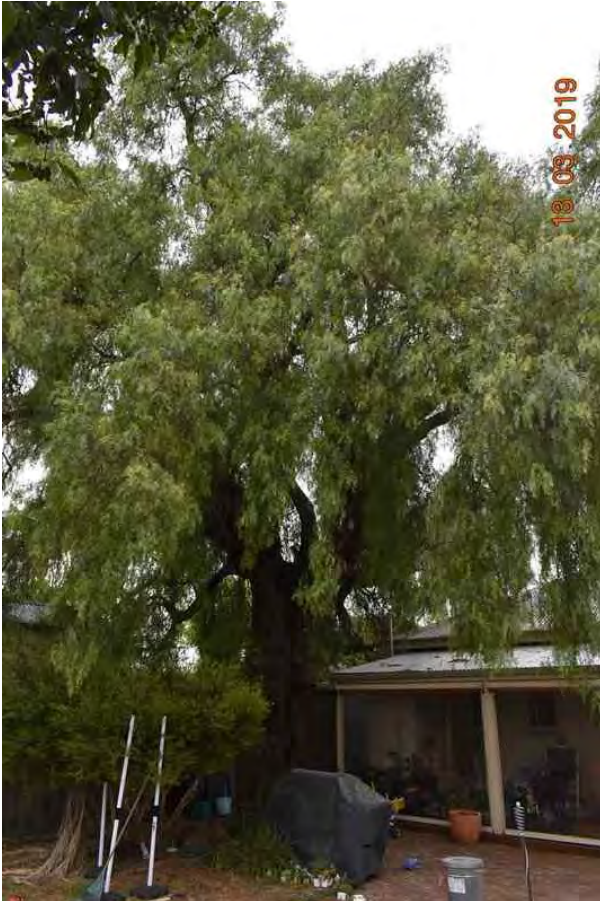
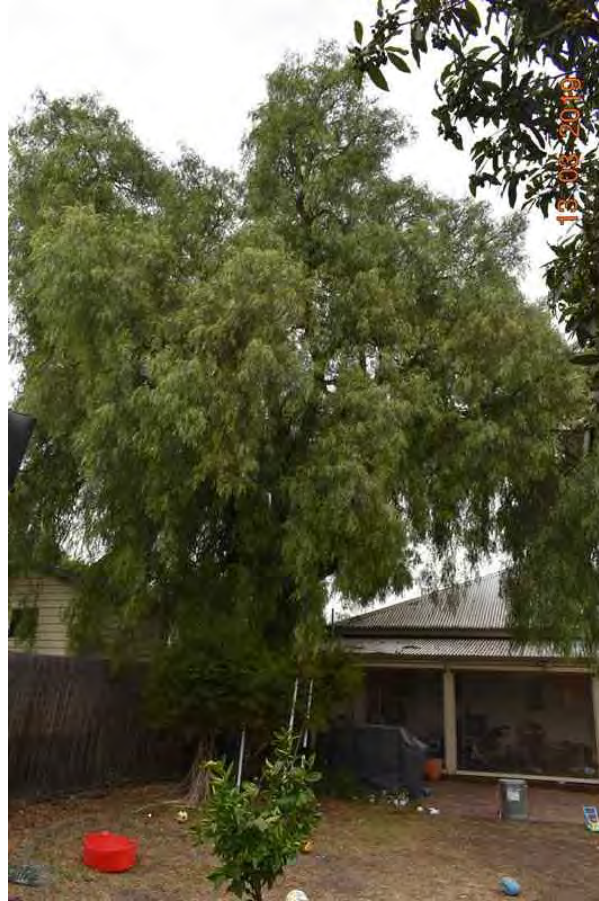
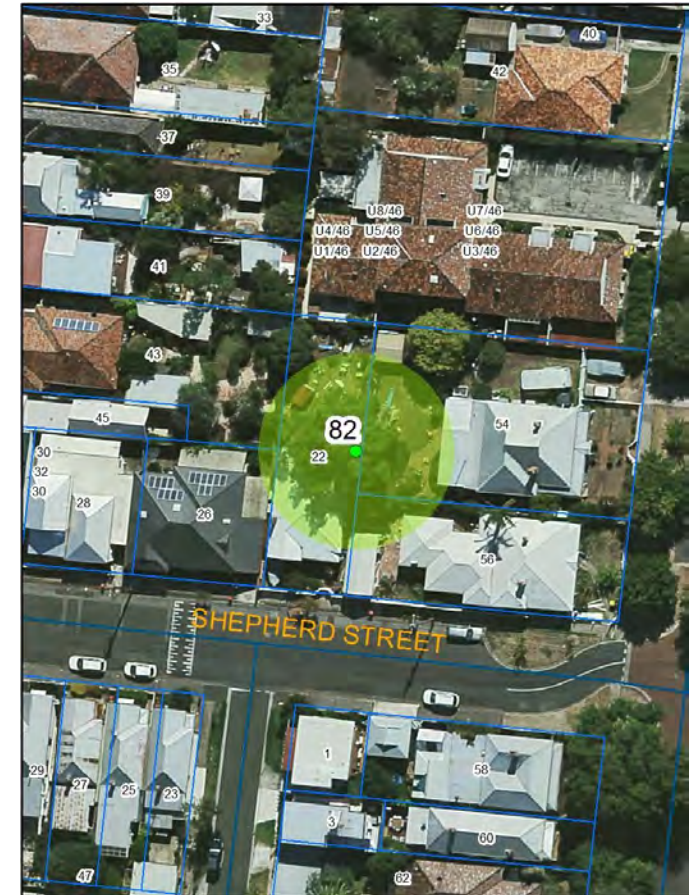
**Asset ID:** 94

**Failure Probability:** 4. Low

**Failure Size:** 4. 26-100mm

**Defects:** None

**Recommended Works:** No works

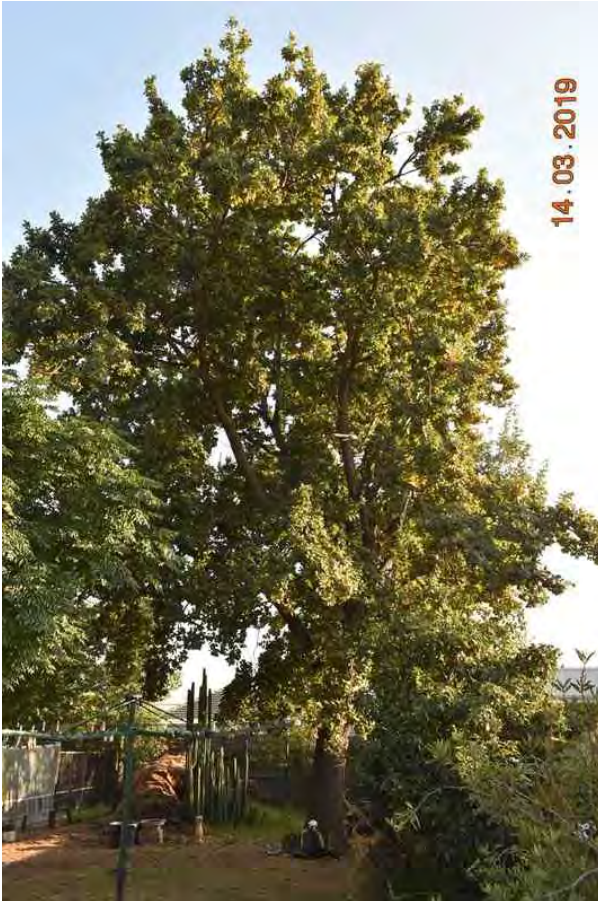
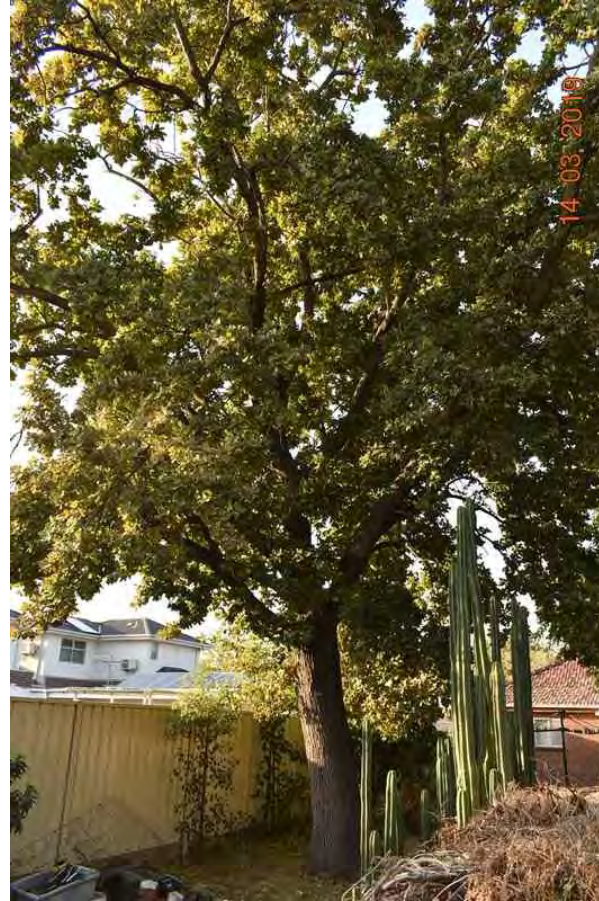
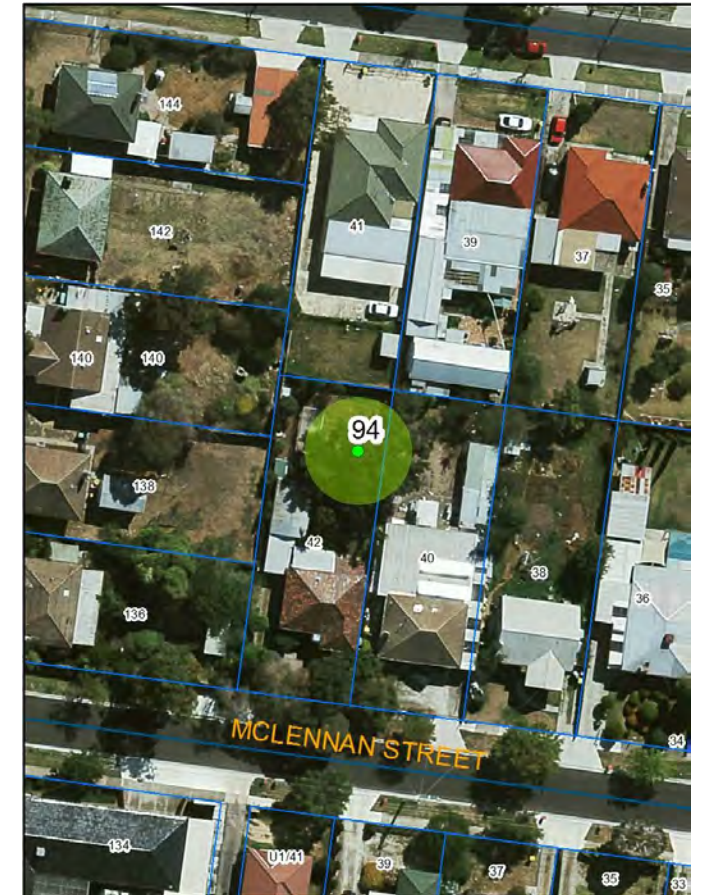
**Asset ID:** 97

**Failure Probability:** 4. Low

**Failure Size:** 3. 101-250mm

**Defects:** Decay in canopy, Included bark in trunk, Canopy lopped, Codominant trunks

**Recommended Works:** No works

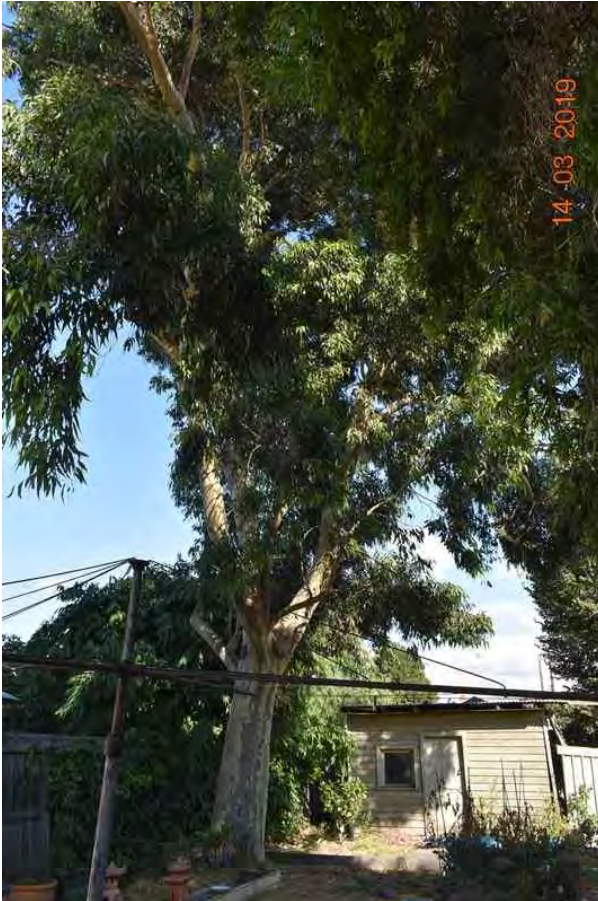
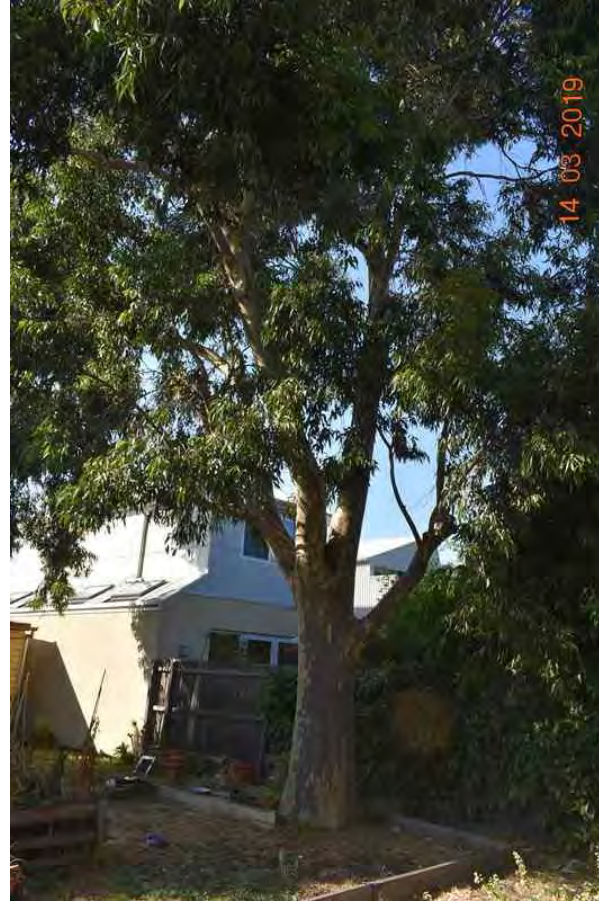
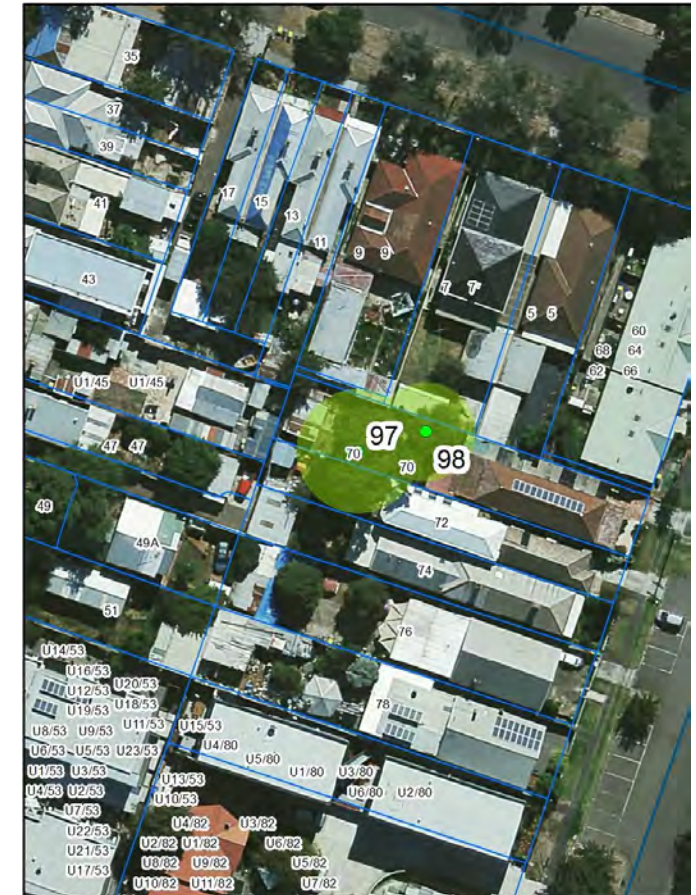
**Asset ID:** 98

**Failure Probability:** 4. Low

**Failure Size:** 4. 26-100mm

**Defects:** Codominant trunks

**Recommended Works:** No works

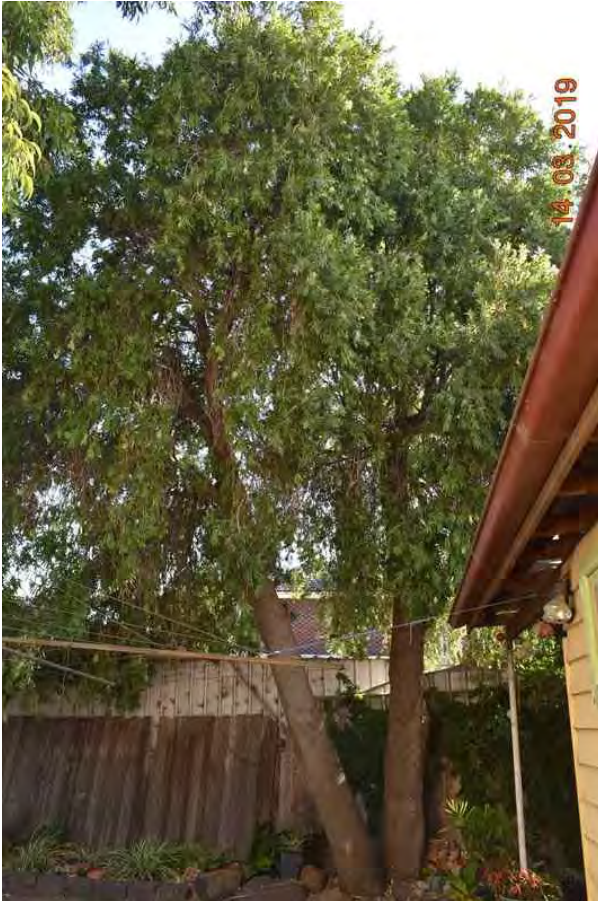
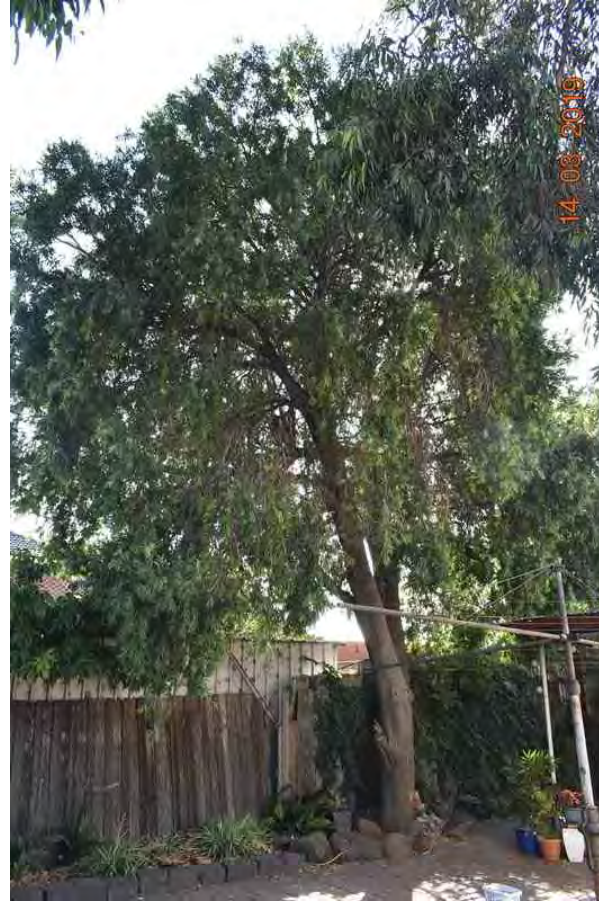
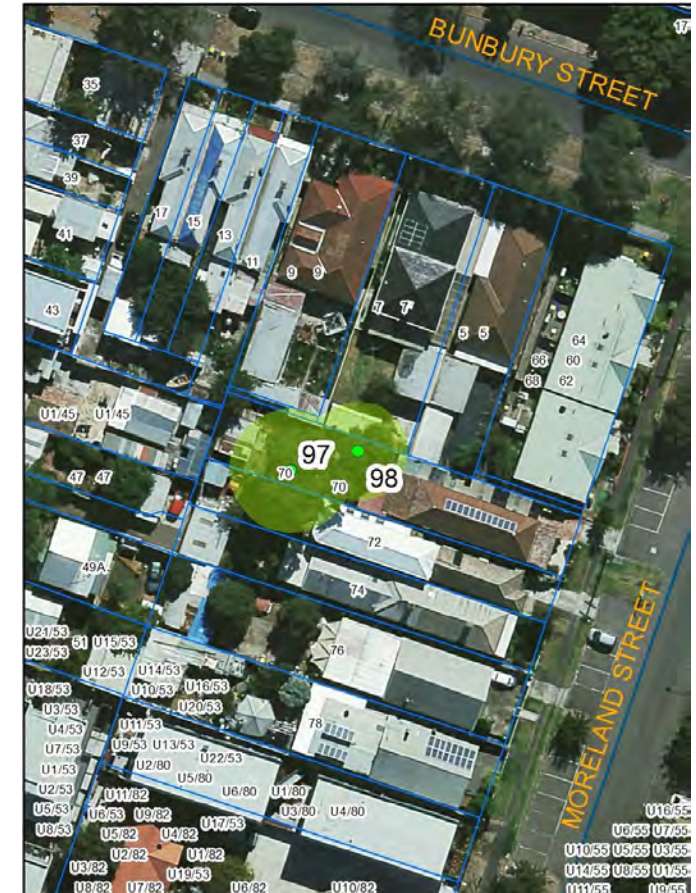
**Asset ID:** 101

**Failure Probability:** 3. Moderate

**Failure Size:** 3. 101-250mm

**Defects:** None

**Recommended Works:** Structural pruning

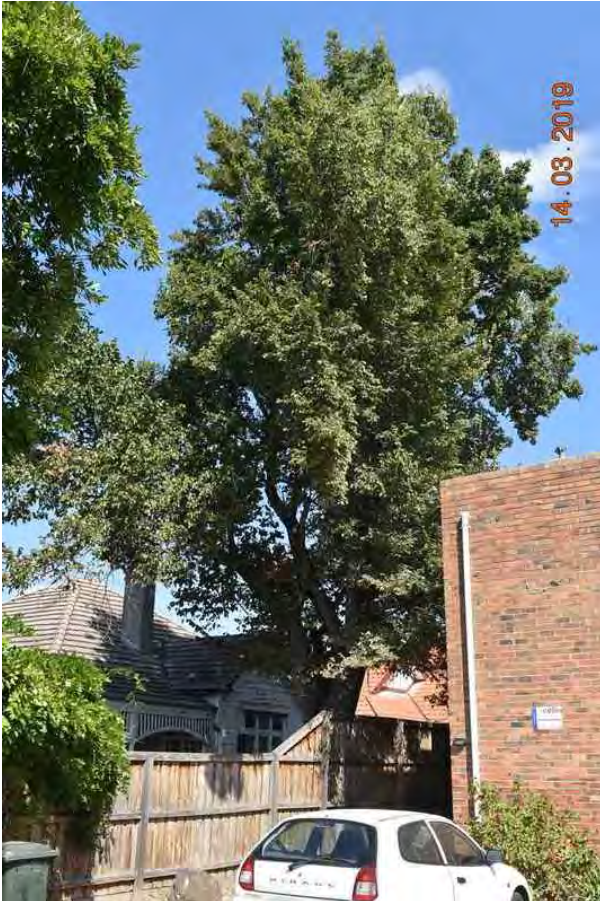
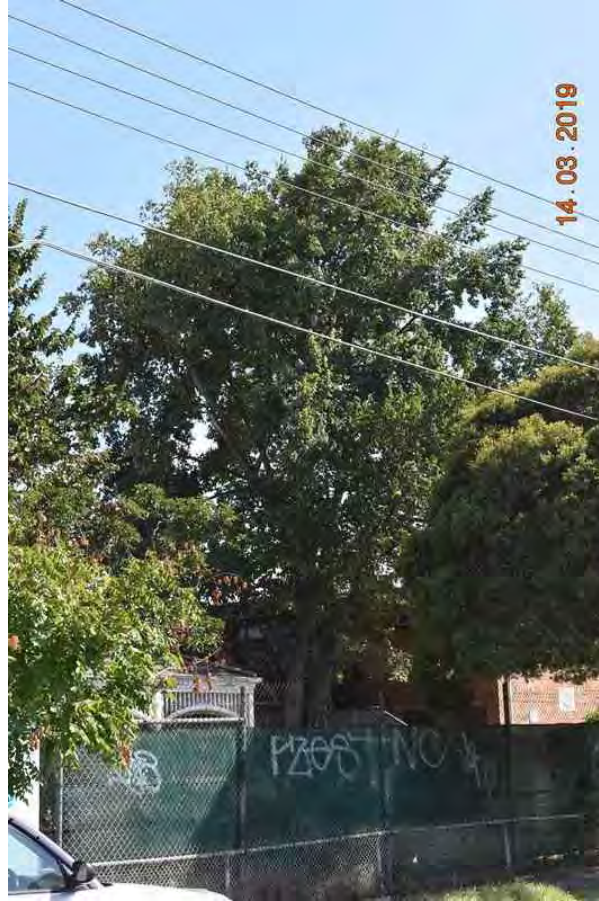
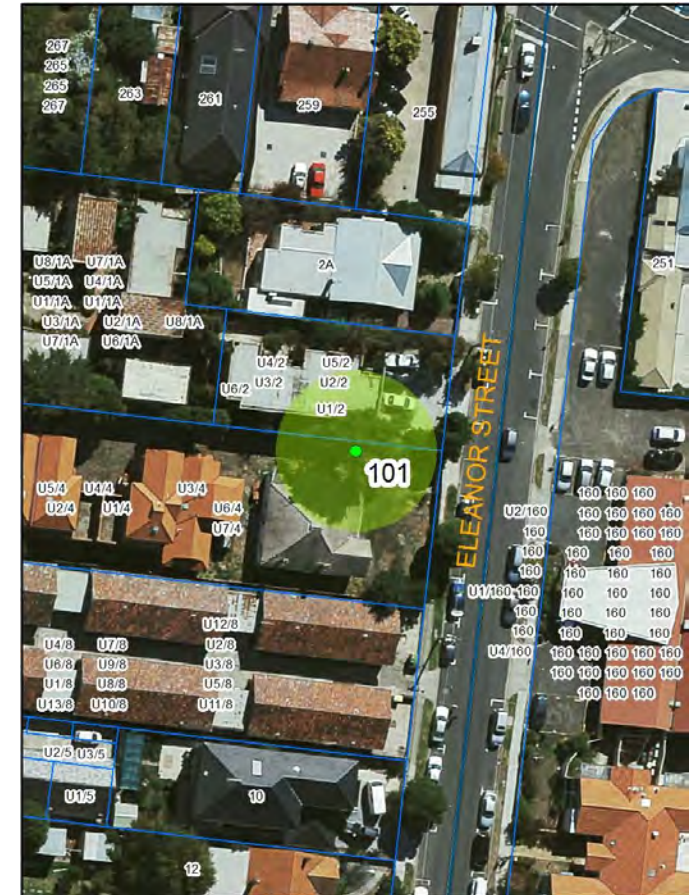
**Asset ID:** 104

**Failure Probability:** 3. Moderate

**Failure Size:** 3. 101-250mm

**Defects:** Codominant trunks, Other

**Recommended Works:** No works

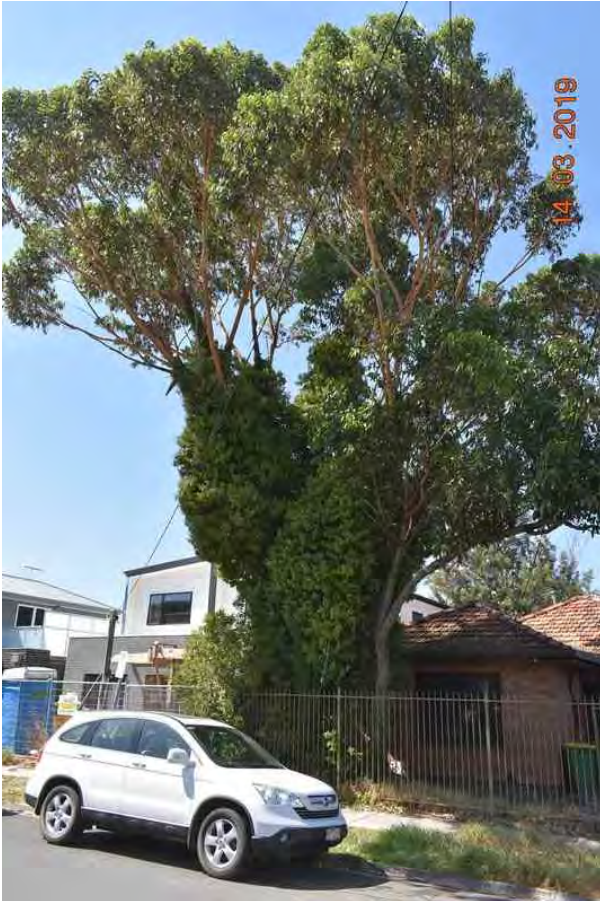
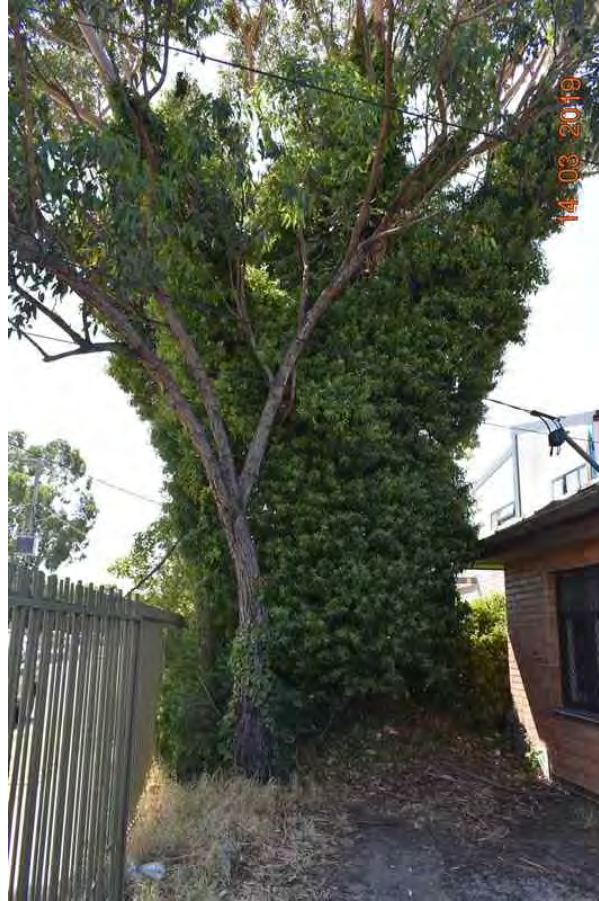
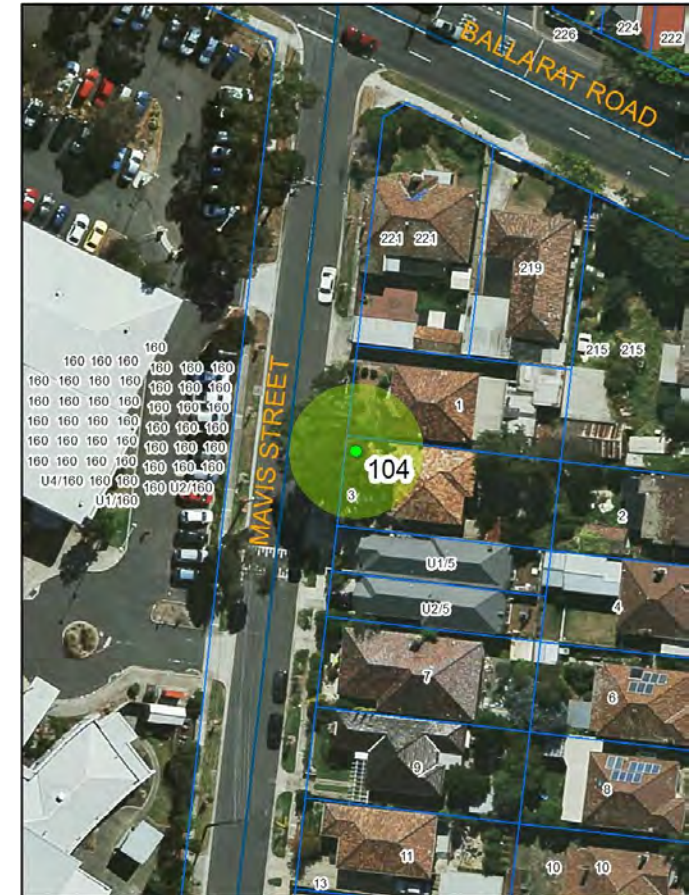
**Asset ID:** 105

**Failure Probability:** 3. Moderate

**Failure Size:** 3. 101-250mm

**Defects:** None

**Recommended Works:** No works

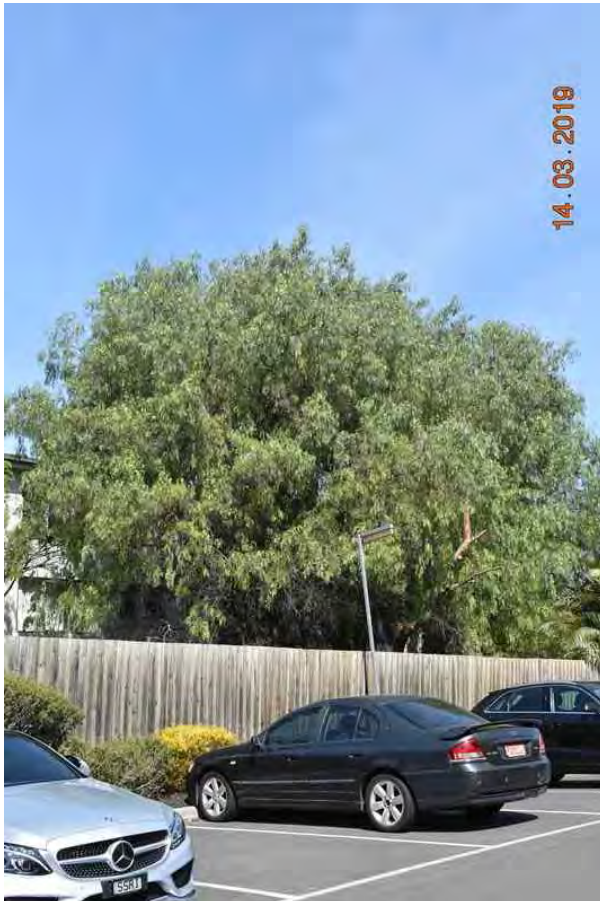
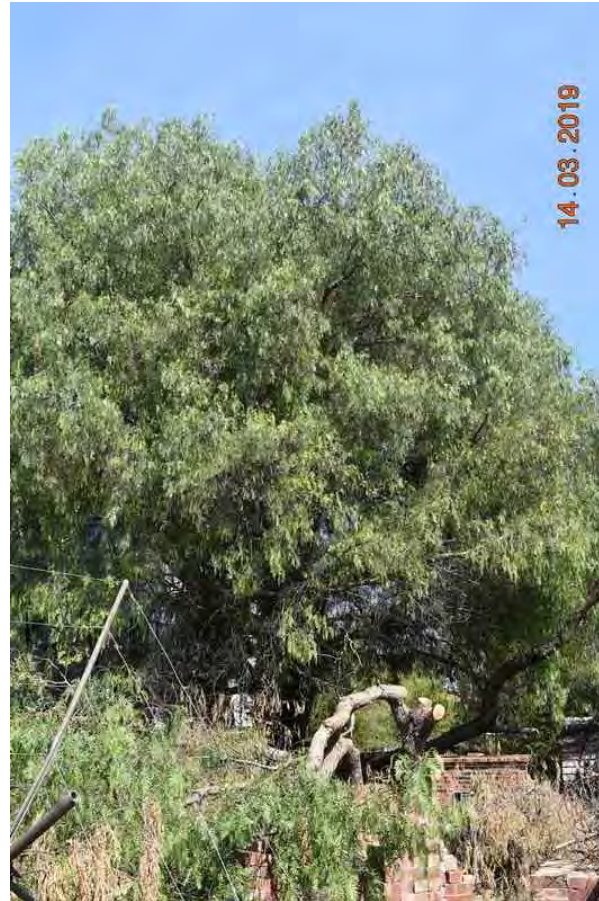
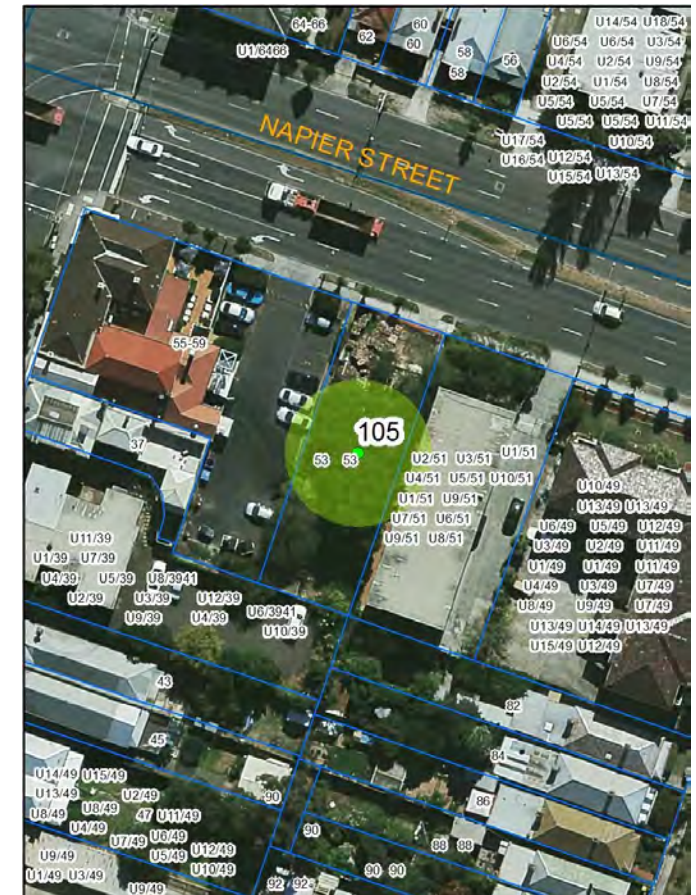
**Asset ID:** 106

**Approximate Age:** 61-80 years  
**ULE:** 21-40 years  
**Health:** Good  
**Structure:** Fair  
**Failure Probability:** 4. Low  
**Failure Size:** 3. 101-250mm  
**Target:** 4. Pedestrians, 3/day to 1/hr  
**Risk Score:** 1 in 50000000  
**Risk Category:** Very low  
**Significance Statement:** This tree does not warrant inclusion on the significant tree register

**Defects:** None  
**Recommended Works:** No works  
**Works Priority:** None  
**Comments:** Not big enough, couldn't get access, assessed from adjoining property and rear lane, dbh and srz estimated  
**Record Type:** Single Tree  
**No. of Trees:** 1

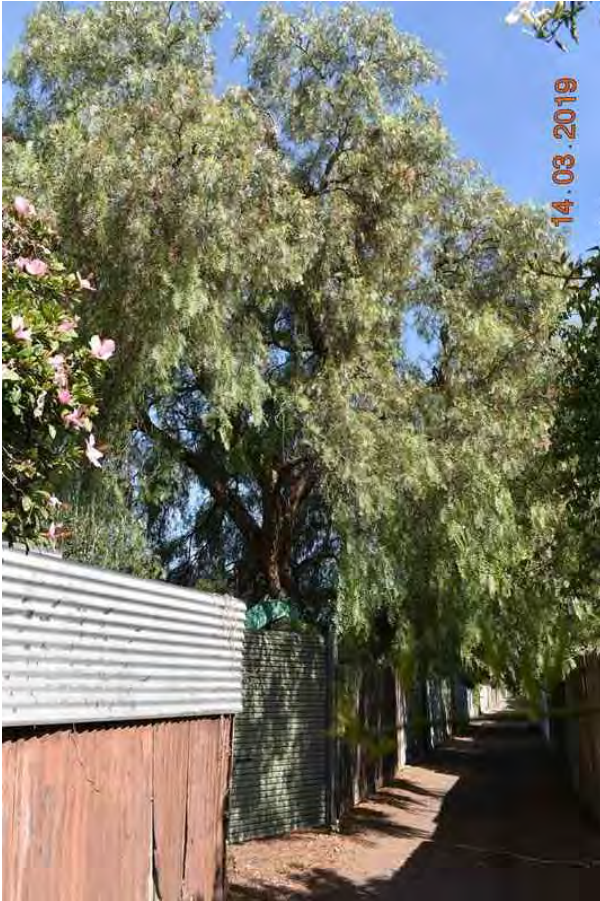
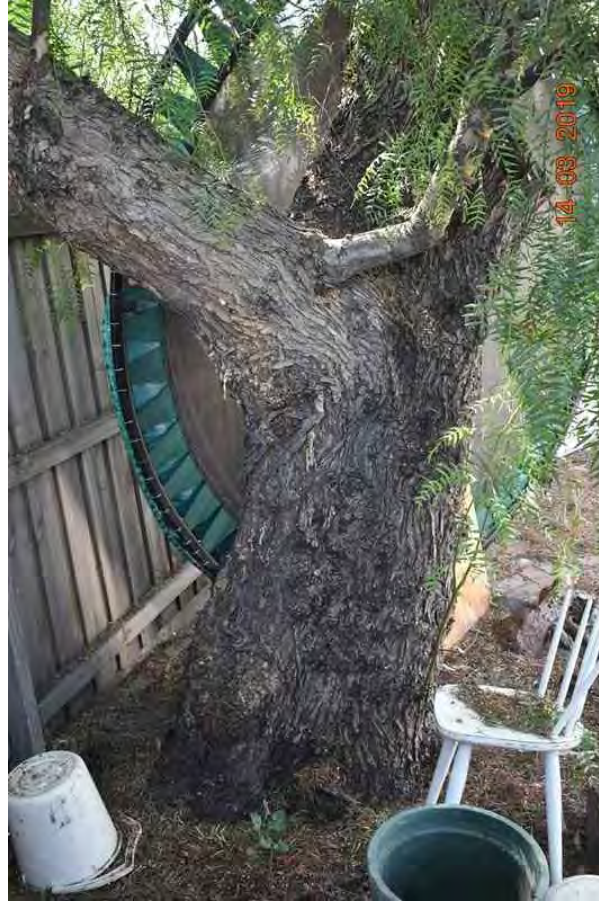
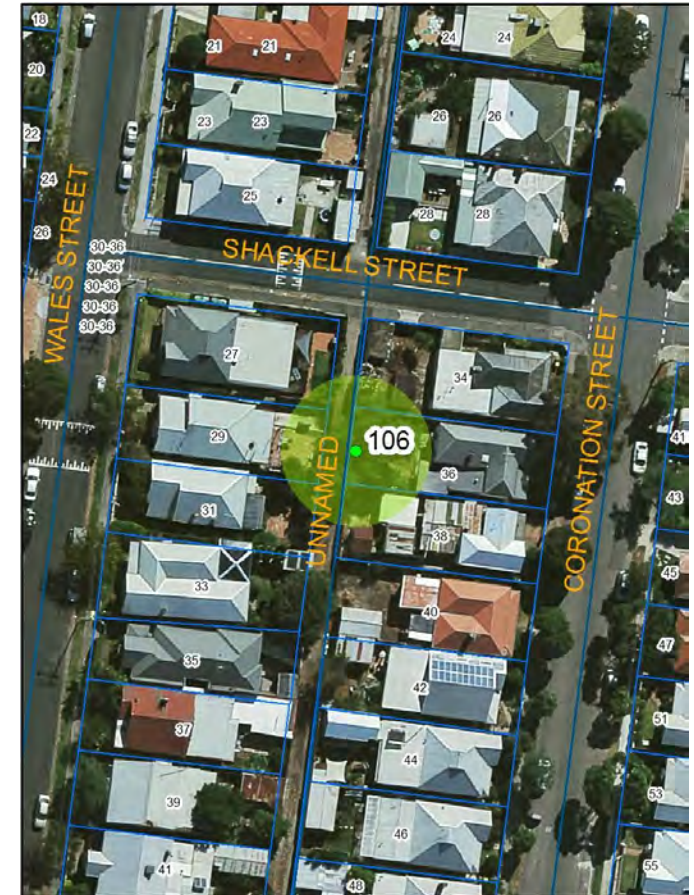
**Asset ID:** 107

**Failure Probability:** 3. Moderate

**Failure Size:** 3. 101-250mm

**Defects:** Canopy lopped, Trunk lopped, Codominant trunks

**Recommended Works:** Risk reduction pruning
