# Maribyrnong City Council Significant Tree Register 2019 Draft for Consultation

**Homewood Consulting Pty Ltd**

**Maribyrnong City Council**

December 2019

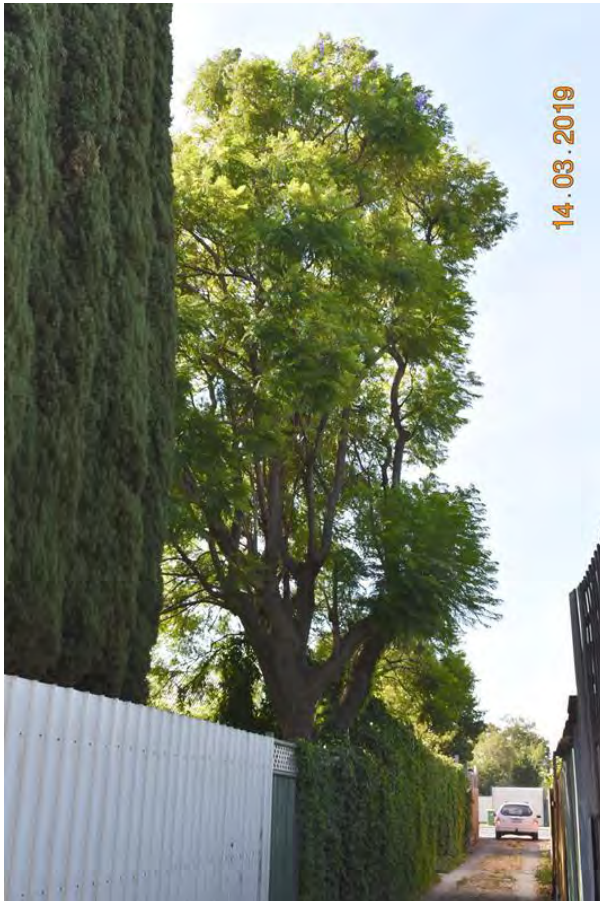
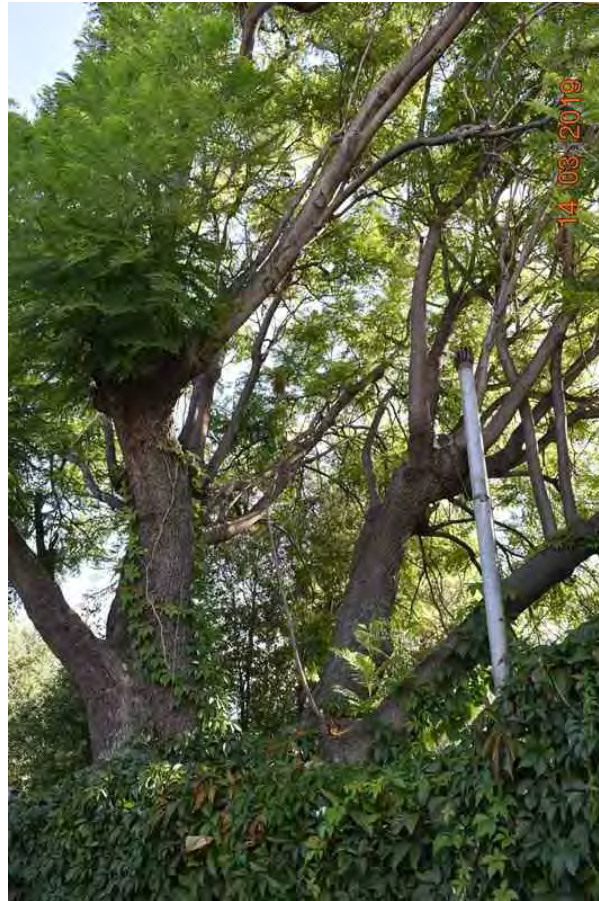
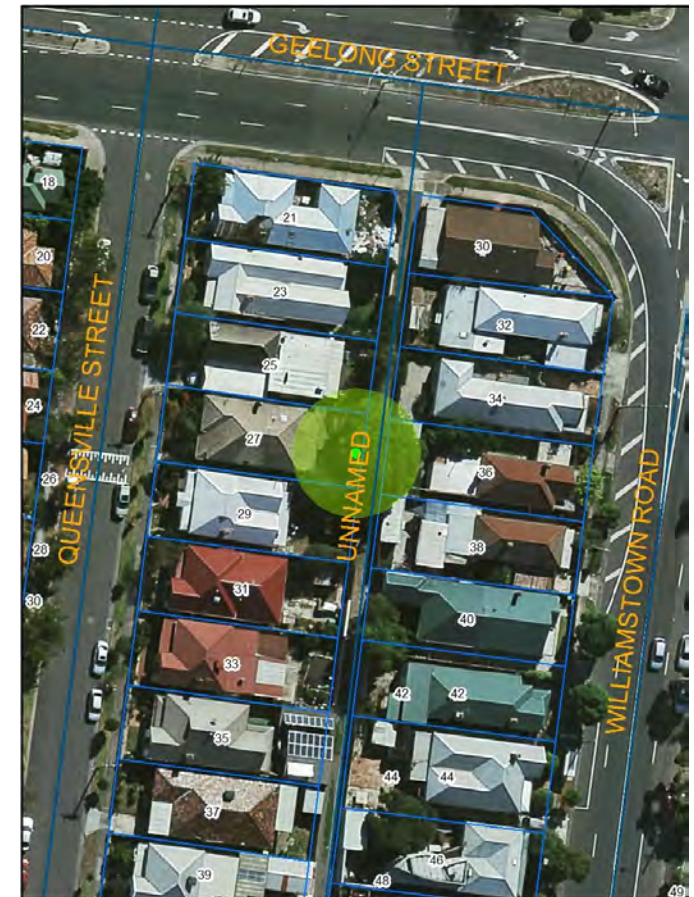
**Asset ID:** 112

**Failure Probability:** 3. Moderate

**Failure Size:** 3. 101-250mm

**Defects:** Trunk lopped, Canopy lopped, Included bark in trunk, Codominant trunks

**Recommended Works:** No works

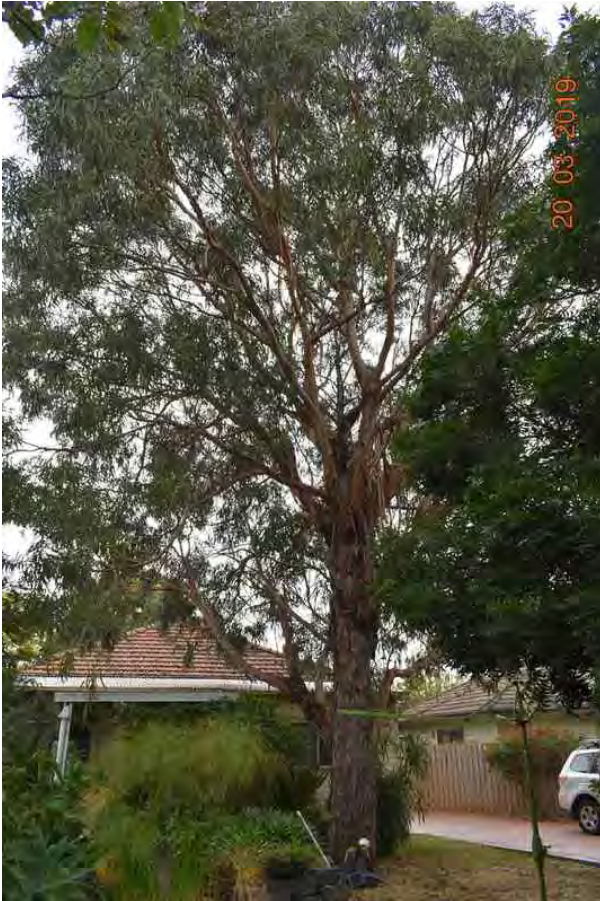
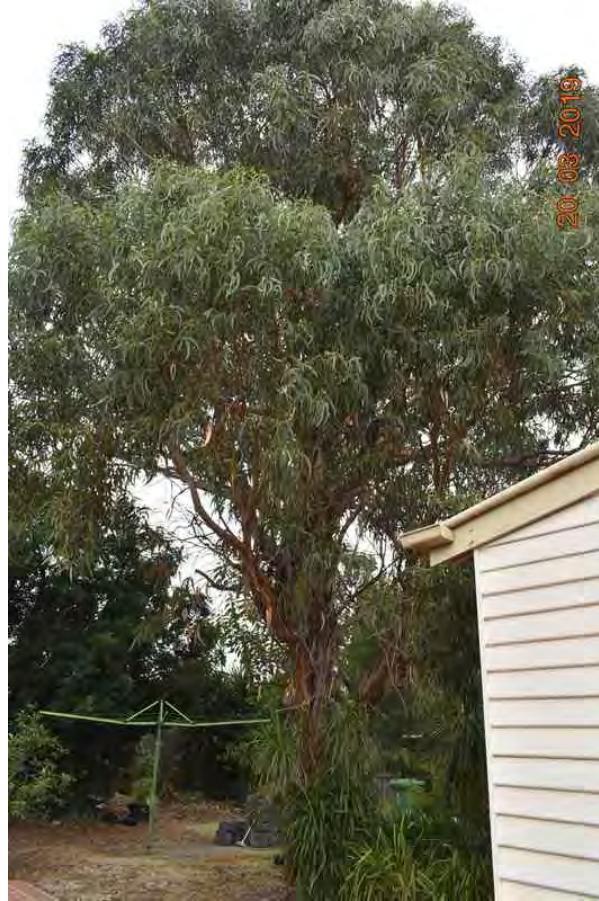
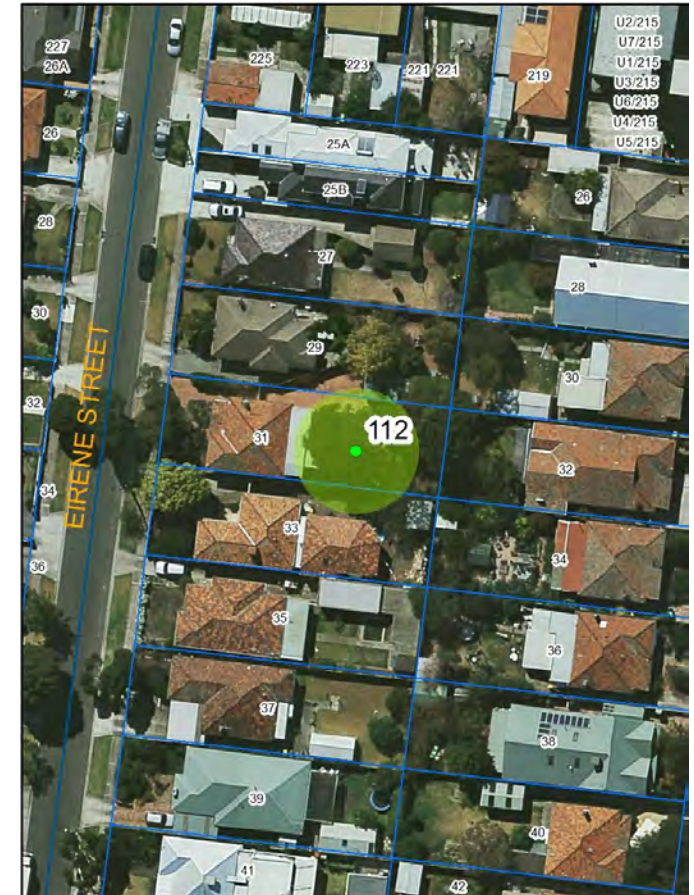
**Asset ID:** 113

**Failure Probability:** 3. Moderate

**Failure Size:** 3. 101-250mm

**Defects:** Codominant trunks

**Recommended Works:** No works

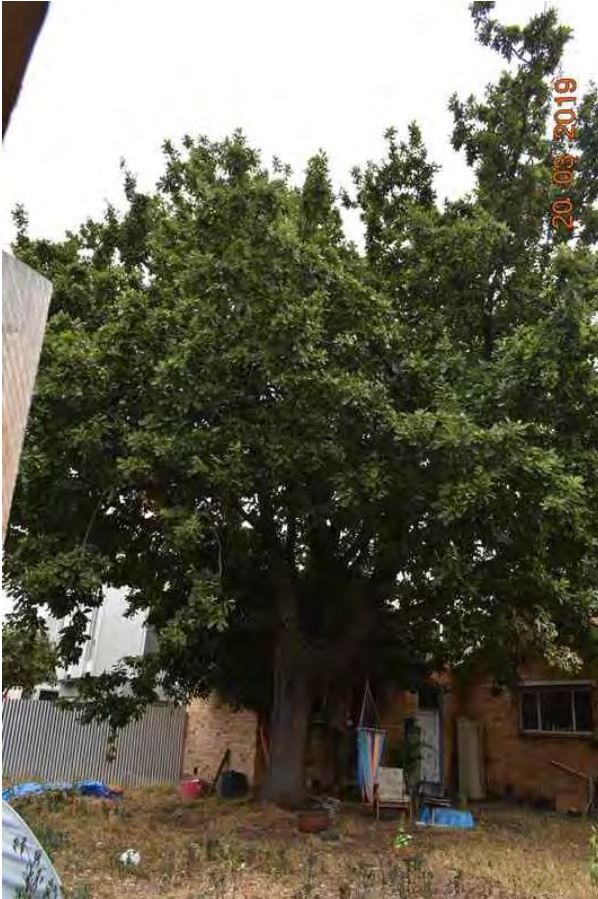
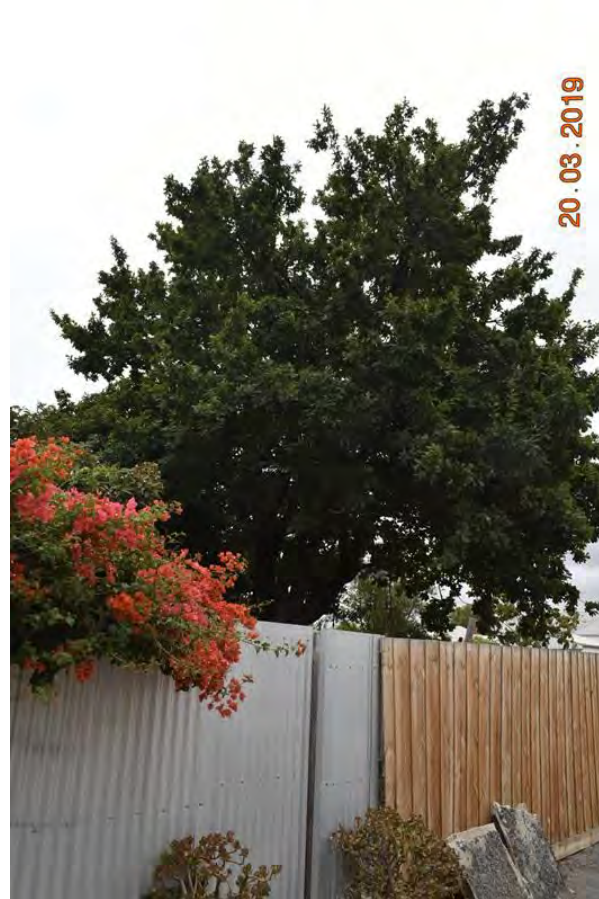
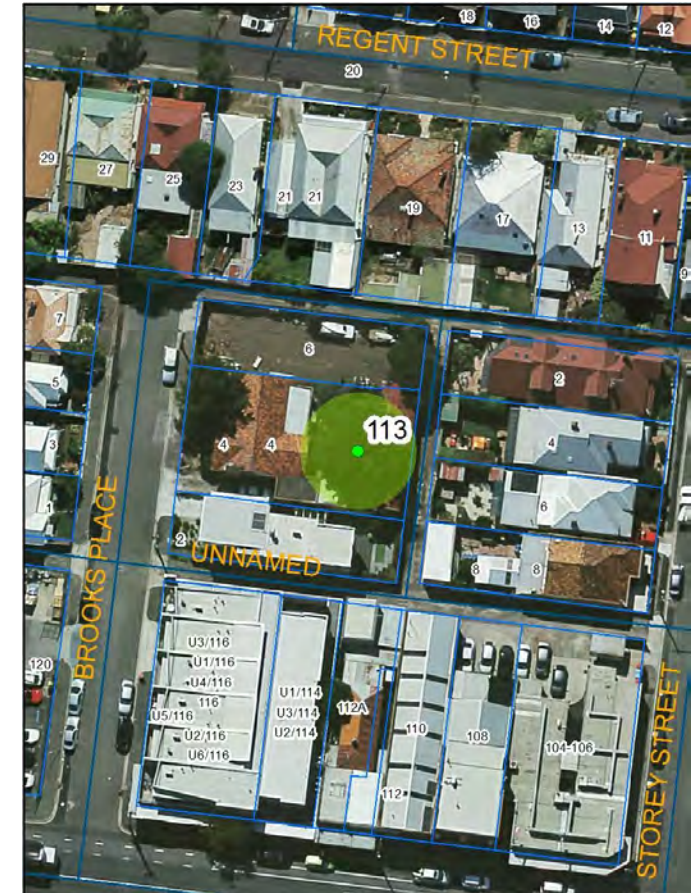
**Asset ID:** 118

**Failure Probability:** 3. Moderate

**Failure Size:** 3. 101-250mm

**Defects:** Canopy lopped, Trunk lopped, Codominant trunks

**Recommended Works:** No works

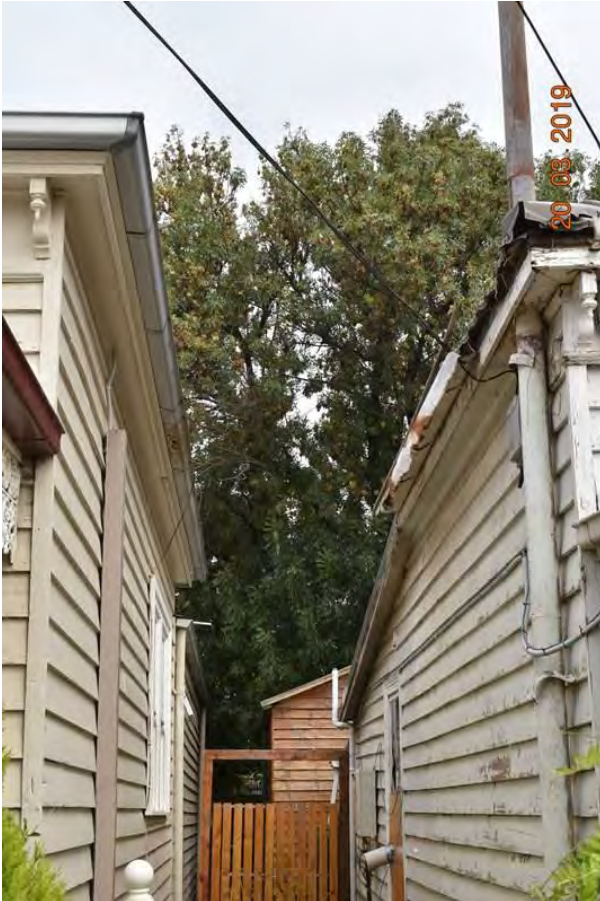
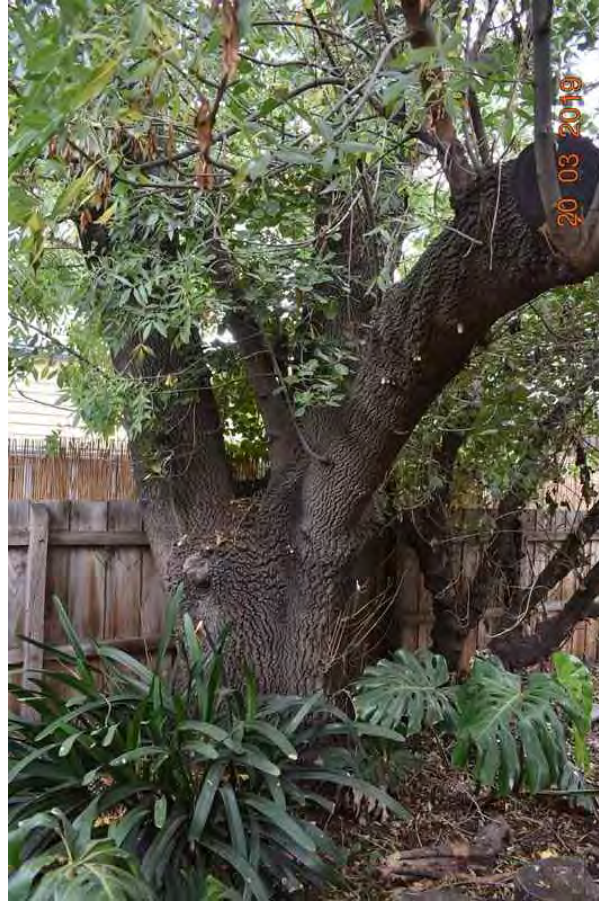
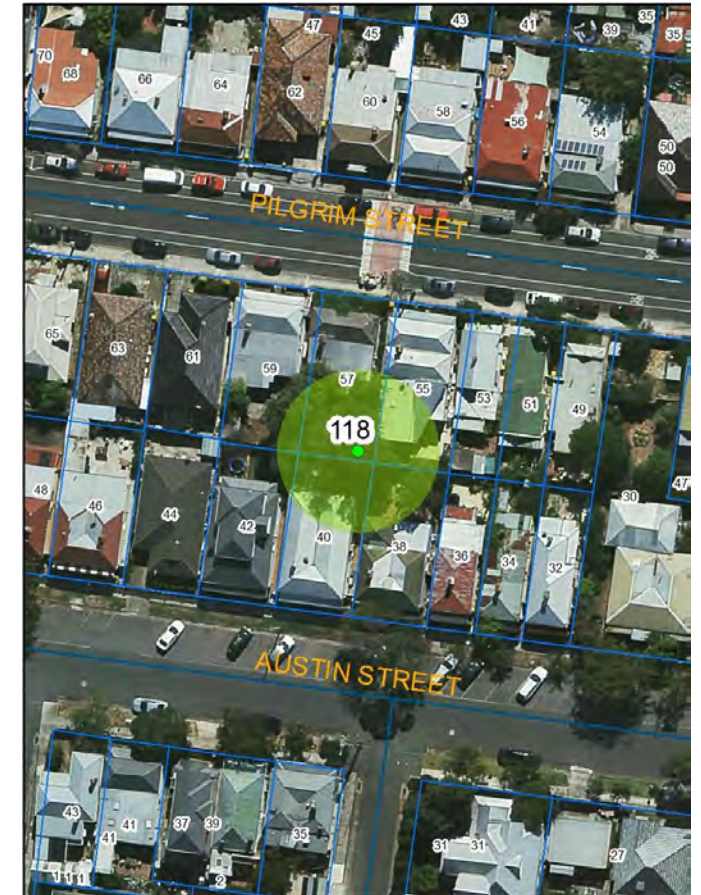
**Asset ID:** 123

**Approximate Age:** 81-100 years  
**ULE:** 11-20 years  
**Health:** Good  
**Structure:** Fair  
**Failure Probability:** 4. Low  
**Failure Size:** 3. 101-250mm  
**Target:** 3. Pedestrians, 2-7/hr  
**Risk Score:** 1 in 5000000  
**Risk Category:** Low  
**Significance Statement:**

**Defects:** None  
**Recommended Works:** No works  
**Works Priority:** None  
**Comments:** Not big enough, damaging fence and close to house  
**Record Type:** Single Tree  
**No. of Trees:** 1

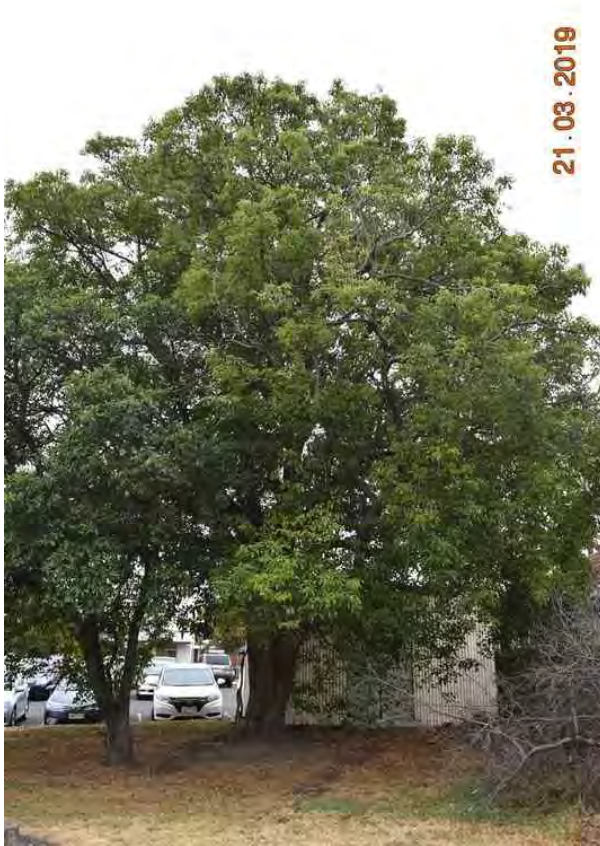
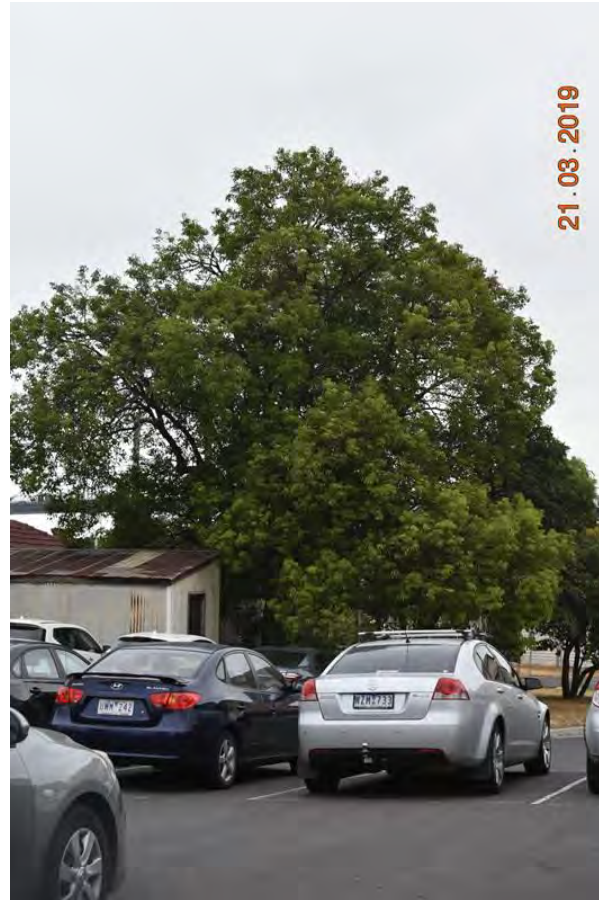
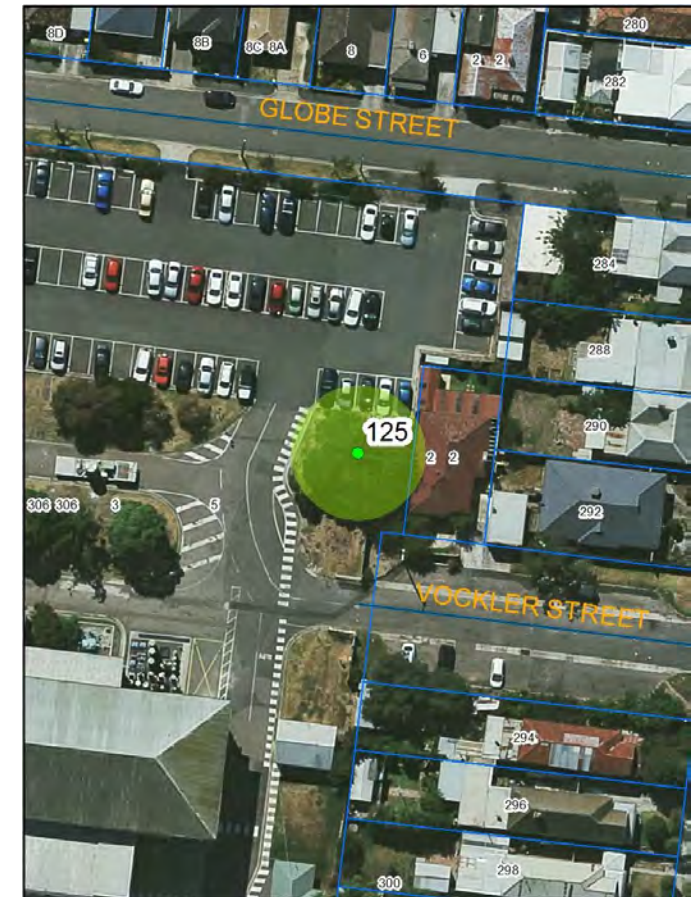
**Asset ID:** 125

**Failure Probability:** 4. Low

**Defects:** Included bark in trunk, Codominant trunks

**Recommended Works:** No works

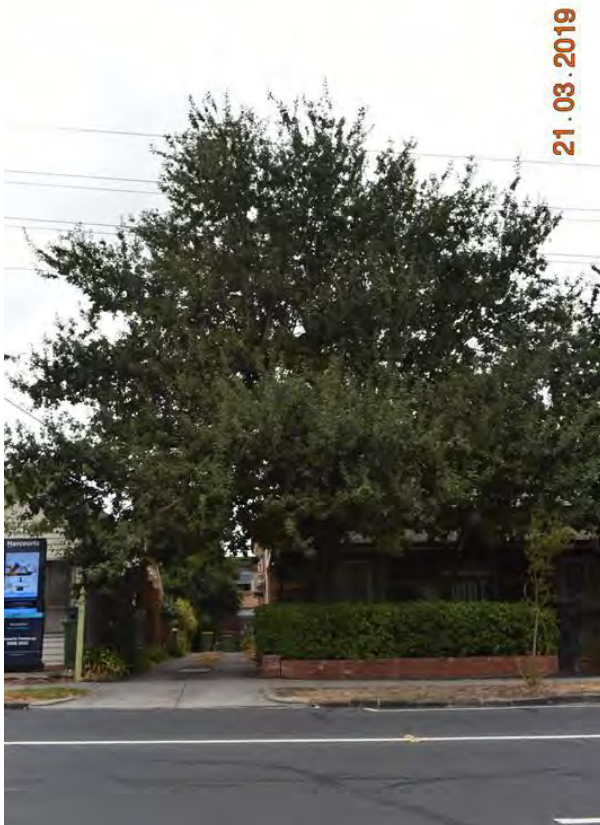
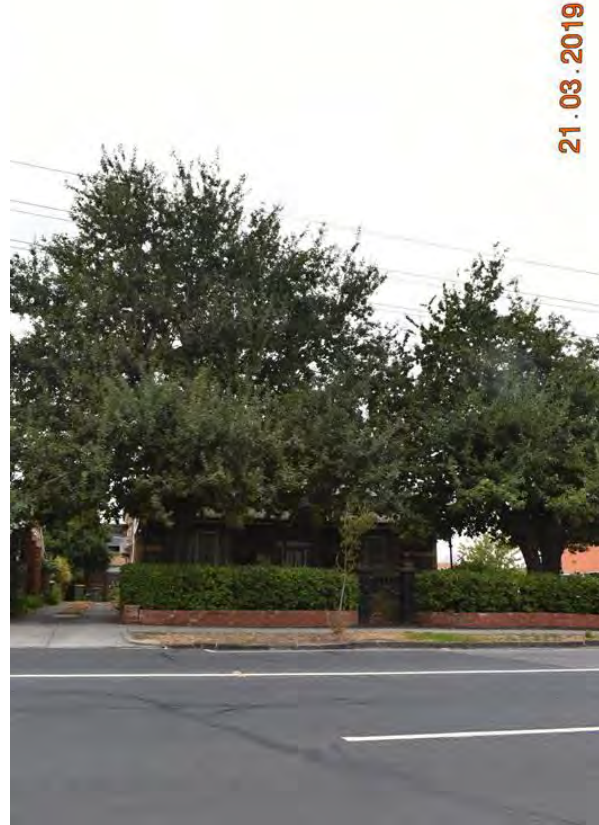
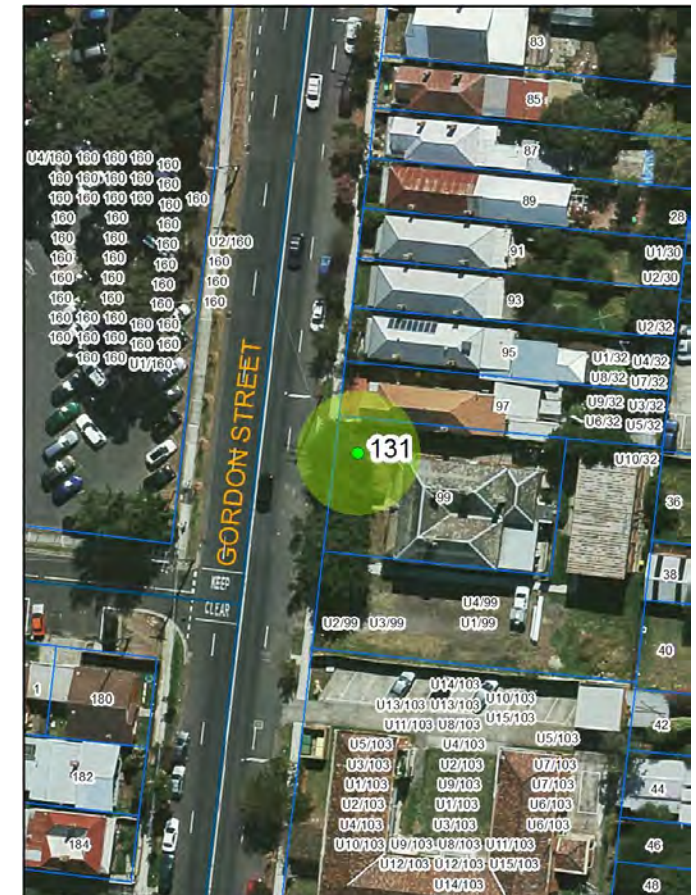
**Asset ID:** 131

**Failure Probability:** 3. Moderate

**Defects:** Canopy pruned for power line clearance, Canopy lopped, Trunk lopped, Codominant  
**Recommended Works:** No works

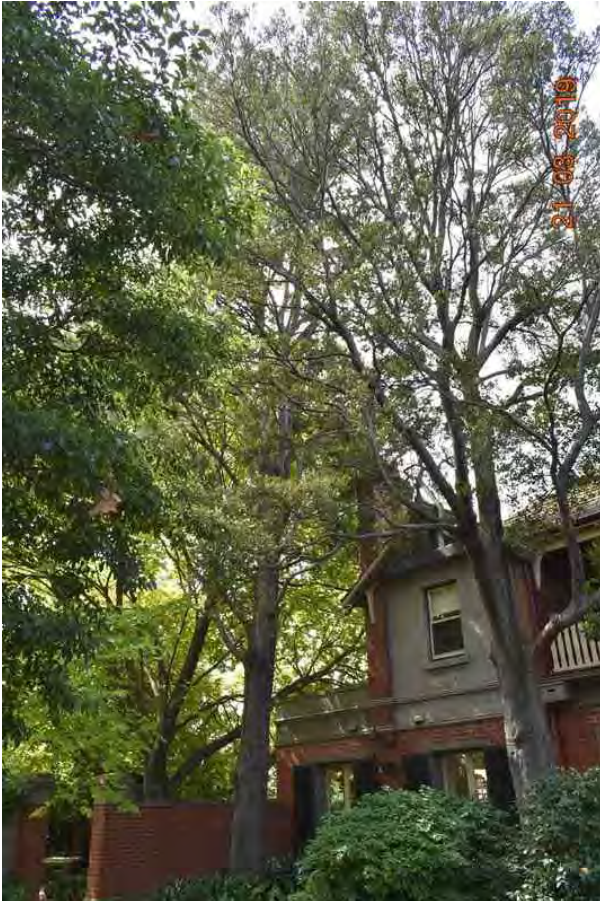
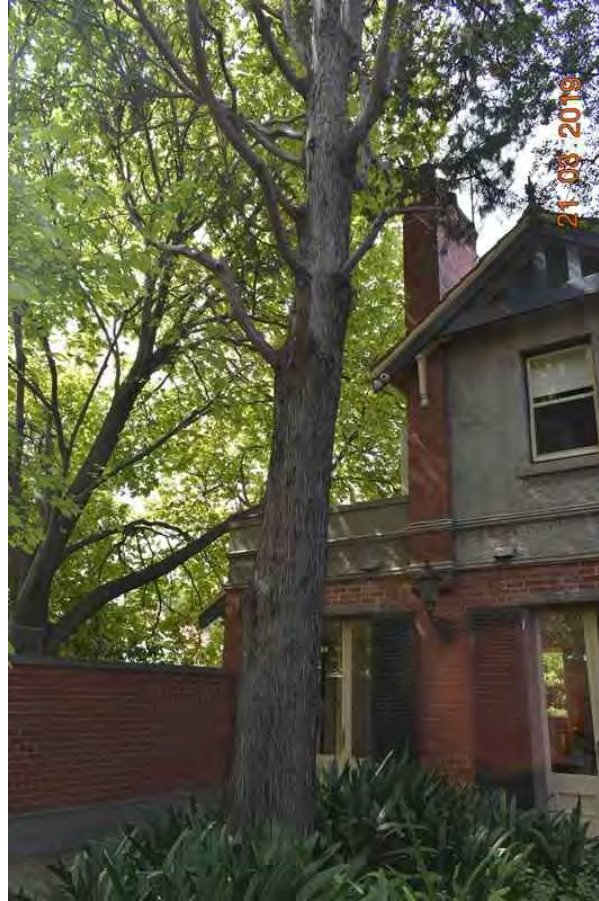
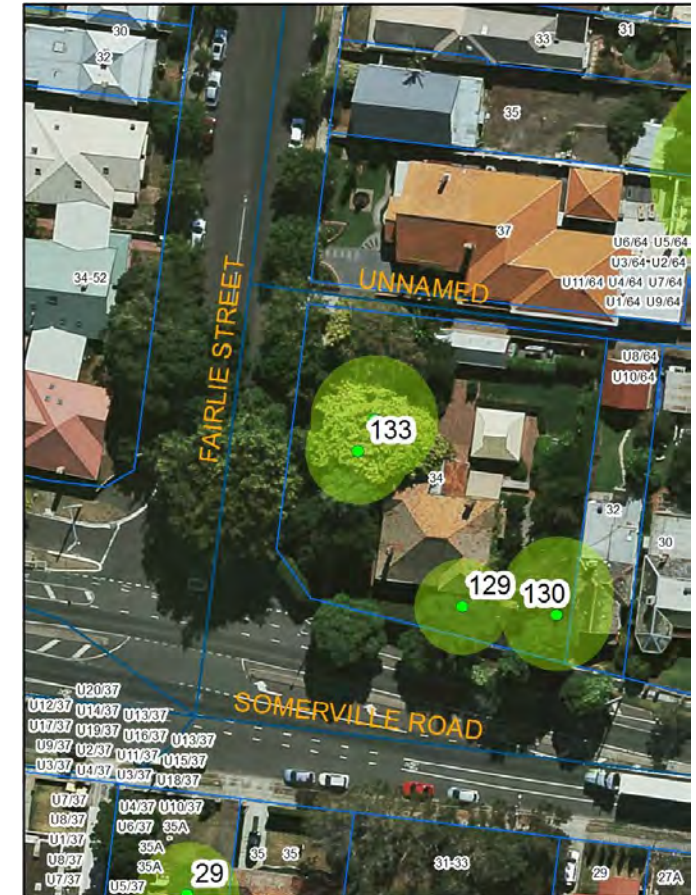
**Asset ID:** 133

**Failure Probability:** 3. Moderate

**Defects:** Codominant stems in canopy

**Recommended Works:** No works

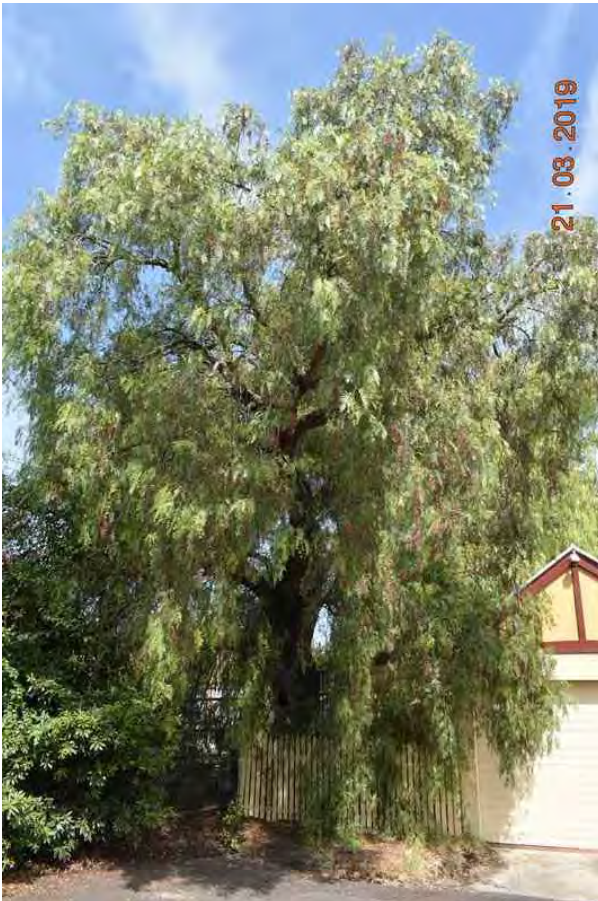
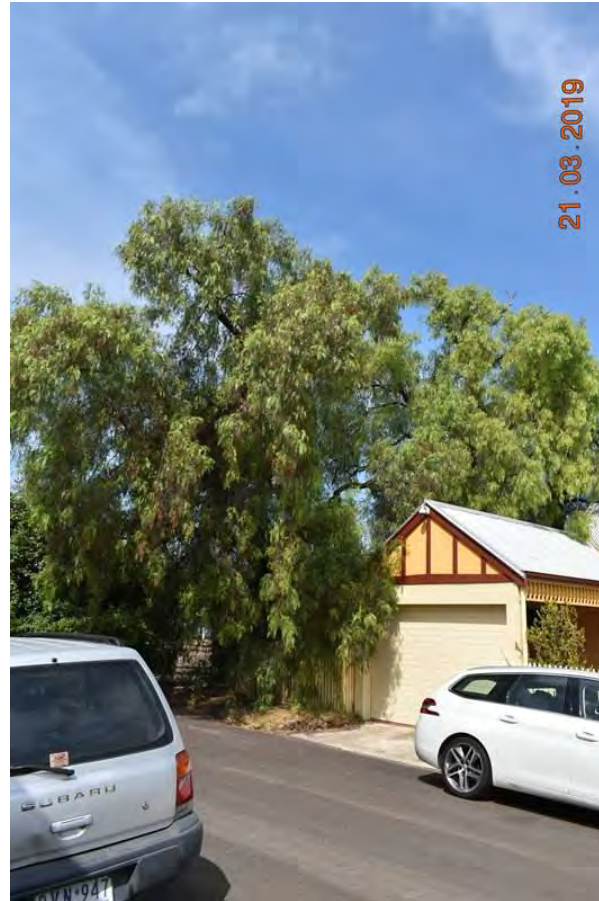
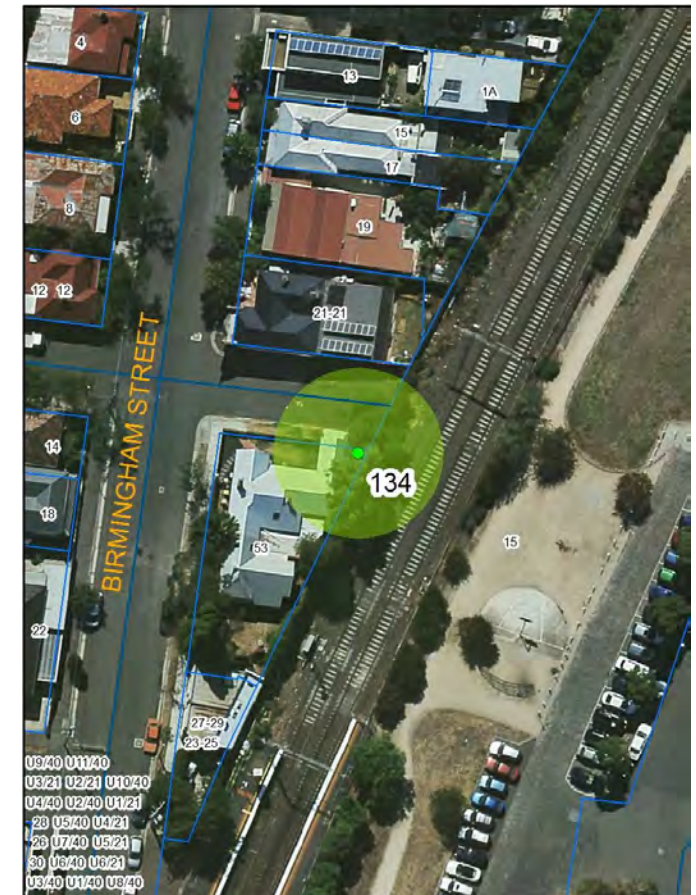
**Asset ID:** 134

**Approximate Age:** 61-80 years  
**ULE:** 11-20 years  
**Health:** Good  
**Structure:** Fair  
**Failure Probability:** 3. Moderate  
**Failure Size:** 4. 26-100mm  
**Target:** 4. Pedestrians, 3/day to 1/hr  
**Risk Score:** 1 in 50000000  
**Risk Category:** Very low  
**Significance Statement:** This tree does not warrant inclusion on the significant tree register.

**Defects:** Heavy decay in trunk, Cavity in trunk  
**Recommended Works:** No works  
**Works Priority:** None  
**Comments:** Does not meet criteria  
**Record Type:** Multiple Trees  
**No. of Trees:** 2

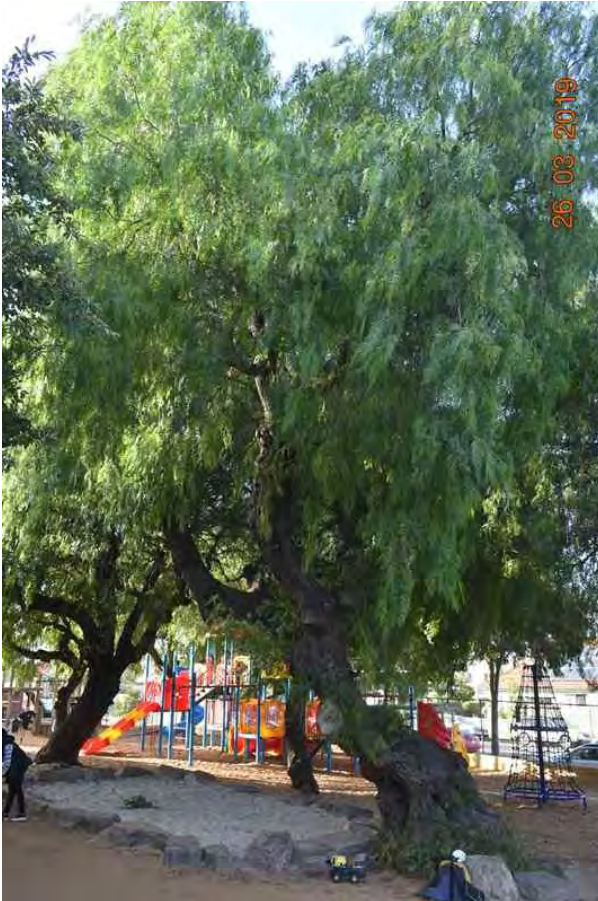
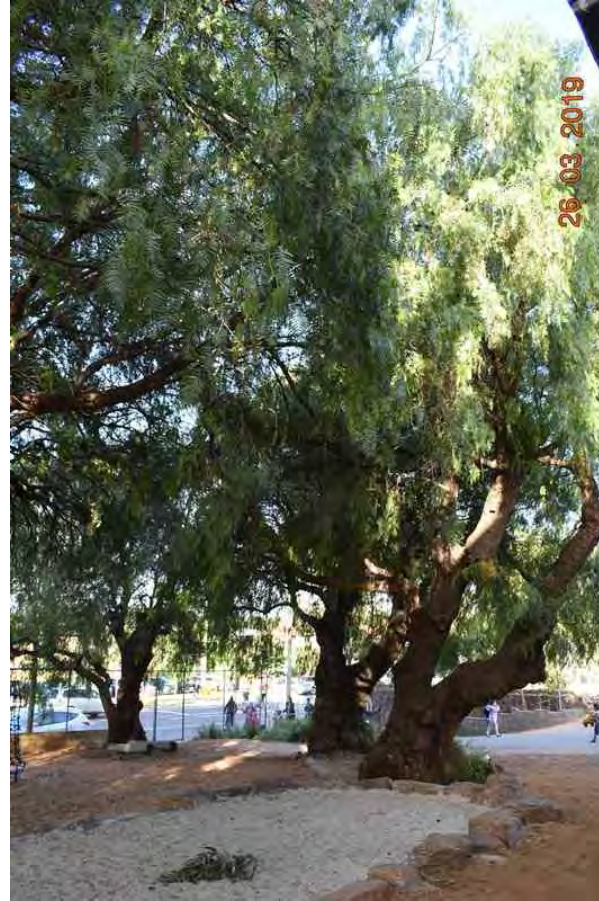
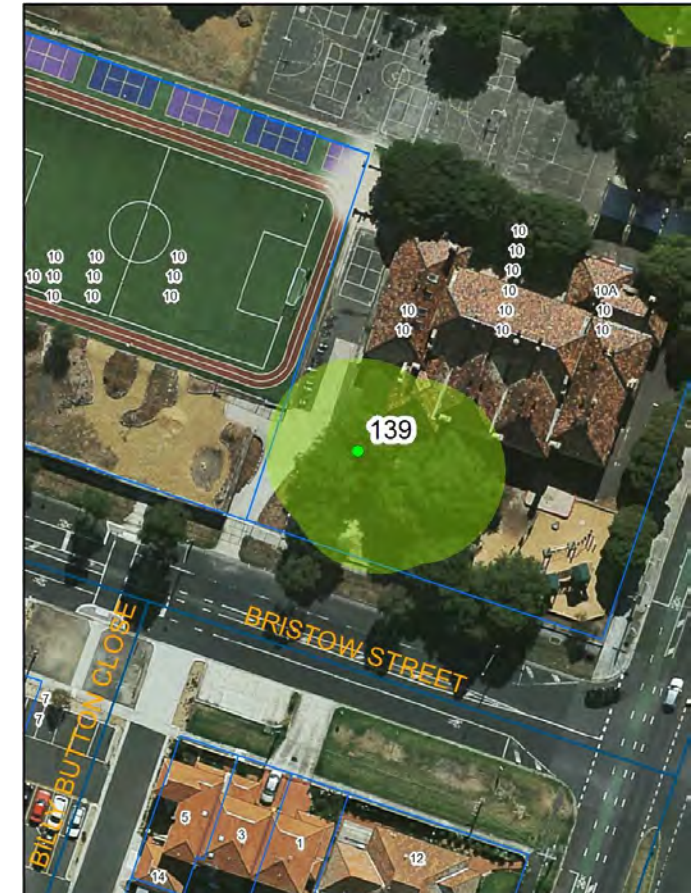
**Asset ID:** 139

**Approximate Age:** 100+ years  
**ULE:** 21-40 years  
**Health:** Good  
**Structure:** Fair  
**Failure Probability:** 4. Low  
**Failure Size:** 3. 101-250mm  
**Target:** 2. Pedestrians, 8-72/hr  
**Risk Score:** 1 in 500000  
**Risk Category:** Moderate  
**Significance Statement:** This tree does not warrant inclusion on the significant tree register

**Defects:** Canopy lopped  
**Recommended Works:** No works  
**Works Priority:** None  
**Comments:** Does not meet criteria  
**Record Type:** Multiple Trees  
**No. of Trees:** 3

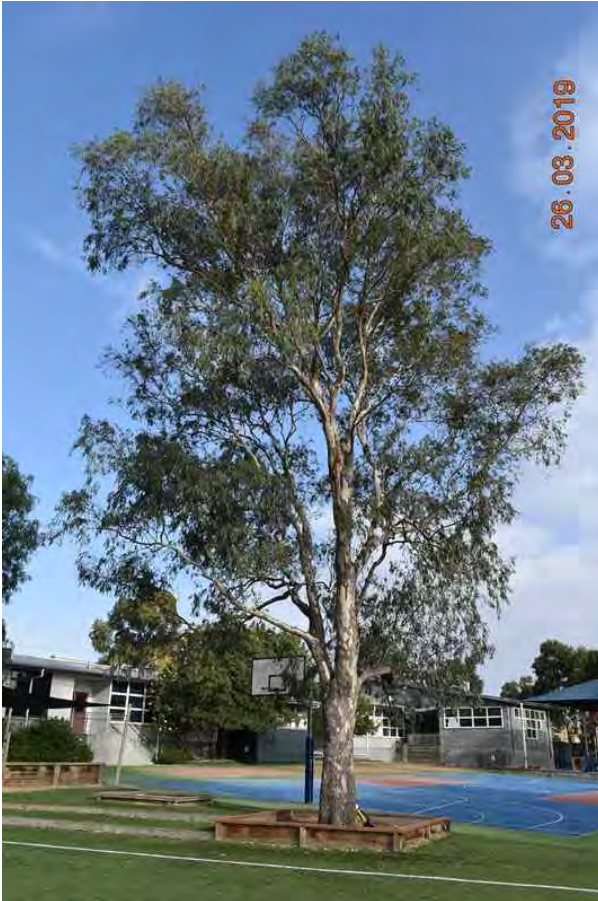
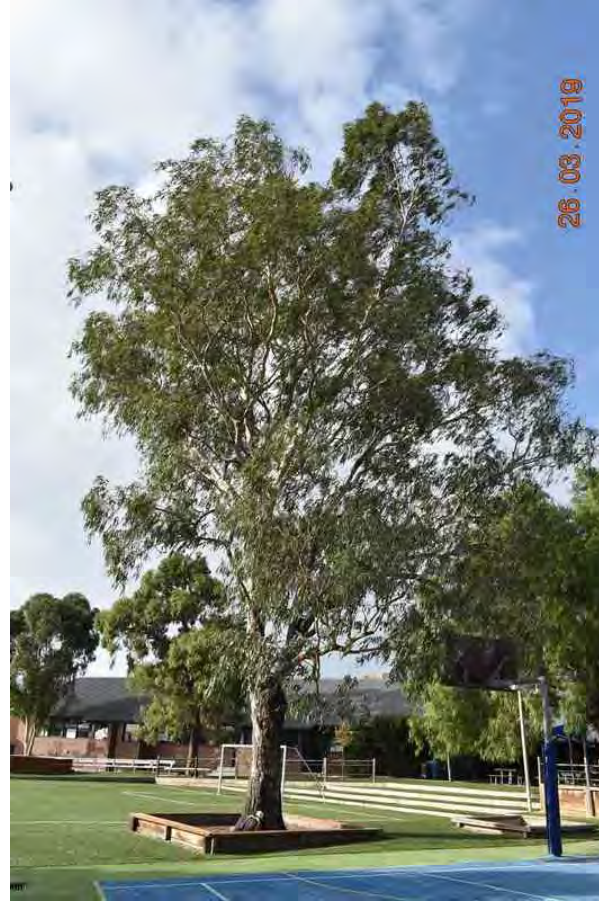
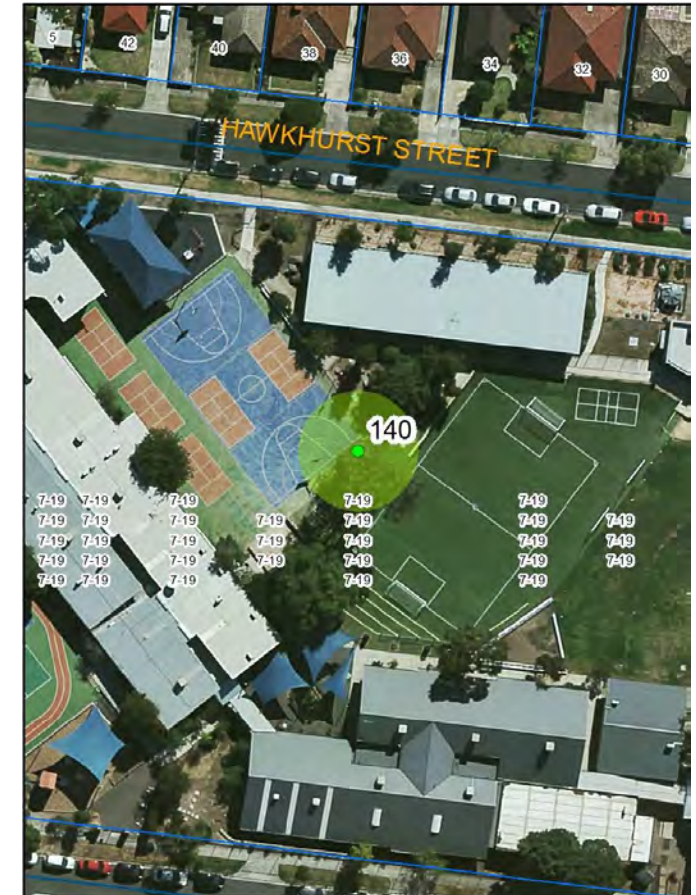
**Asset ID:** 140

**Failure Probability:** 4. Low

**Defects:** Included bark in trunk, Codominant trunks

**Recommended Works:** No works

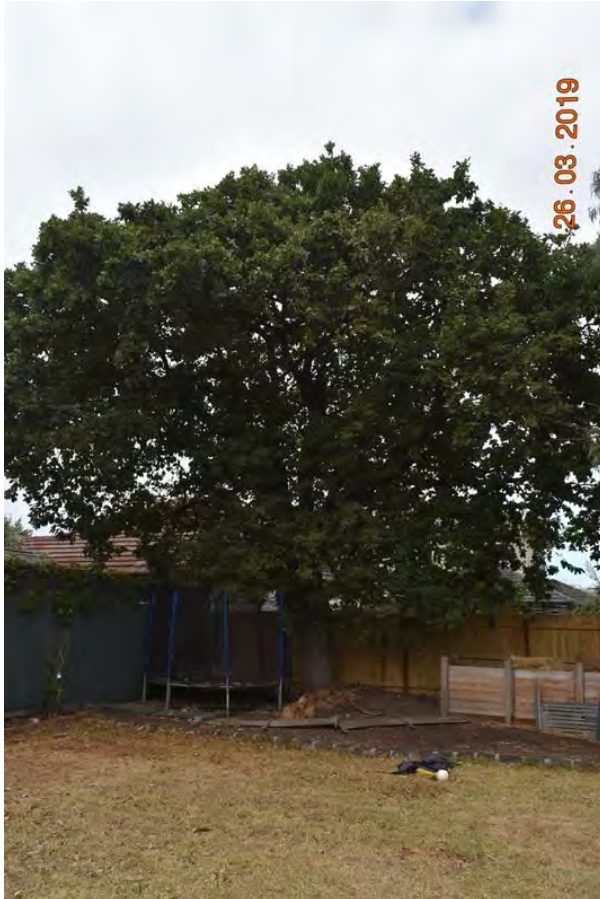
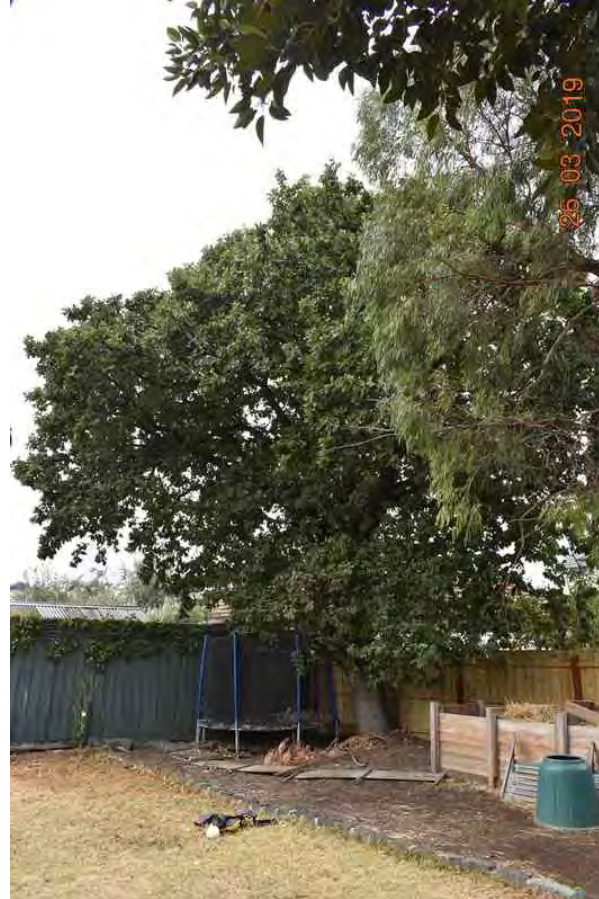
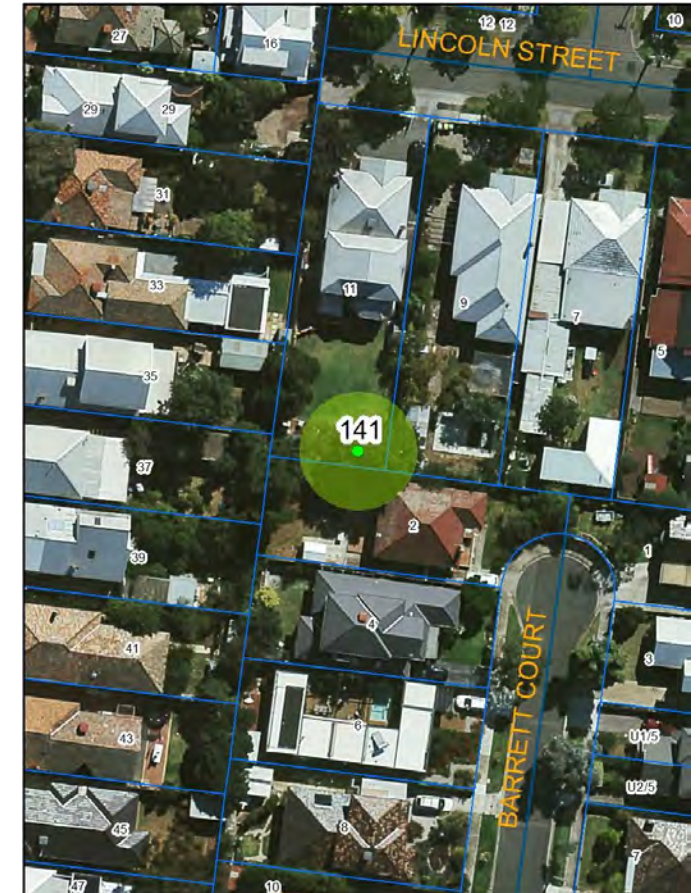
**Asset ID:** 141

**Failure Probability:** 3. Moderate

**Defects:** Decay in trunk, Mechanical damage to roots, Canopy lopped, Codominant trunks  
**Recommended Works:** No works

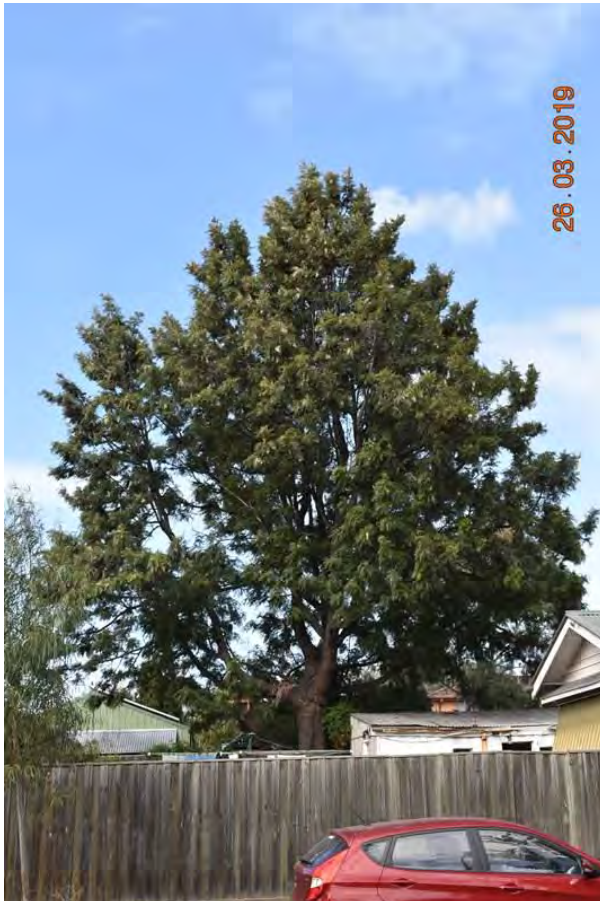
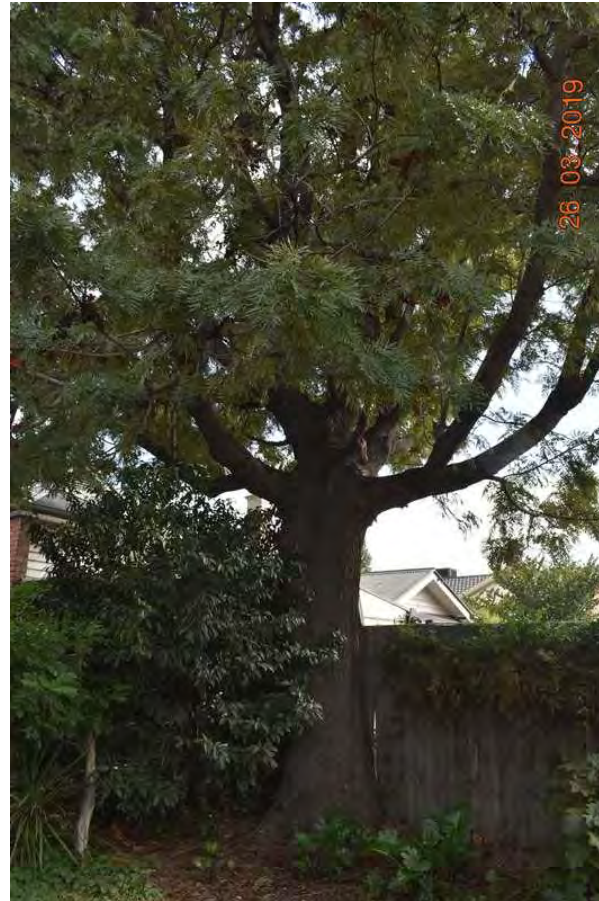
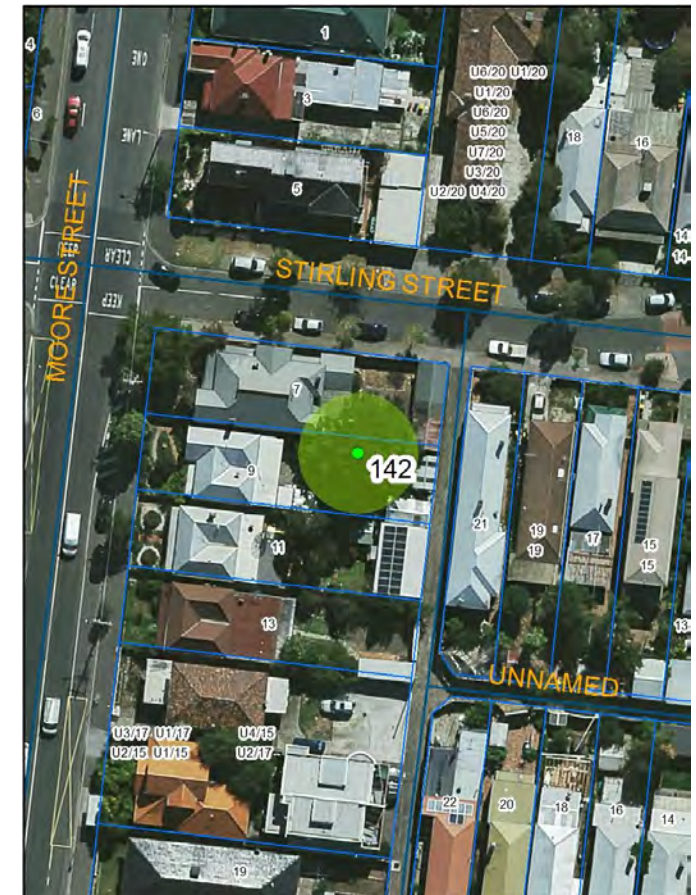
**Asset ID:** 142

**Failure Probability:** 3. Moderate

**Defects:** Canopy lopped, Codominant trunks, Canopy wound from previous failure  
**Recommended Works:** No works

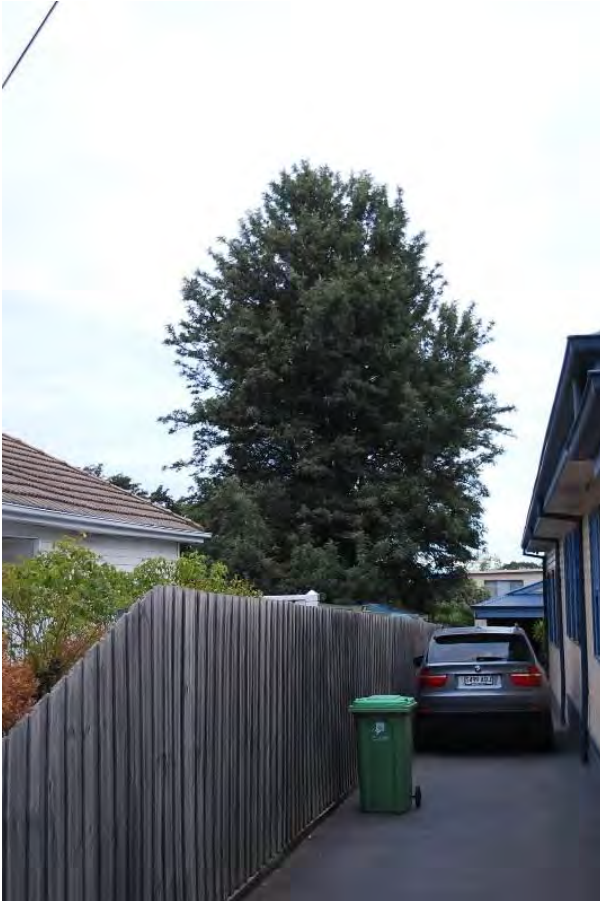
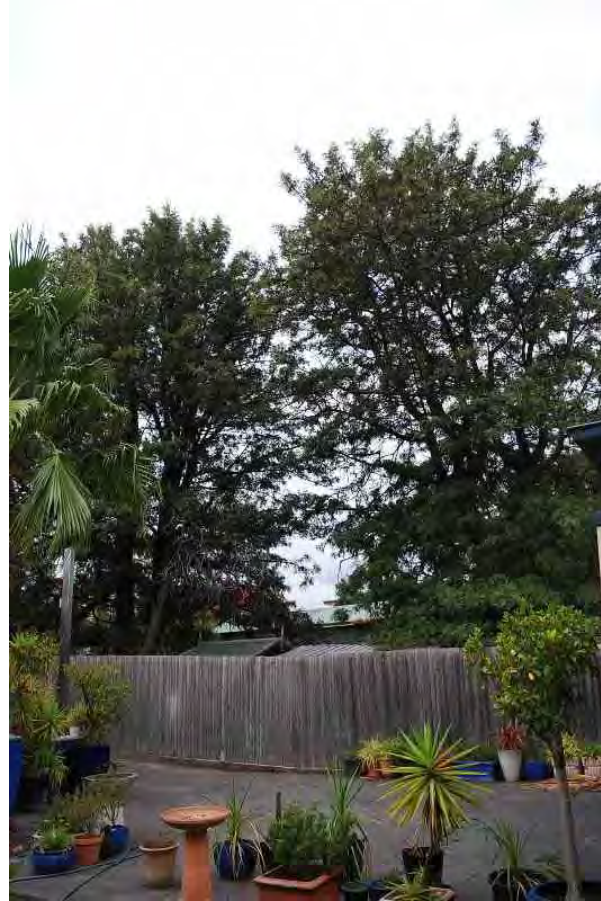
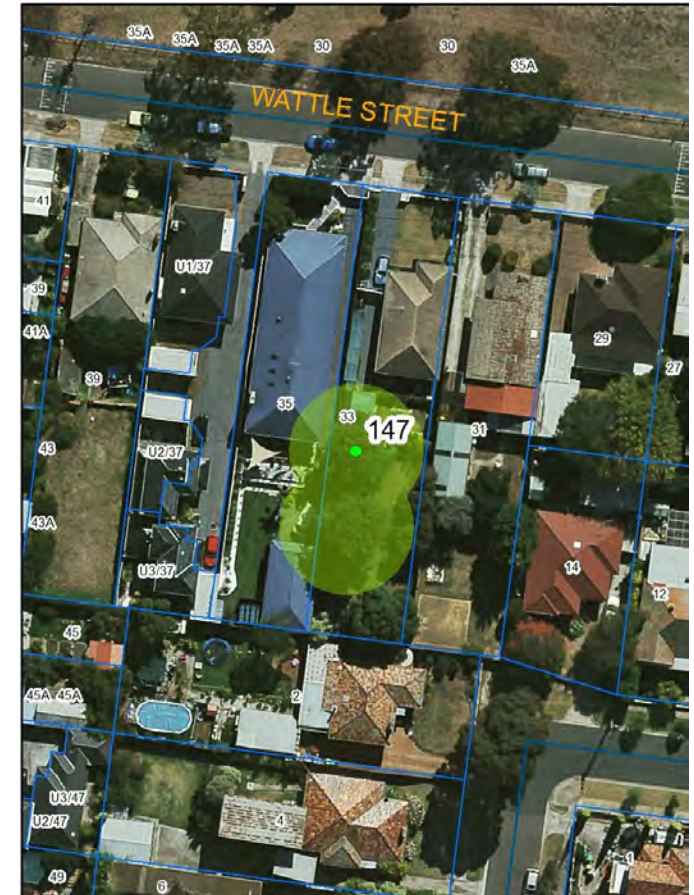
**Asset ID:** 147

**Failure Probability:** 2. High

**Defects:** Codominant trunks, Active split

**Recommended Works:** Structural pruning
