# Maribyrnong City Council Significant Tree Register 2019 Draft for Consultation

**Homewood Consulting Pty Ltd**

**Maribyrnong City Council**

December 2019

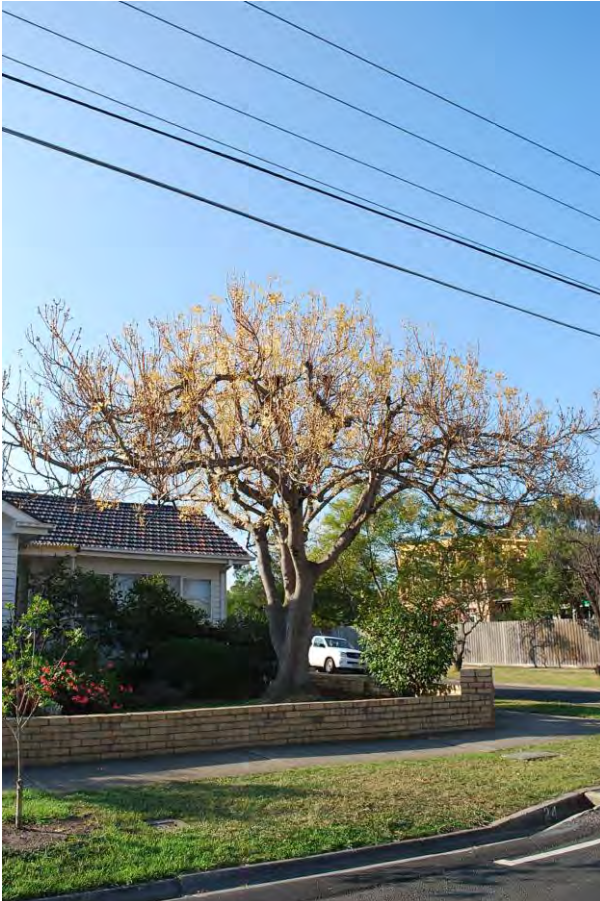
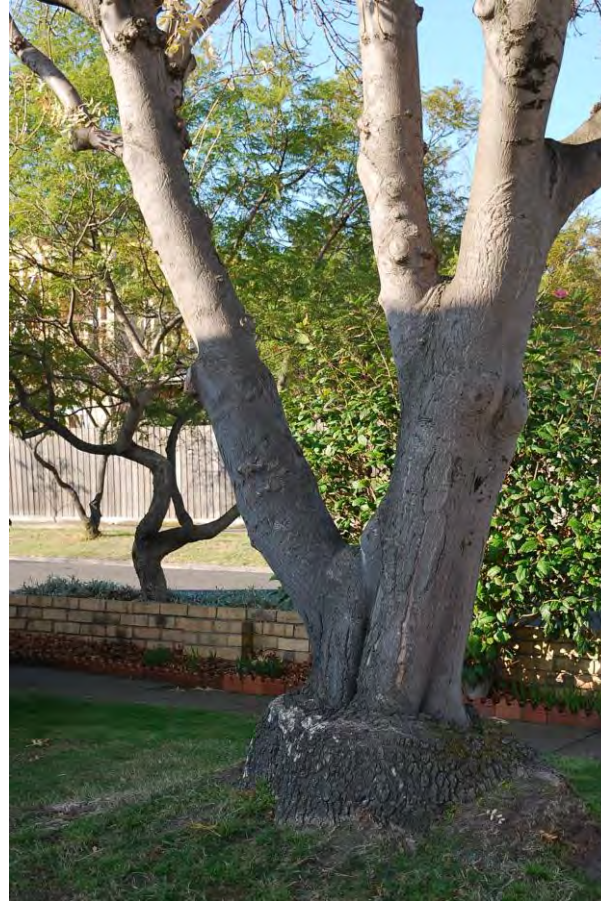
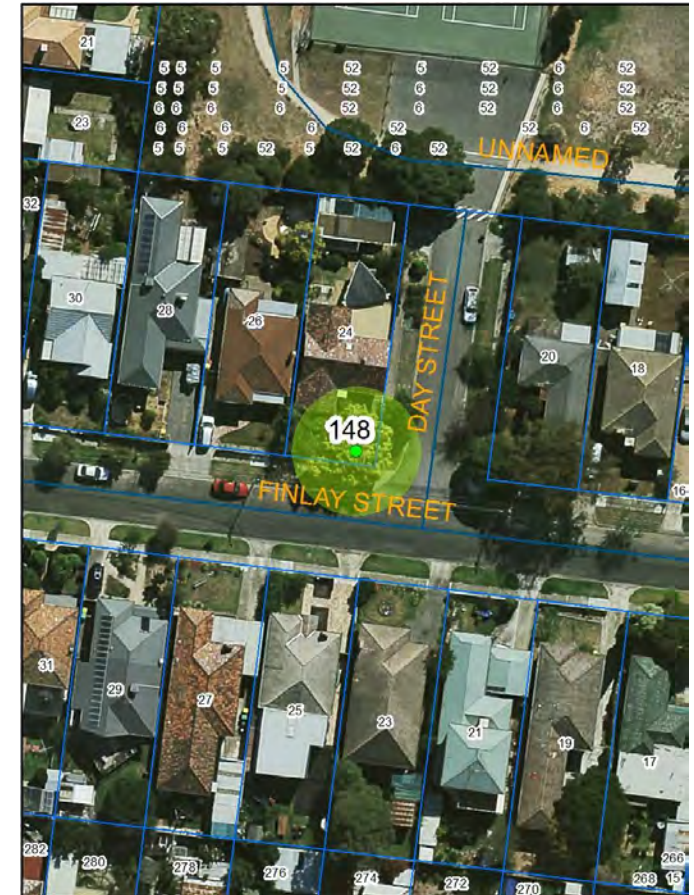
**Asset ID:** 148

**Failure Probability:** 4. Low

**Defects:** Codominant trunks

**Recommended Works:** No works

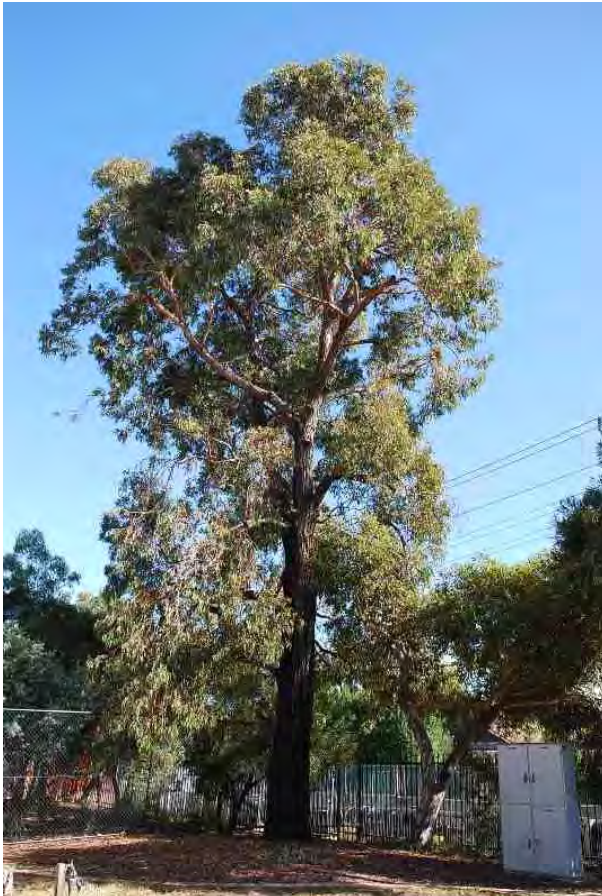
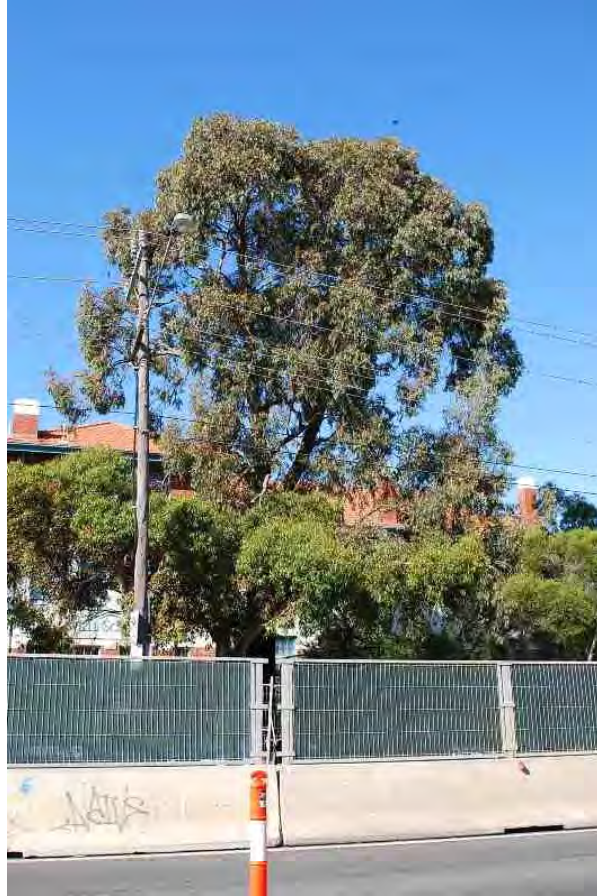
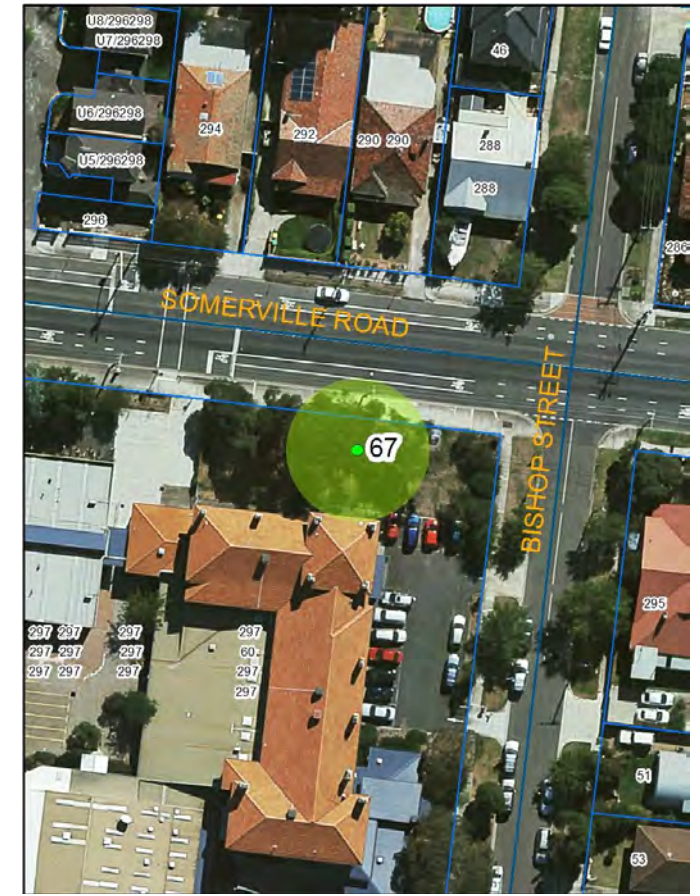
**Defects:** Codominant stems in canopy

**Recommended Works:** No works

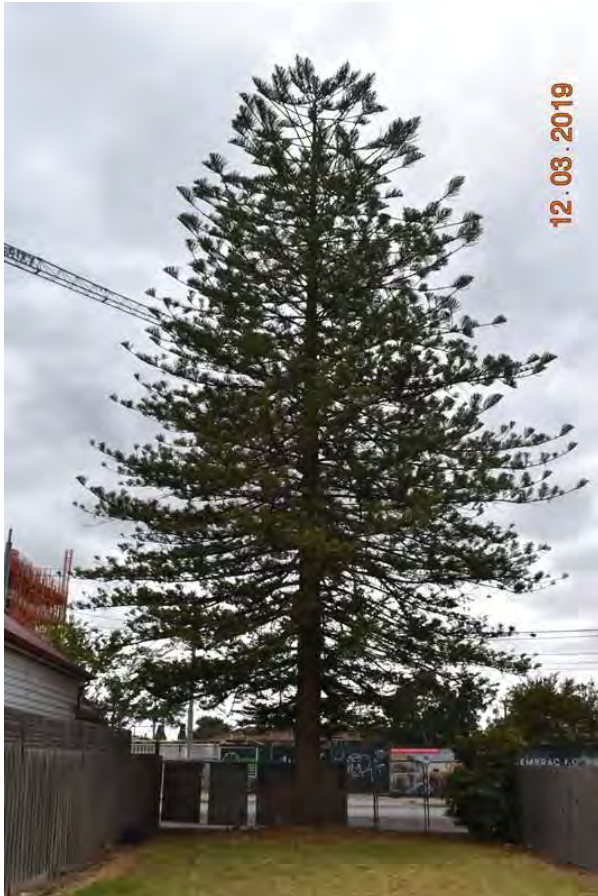
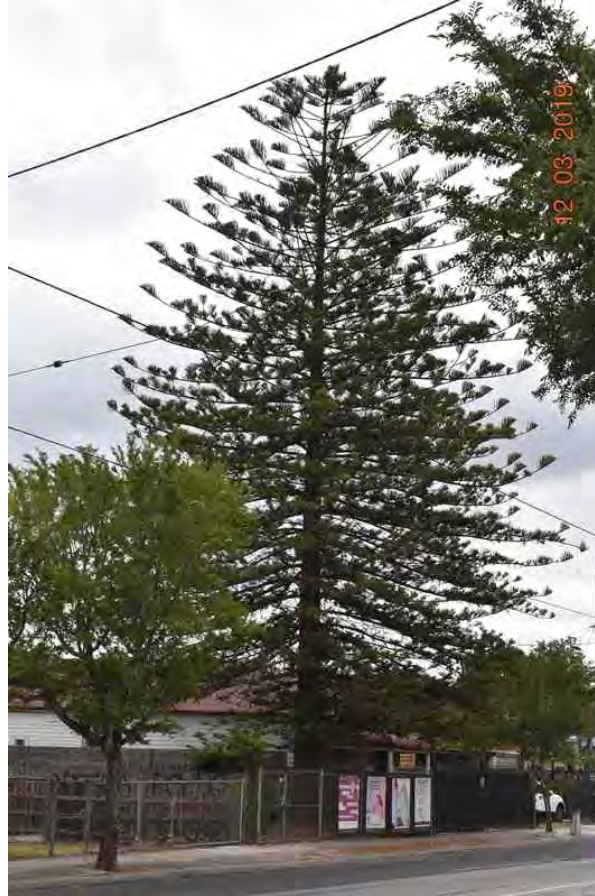
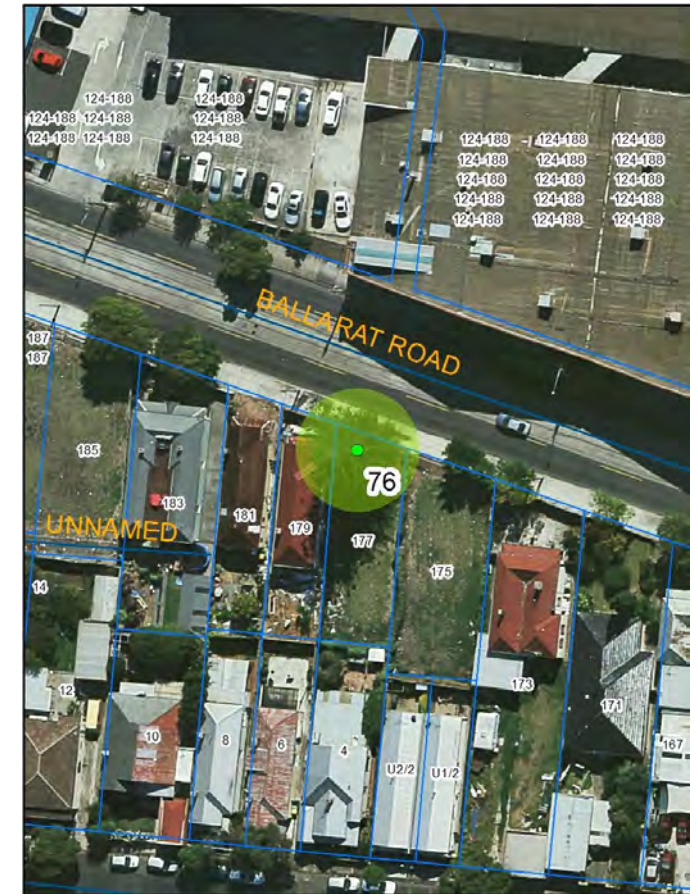
**Asset ID:** 76

**Defects:** None

**Recommended Works:** No works

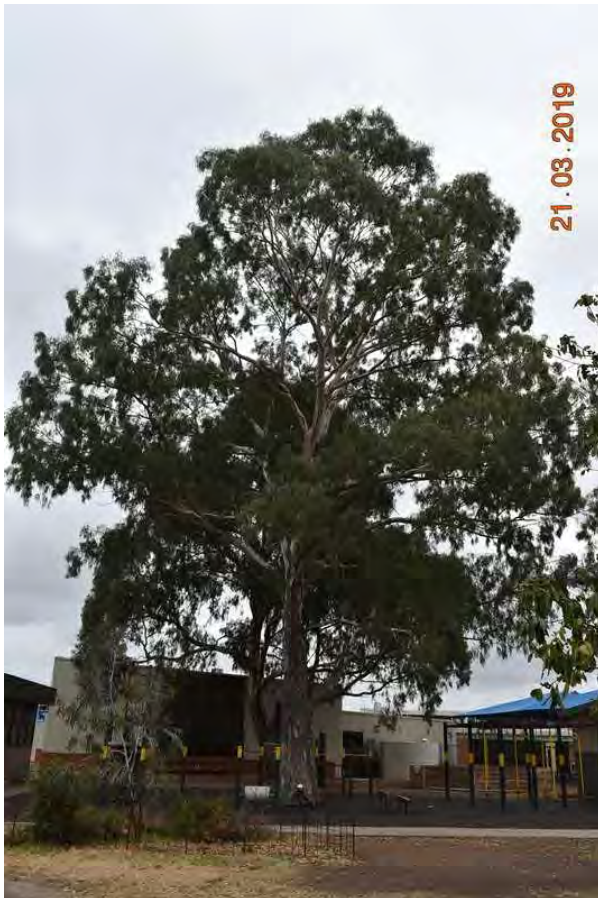
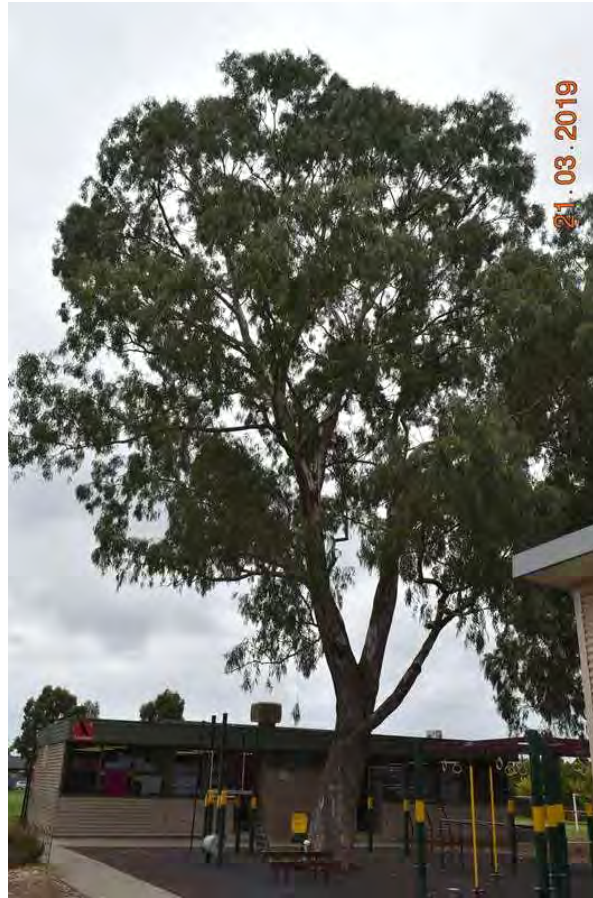
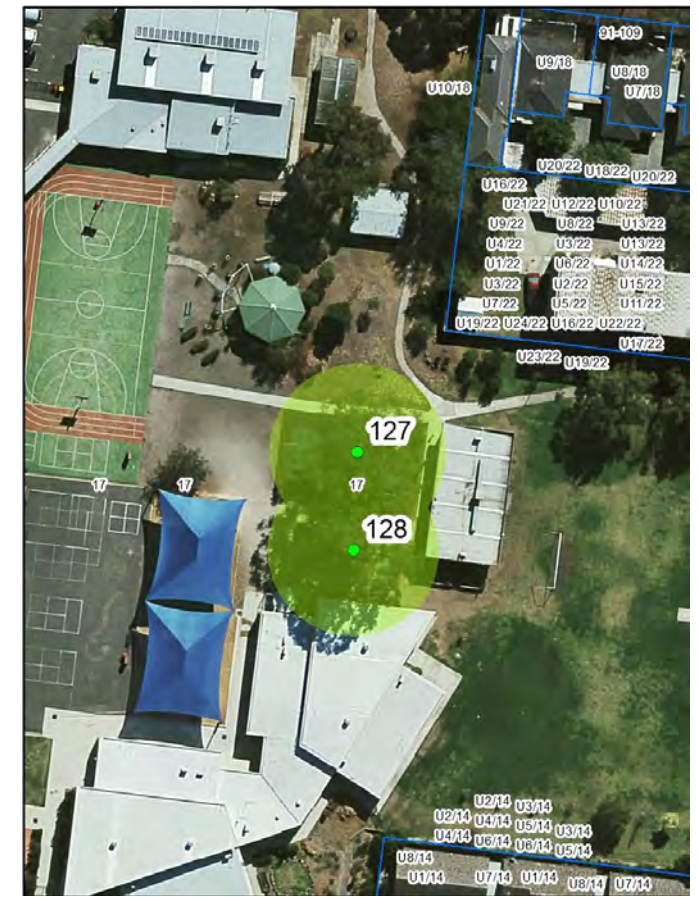
**Asset ID:** 127

**Significance Statement:** This is a large specimen in good condition, particularly in context with its built surrounds.

**Defects:** None

**Recommended Works:** No works

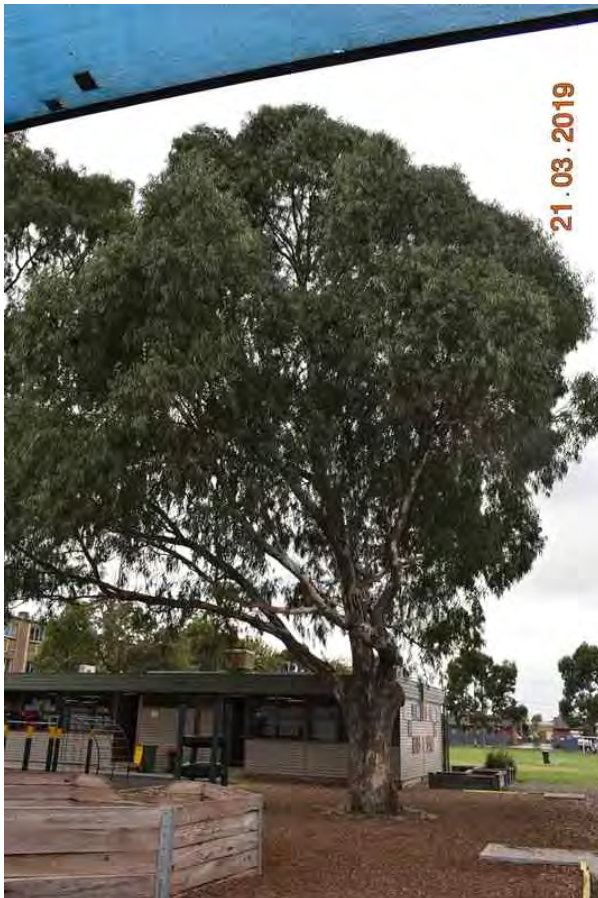
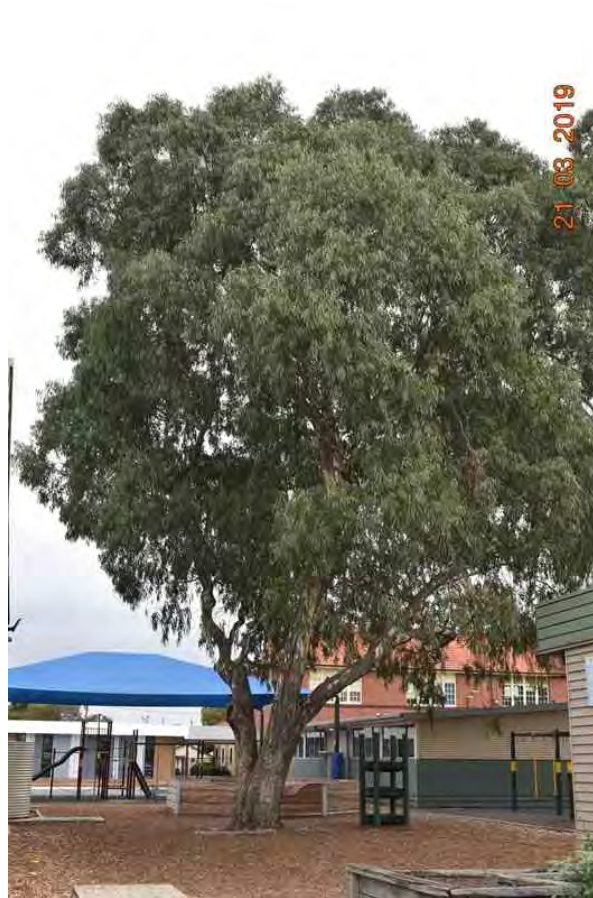
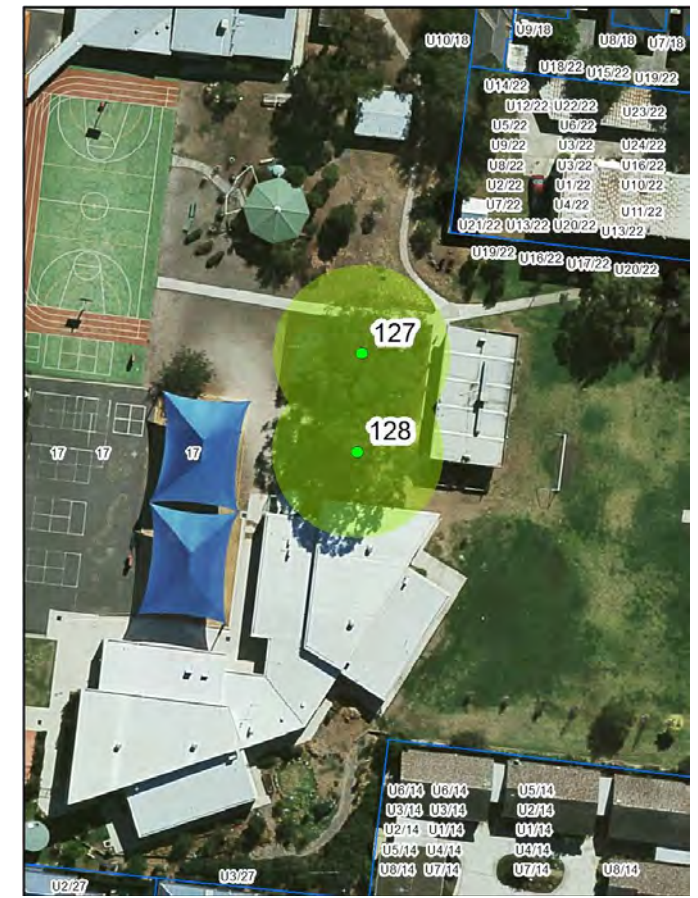
**Asset ID:** 128

**Defects:** Trunk lopped, Included bark in trunk, Codominant trunks

**Recommended Works:** No works

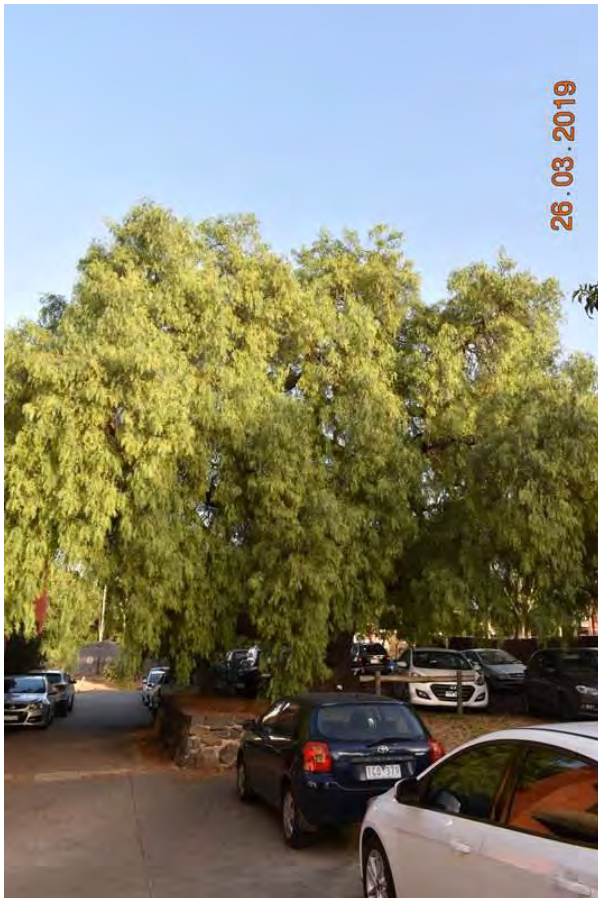
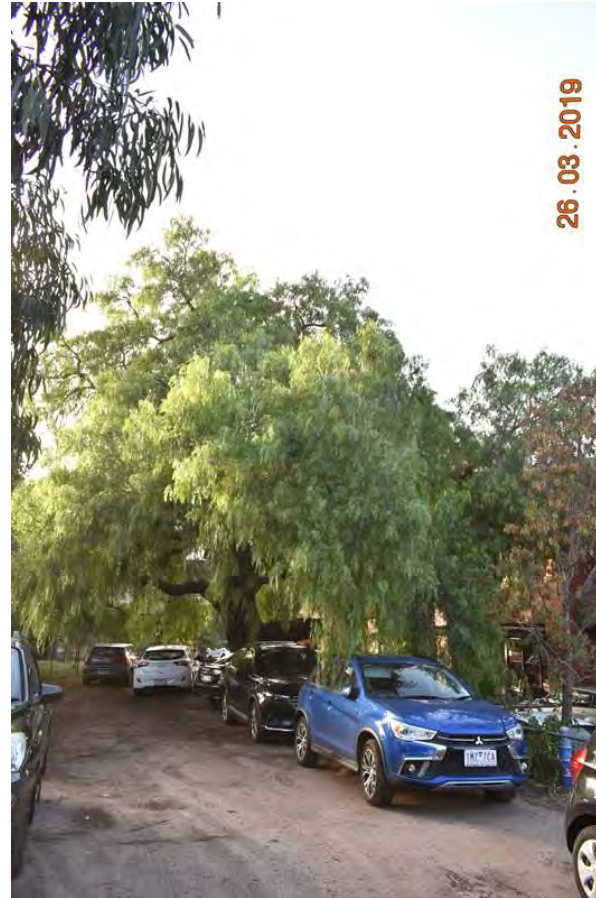
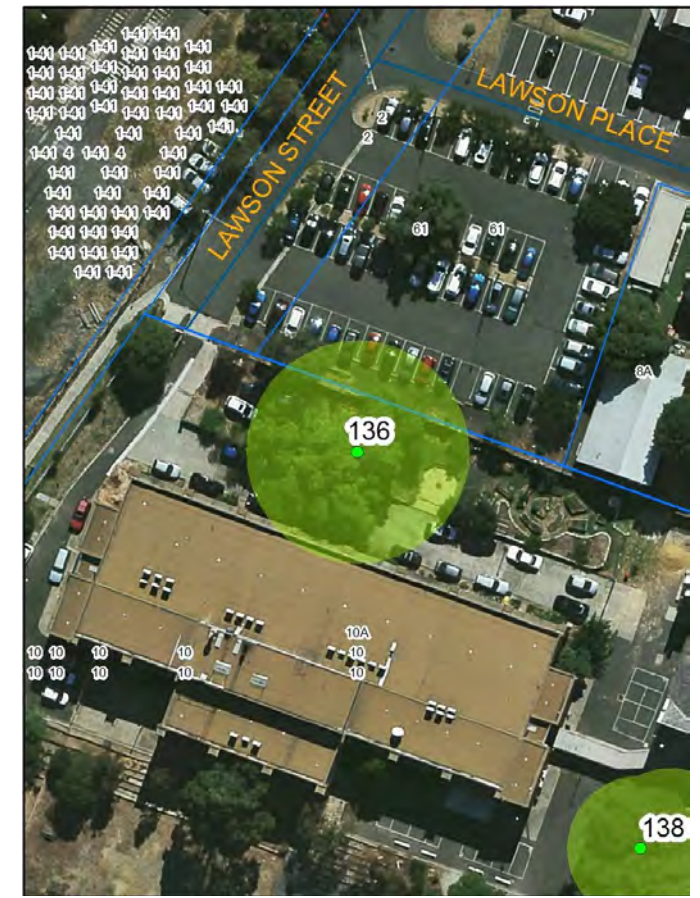
**Asset ID:** 136

**Approximate Age:** 100+ years  
**ULE:** 21-40 years  
**Health:** Good  
**Structure:** Fair  
**Failure Probability:** 4. Low  
**Failure Size:** 3. 101-250mm  
**Target:** 3. Pedestrians, 2-7/hr  
**Risk Score:** 1 in 5000000  
**Risk Category:** Low  
**Significance Statement:** This is a large old specimen in good condition, providing a widespread canopy and an expanse of shade to surrounding parked vehicles and pedestrians.

**Defects:** None  
**Recommended Works:** Risk reduction pruning  
**Works Priority:** Low  
**Comments:** Land set aside for public purposes  
**Record Type:** Single Tree  
**No. of Trees:** 1

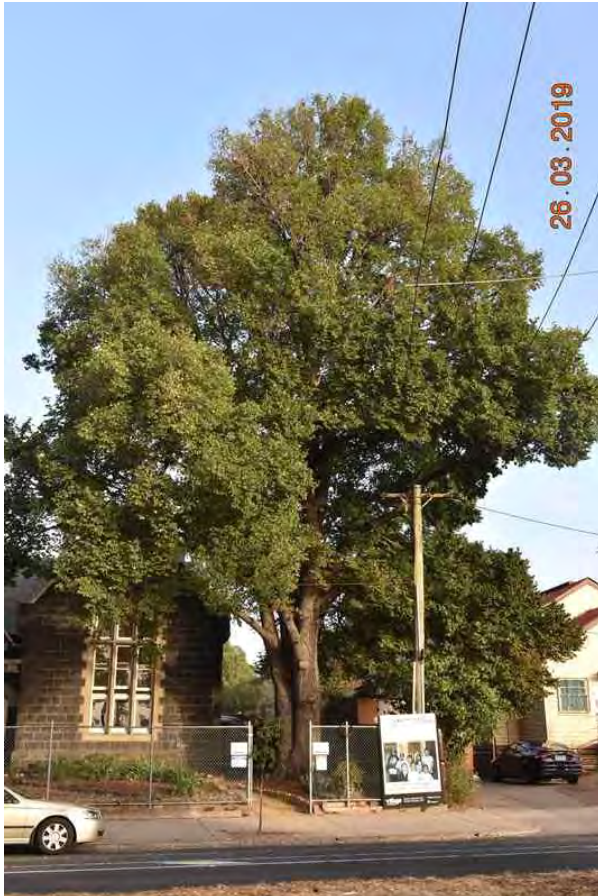
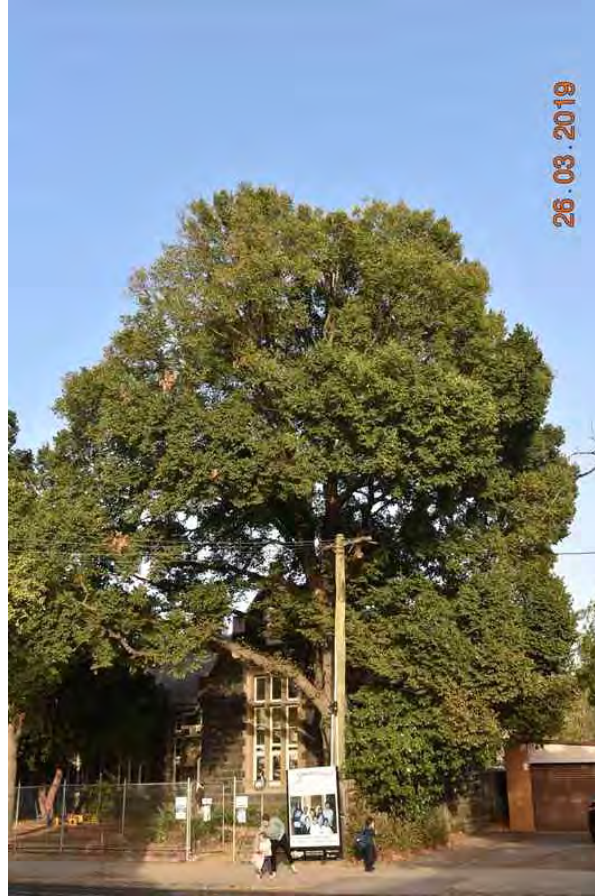
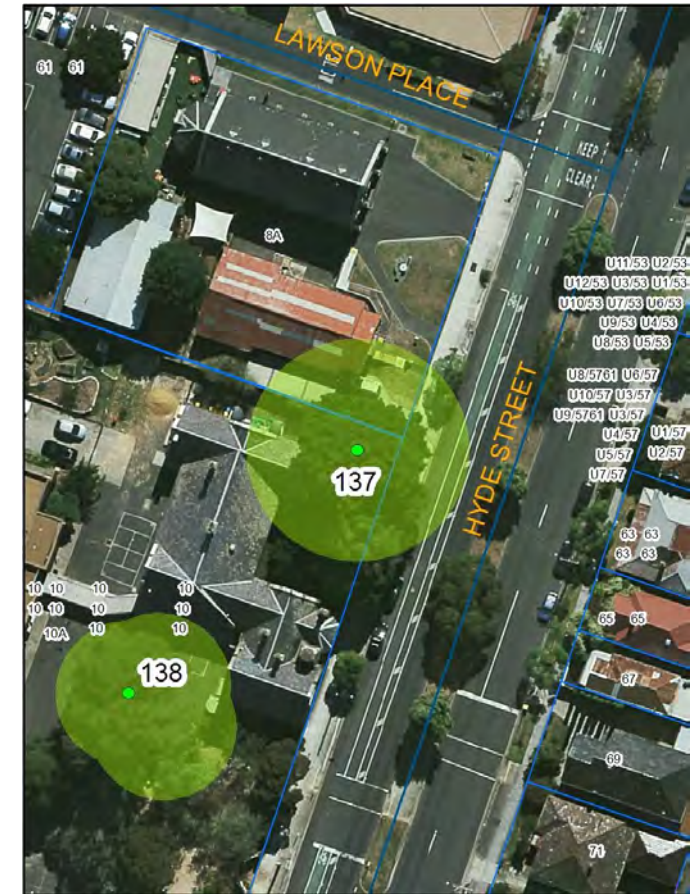
**Asset ID:** 137

**Defects:** Included bark in trunk, Codominant trunks

**Comments:** Some Elm Leaf Beetle damage. Tree is cabled. Land set aside for public purposes

**Recommended Works:** No works

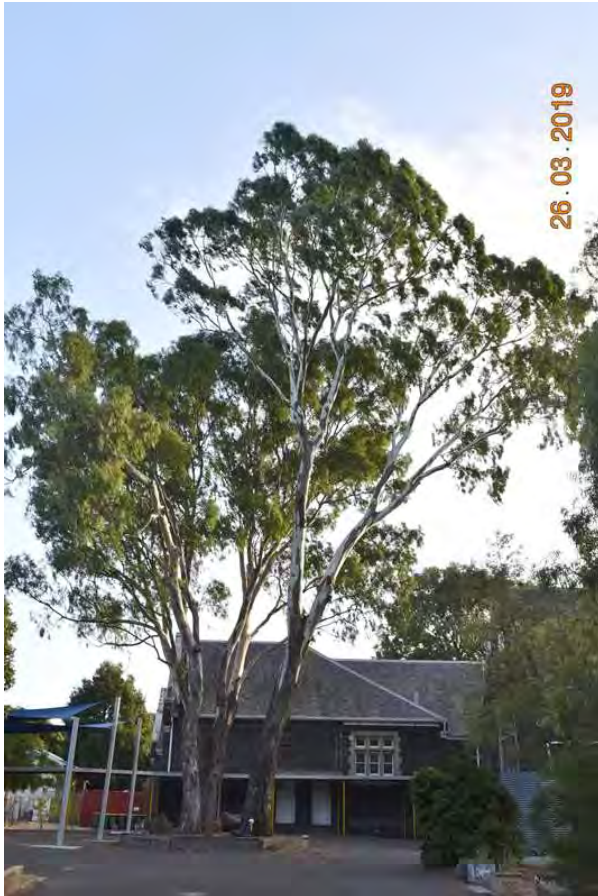
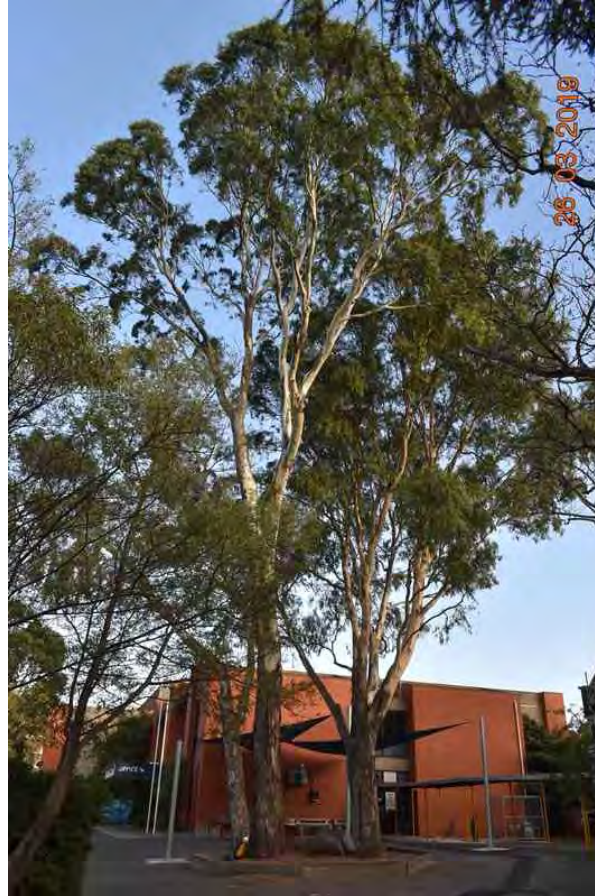
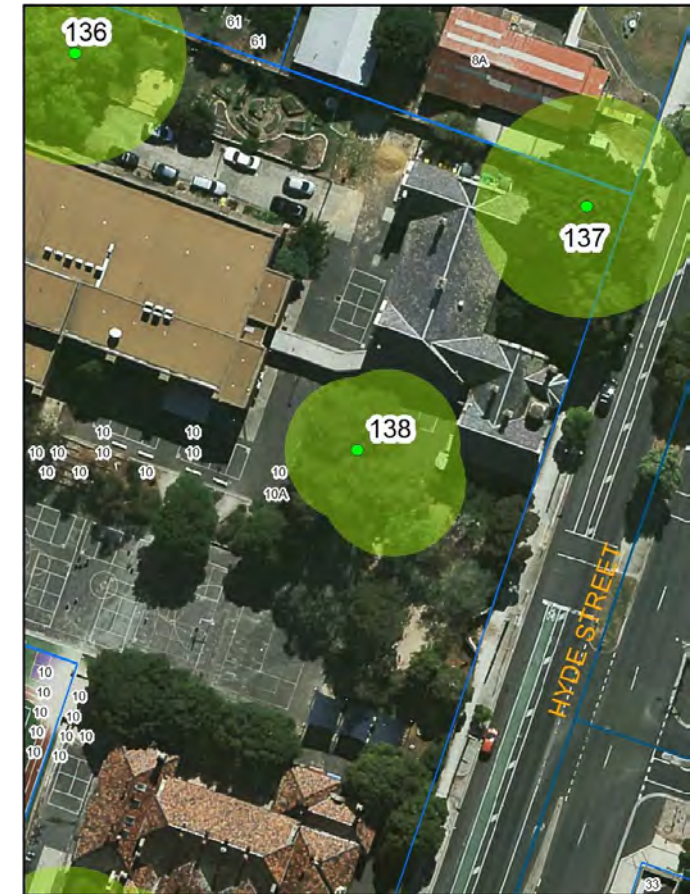
**Asset ID:** 138

**Defects:** Codominant trunks

**Recommended Works:** No works
